Derrybrien Wind Farm Development Decommissioning Project – Retained Development

GEOTECHNICAL STABILITY REPORT - WIND FARM SITE (PART I)

DERRYBRIEN WIND FARM
GEOTECHNICAL STABILITY REPORT & ASSESSMENT OF STABILITY IMPACTS OF ON-SITE ACTIVITIES

Document No:	**11-147-R04**	**Issue 02 (Rev. 0)**
Made:	Conor O'Donnell / Niamh Farrell	
Checked:	Conor O'Donnell

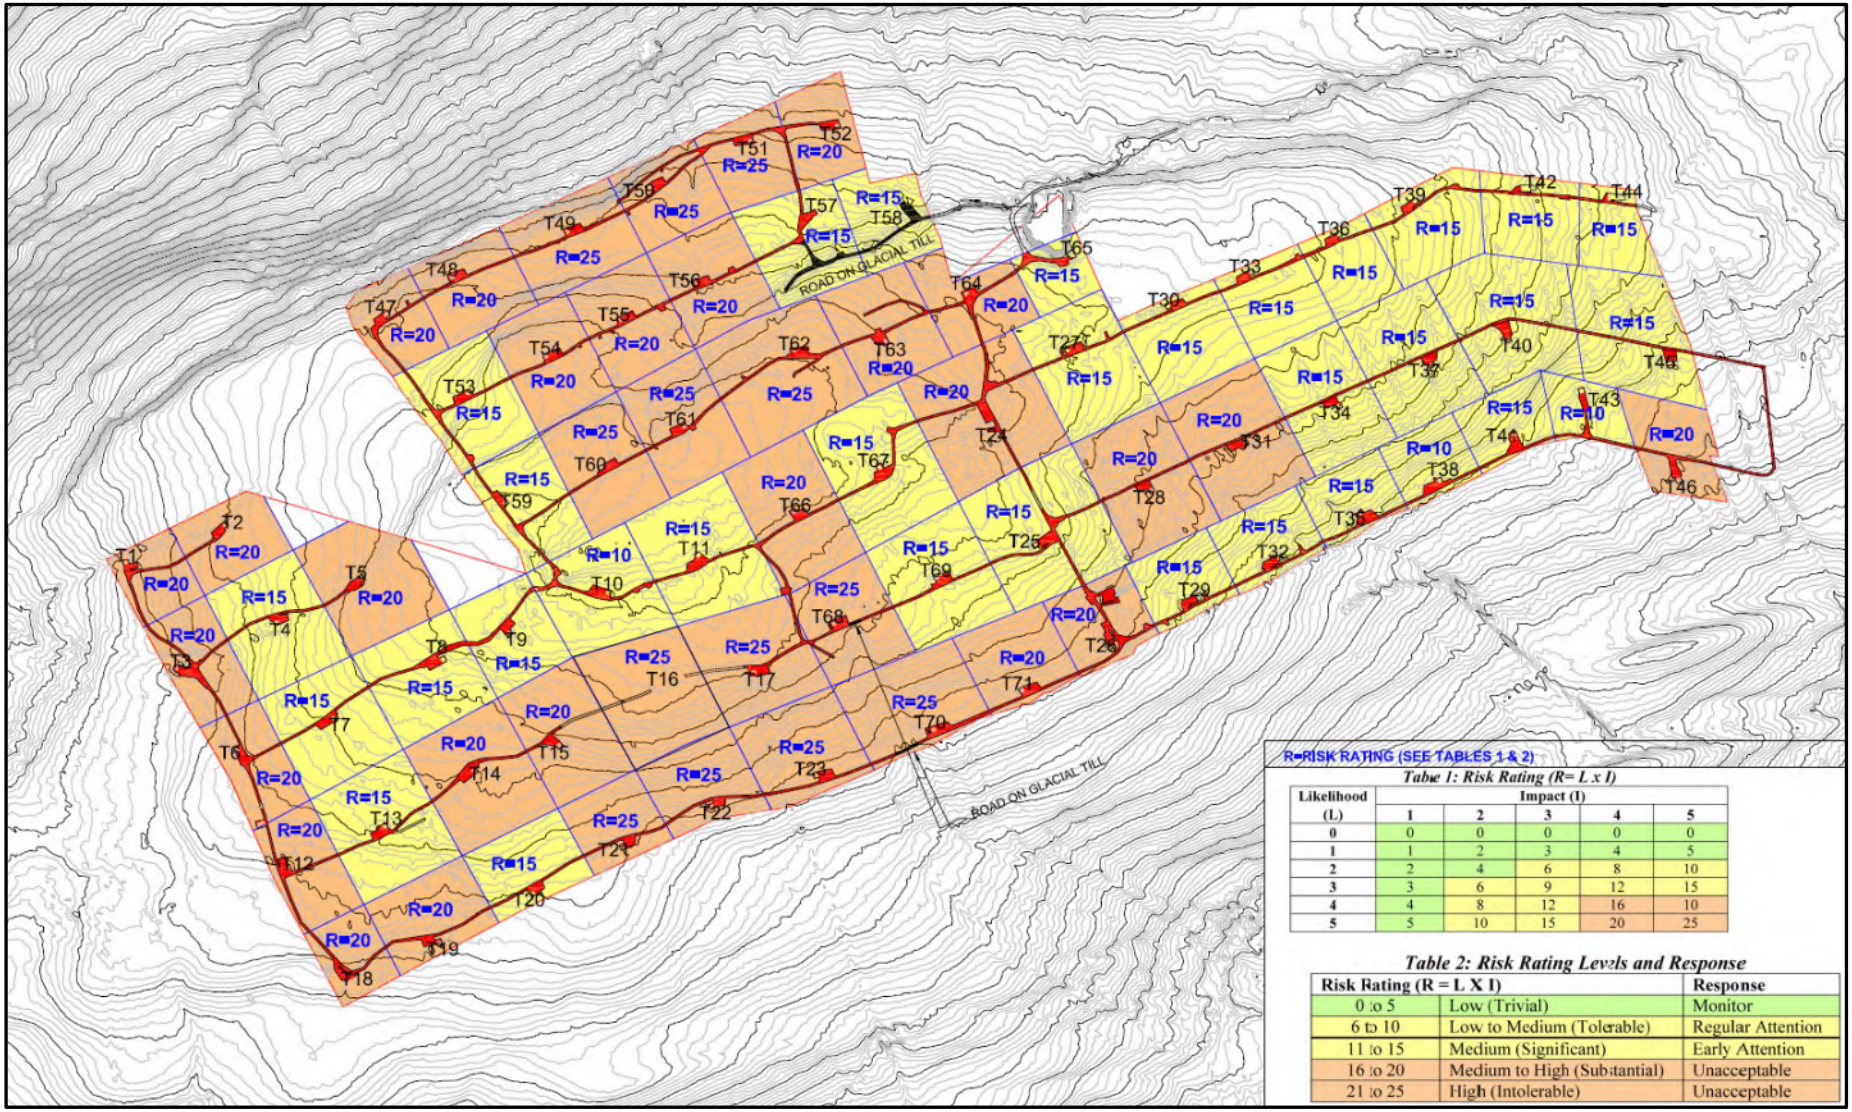
Figure 2-17 – Baseline Peat Stability Risk Assessment for site in original condition in 1998 prior to construction

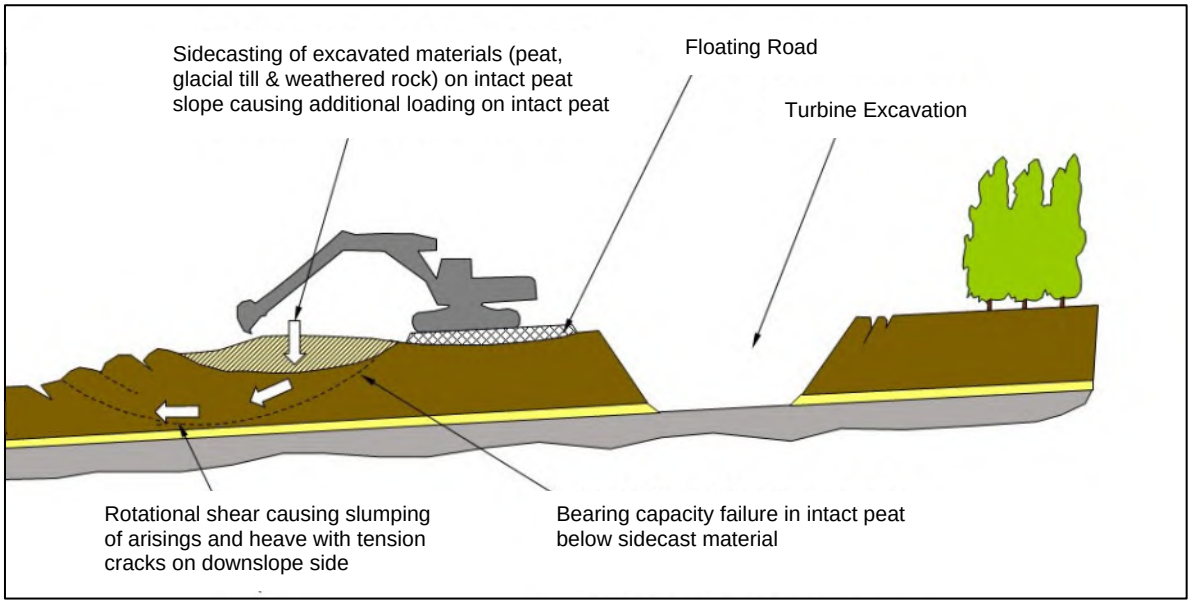
Figure 3-29 - Bearing capacity failure below sidecast materials

At Turbines T23, T29 and T66 there was a localised bearing capacity failure in the intact peat under the weight of the sidecast material. At each of these turbines the arisings from the foundation excavation were placed on the intact peat slopes along the edge of the forest on the downslope side of the turbine and floating road.

The bearing capacity failures were characterised by a rotational shear failure in the intact peat under the arisings, which caused slumping of the excavated material and heave with tension cracks in the intact peat downslope, giving the slope an irregular stepped profile, as shown in Figure 3-29. Some trees within the zone of ground movement were tilted over.

Turbines T23 and T29 are located along the southern boundary of the site. The bearing capacity failure at these turbines occurred in relatively shallow peat (1.0-1.5m deep) on gently sloping ground (2-4°).

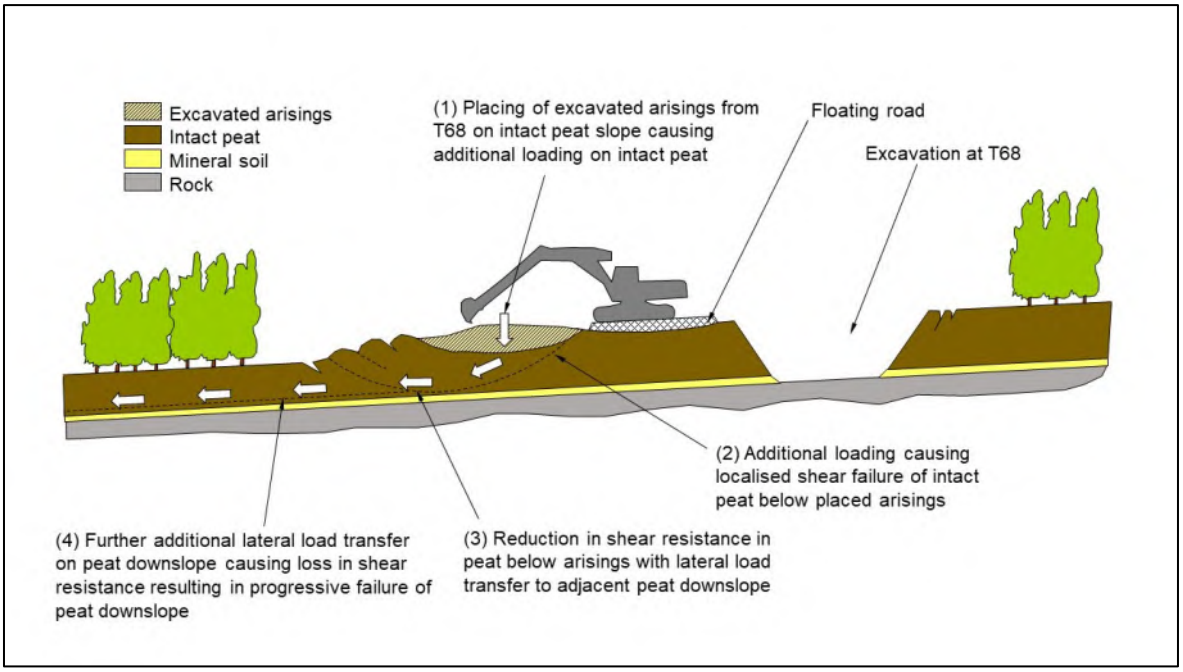
The failure mechanism that AGEC proposed is shown schematically in Figure 3-30. The additional surcharge load from the arisings on the intact peat slopes could have initially caused a localised shear failure in the underlying intact peat. This would have reduced its shear resistance and resulted in a redistribution or transfer of lateral load to the adjacent peat downslope. Additional transfer of lateral loading as more material was placed on the slopes could have led to a progressive shear failure and reduction in shear resistance along the base of the peat further downslope. Ultimately, this could have led to the large planar or translational peat slide that occurred on the inclined slopes.

Figure 3-30 - Schematic of likely failure mechanism of 16th October peat slide

Although the peat slide occurred while the excavated peat was being sidecast on the intact peat slopes downslope from Turbine T68, site observations at the time of the slide indicated that the failed mass of peat initially moved as a rigid body in a large planar slide over a wide area on the slopes of the mountain. The magnitude of loading from the sidecast material over a very small area at the top of the slide was actually quite low relative to the scale and characteristics of the slide. Furthermore, excavated arisings from the turbine foundations had already been sidecast on the intact peat slopes in a number of other locations on the site without causing a failure in the peat. Therefore, on its own it does not fully explain why the slide occurred at T68.

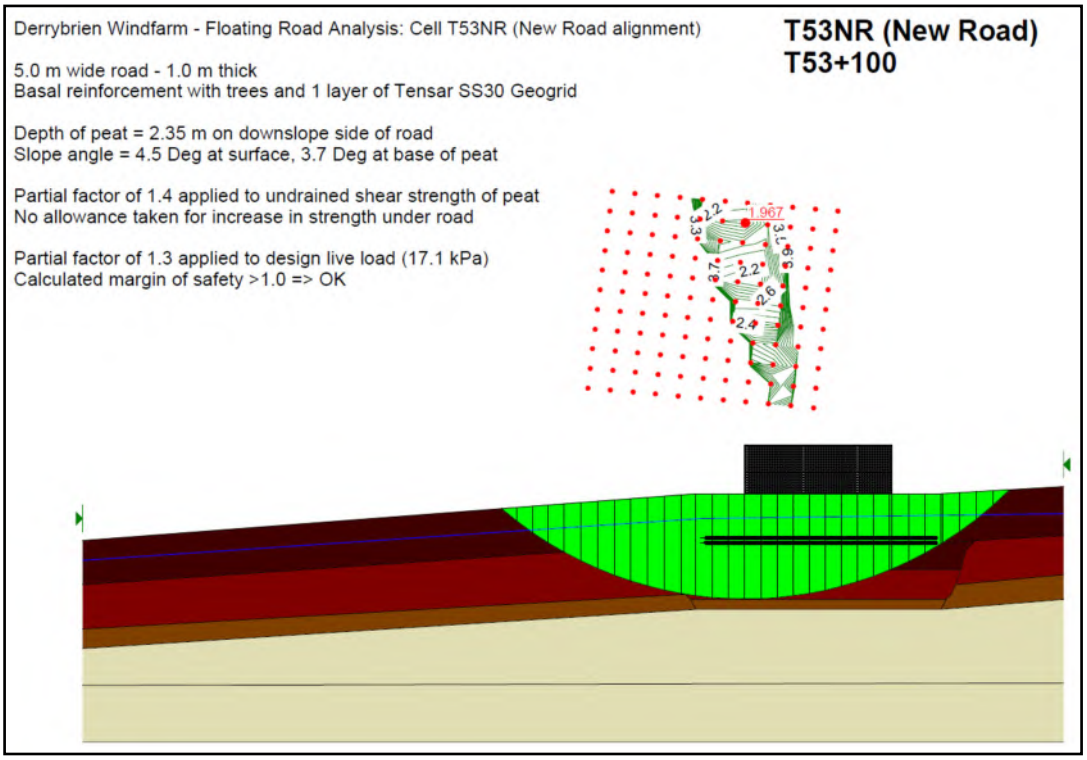
The road was conservatively modelled as a 5.0 m wide x 1.0 m thick layer of rockfill reinforced with geogrids. A live load surcharge of 17.1kN/m^2 was applied over a 3.0 m wide strip at the centre of the road to represent the design crane load.

The analyses were carried out using Design Approach 3 (DA-3) of IS-EN1997-1 – Eurocode 7 for Geotechnical Design, Part 1 – General Rules. Partial factors of 1.4 and 1.3 were applied to the characteristic undrained shear strength and live load surcharge, respectively. Under these conditions a calculated margin of safety >1.0 was acceptable. Figure 3-31 shows an example of the analyses results.

Figure 3-31 - Typical Results of Slope/W Analyses on sections of the floating roads

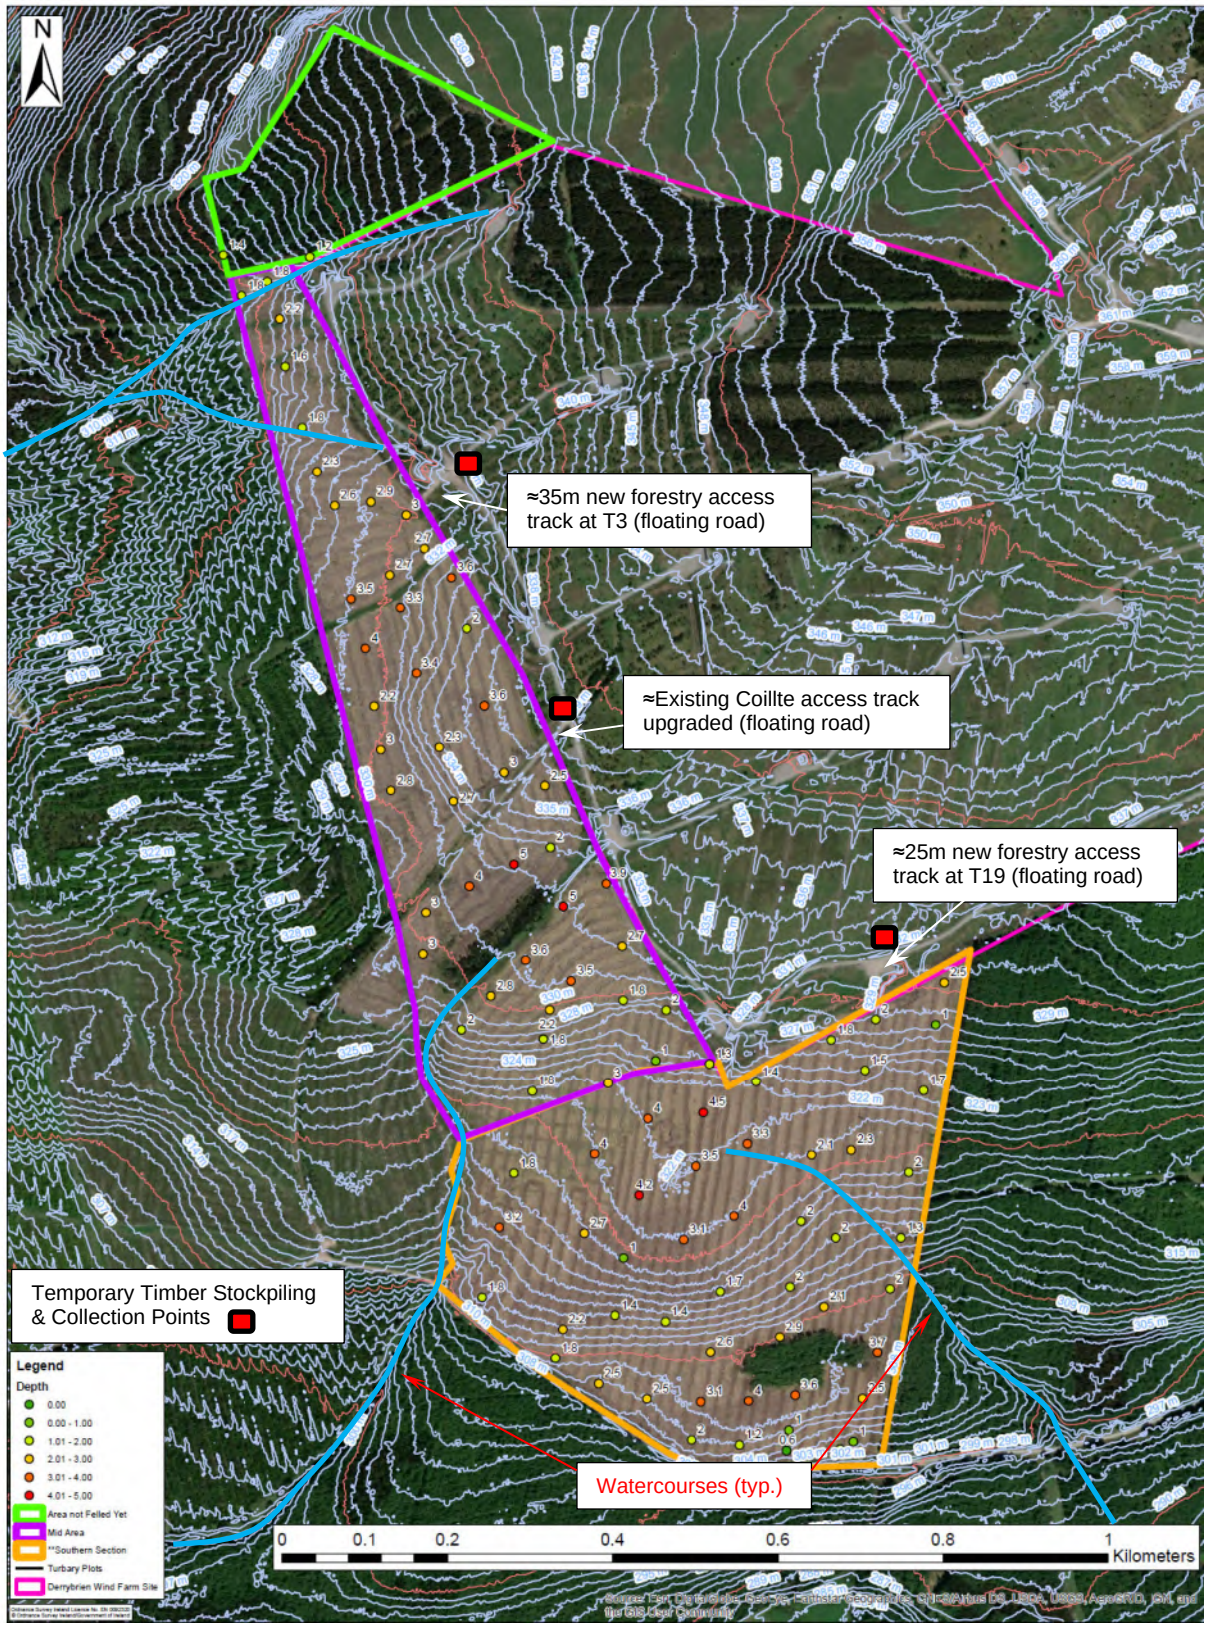
Figure 4-3 shows the topography, peat depth and hydrology in the area where the trees were felled. There are some zones within the felled area where there is a locally higher risk of peat instability, particularly at the convex break in slope along the downslope edge of the gently sloping terraces of locally deeper peat (4-5m) upslope from the watercourses on this side of the wind farm site. However, the live load surcharge from the type of forestry equipment that was used was localised and spread out over the surface of the peat to prevent concentrated loading so that the risk of a peat slide was generally **Low**. Therefore, the effect of the live load surcharge on the stability of the peat was **Medium to Low**, and the significance of the effect was **Slight**.

No incidents of peat instability occurred when the trees were felled.

Figure 4-3- Location and extent of tree felling on the west side of the wind farm site in 2018 showing LiDAR survey contours, natural watercourses and peat depth probes.

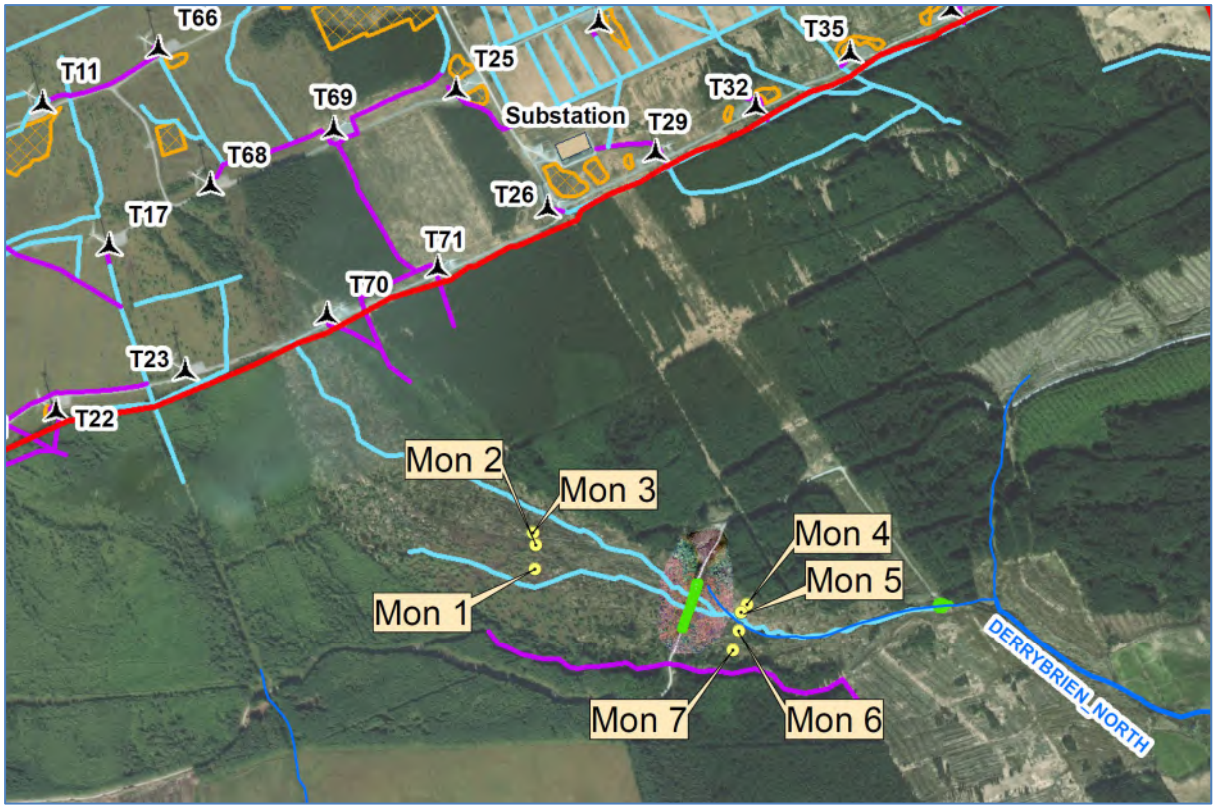
Figure 5-1 shows the location of 7 No. survey monitoring points (Mon 1 to Mon 7) that were established on the peat within the slide area for long-term monitoring of peat movement. Monitoring Points 1-3 are upslope of Barrage No.1, which was constructed across the slide in 2003 downslope from the wind farm site as part of the efforts to contain the peat. The barrage was constructed of rockfill supported on the underlying glacial till. Monitoring Points 4-7 are downslope of the barrage. Figure 5-1 shows movements recorded at the monitoring points between May 2005 and August 2017.

Figure 5-1: Location of survey monitoring points within the slide area (ESBI Drawing No. QS-000192-01-D1-D451-009)

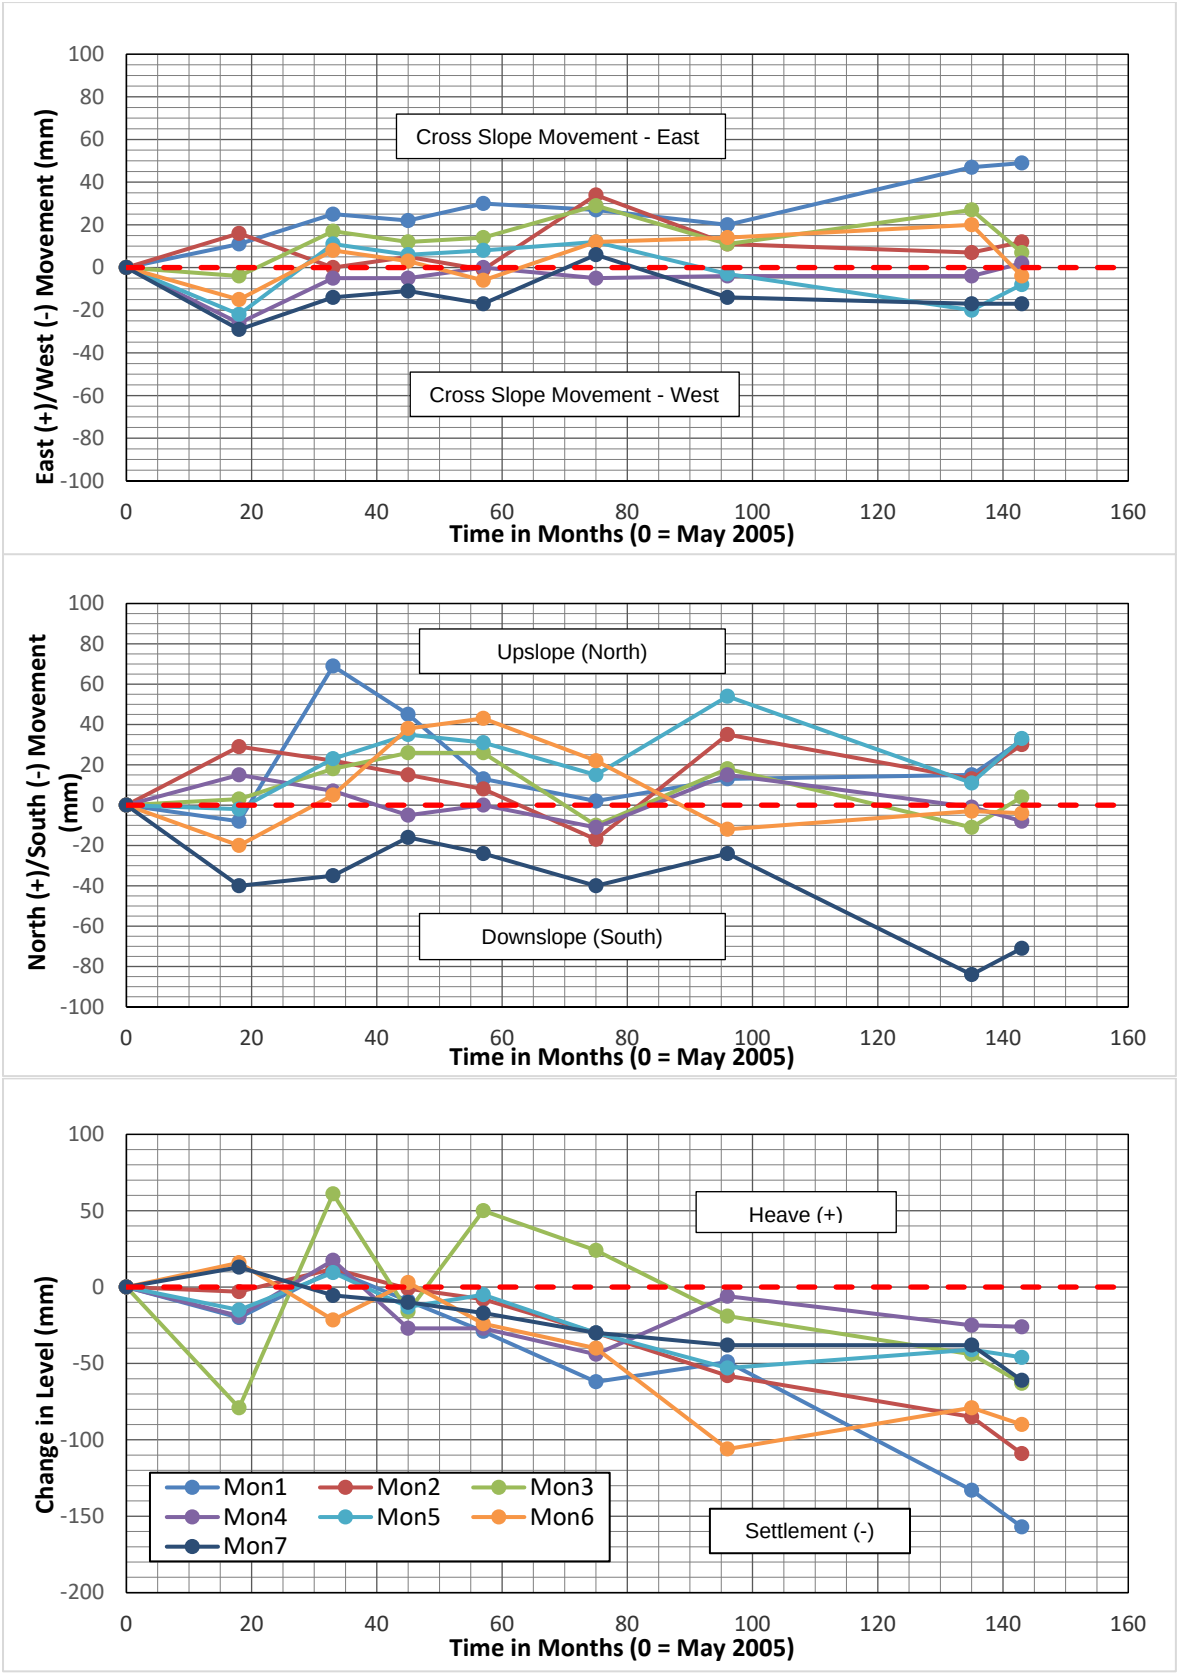
Between 2005 and 2017 the change in Easting and Northing of the survey points was <20-30mm, which is not a significant movement for the peat and is probably within the accuracy of the method of measurement, particularly when it is considered that a positive movement to the North is actually uphill, which is not possible. A slightly higher movement of 70-85 mm to the South was recorded at Monitoring Point No. 7. However, at this location downslope is to the East (see Figure 5-1). Therefore, this would be cross-slope movement, or possibly slightly upslope if the sides of the valley rise on this side. Therefore, it does not indicate that there was any significant creep or downslope movement of the peat within the slide area.

All of the monitoring points consistently showed settlement ranging from 25 mm to 150 mm, typically <100 mm, over the 12 year monitoring period. This is not surprising because the disturbed remoulded peat within the slide area would have dried out over time due to drainage within the slide, which would have caused it to consolidate or settle in-situ. This is supported by the fact that no significant downslope movement was recorded.

Figure 5-2 - Movements recorded at monitoring points in the slide area

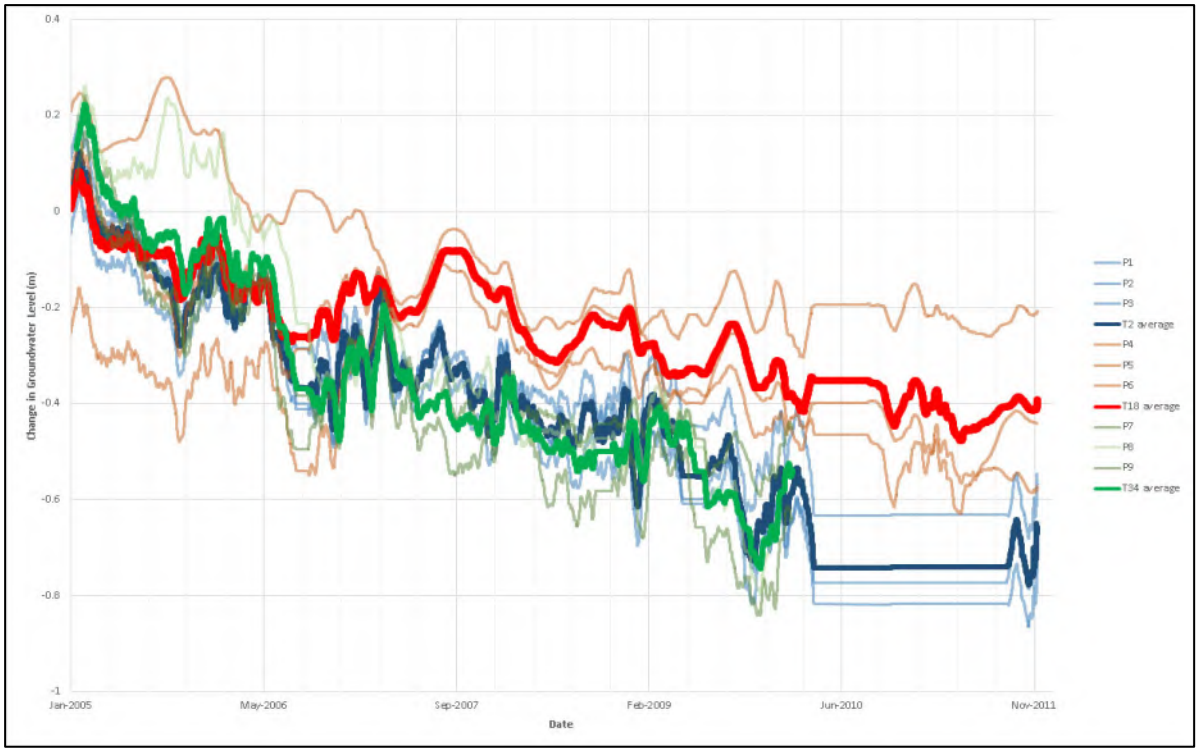
The piezometers were electronic vibrating-wire push-in piezometers that were installed with the tip of the piezometer at the base of the peat to provide a continuous record of daily and seasonal groundwater level fluctuations. Figure 5-3 shows the readings from the piezometers at T2, T18 and T34 up to November 2011. The readings from the piezometers at T49/T50 are not plotted because they malfunctioned after installation.

The short-term regular fluctuation in the data reflects seasonal fluctuations in groundwater level as well as changes in atmospheric pressure, which directly affect the water level readings as they are based on pressure. Nevertheless, the results indicate that, on average, between December 2005 and November 2011 the groundwater level in the peat gradually dropped by about 0.40m at Turbine T18 in the SW corner of the wind farm site, and by about 0.75m at T2 and T34 in the NW corner of the site and in the turbary plots at the east end of the site, respectively.

Figure 5-3 – Groundwater level readings from electronic piezometers at Turbines T2, T18 & T34

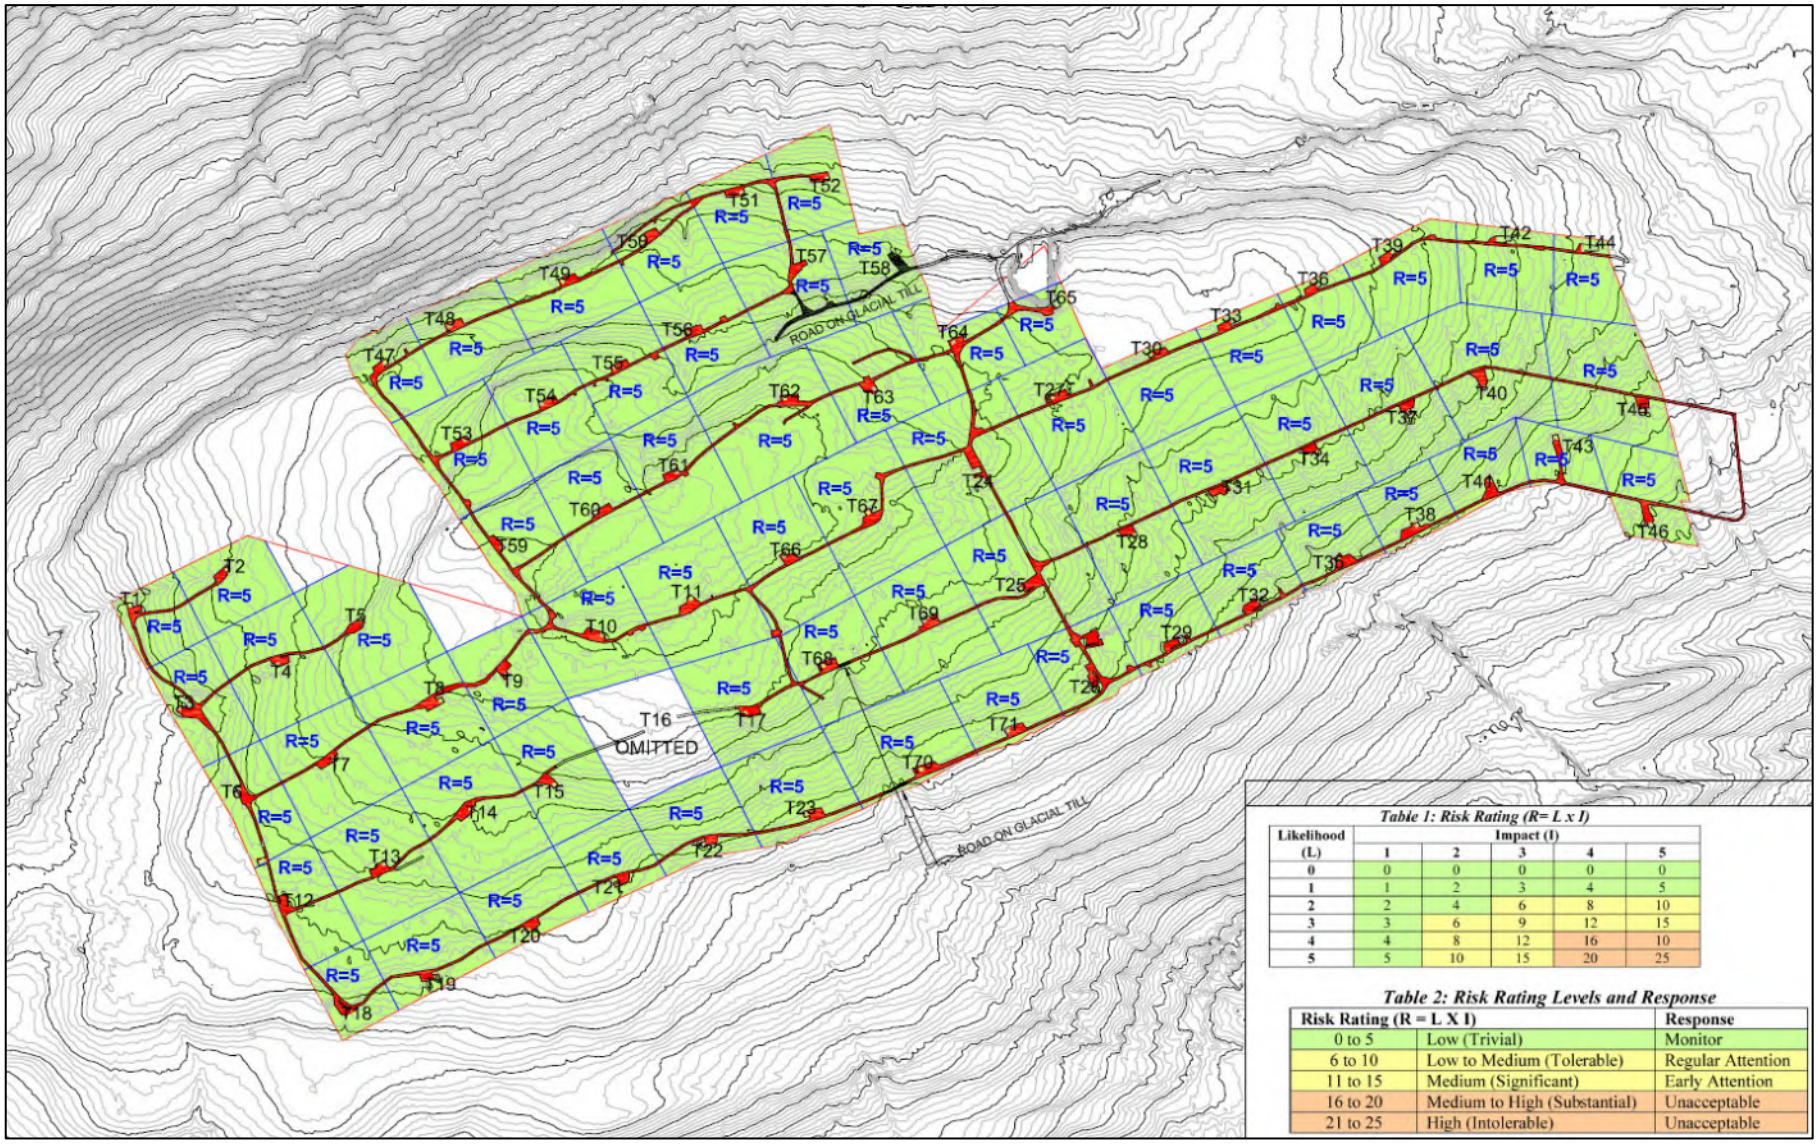
Figure 5-8: Updated PSRA for Site Activities during Decommissioning with Appropriate Mitigation Measures

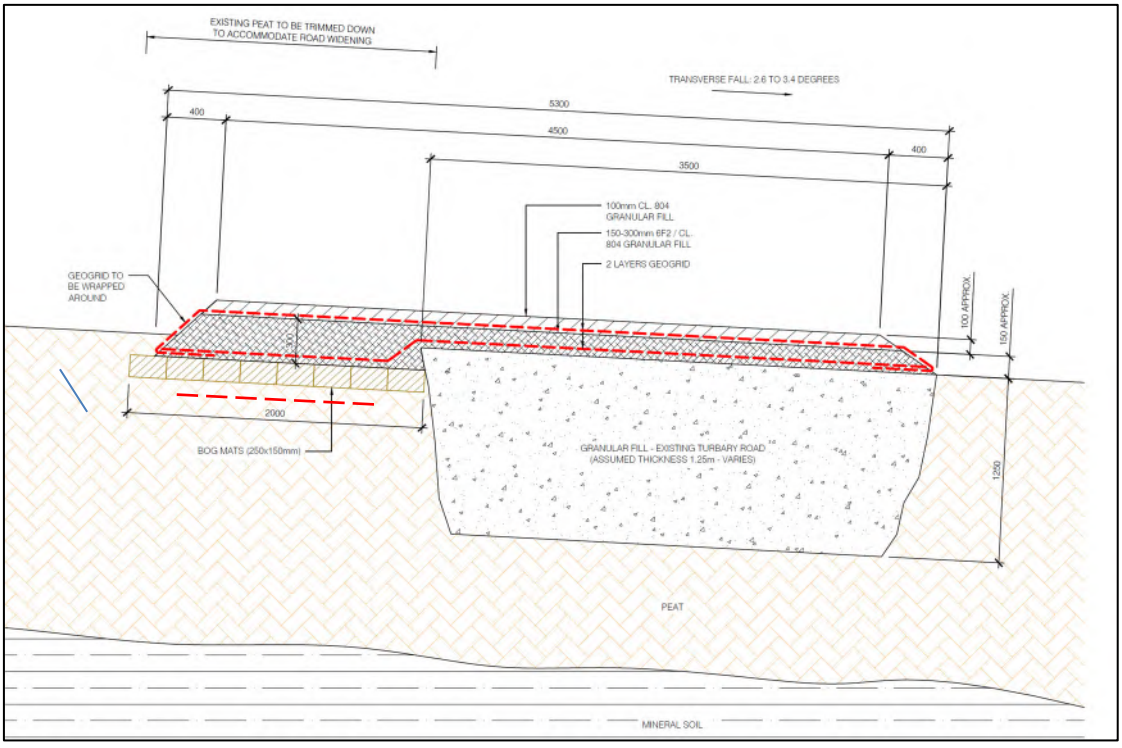
Figure 6-2 – Typical temporary road widening detail.

Where necessary, narrow sections of the turbary road between Turbines T35 and T45 and between T43 and T46 will be temporarily widened by about 1.0-1.5m to provide safe access to the turbines for the Grove GMK6300 mobile crane during decommissioning. A typical detail for the temporary road widening is shown in Figure 6-2. It will involve capping and widening the existing floating road to a minimum width of 4.5m with a 150-300mm thick layer of Class 6F2 crushed rock granular fill reinforced with two layers of geogrid and surfaced with a 100mm thick layer of Clause 804 granular subbase material. Timber bog mats will initially be laid on the surface of the peat along the widened side of the roads to spread out the loads from the mobile cranes and granular capping/subbase layers. Geogrid reinforcement will be laid continuously across the full width of the road and will be designed with a wraparound detail at the edge of the road to reduce deflections under the concentrated wheel loads. Where necessary the peat under the widened section of the road will be trimmed down to ensure that the finished surface of the road has a uniform profile across the full width. The intact peat turves will be retained for reinstatement on completion of the decommissioning works.

Wherever possible the road will be widened on the upslope side. This will reduce the likelihood of peat instability compared to widening on the downslope side because the peat under the existing road has compressed under the weight of the fill giving it a higher strength and a greater resistance to shear failure than the virgin peat downslope from the road.

A typical detail for the temporary road widening is shown in Figure 6-2. The minor civil works will involve widening the existing floating road with a 300mm thick layer of Class 6F2 crushed rock granular capping material supported on a layer of timber bog mats placed on the peat. The capping layer will be reinforced with geogrids and surfaced with a 100mm thick layer of Cl.804 crushed rock granular subbase material. The impact of this will be to apply a small dead load surcharge of approximately 8.5kN/m^2 on the peat upslope from the road. This is equivalent to the dead load from less than 1.0m of peat over the same area, which is low.

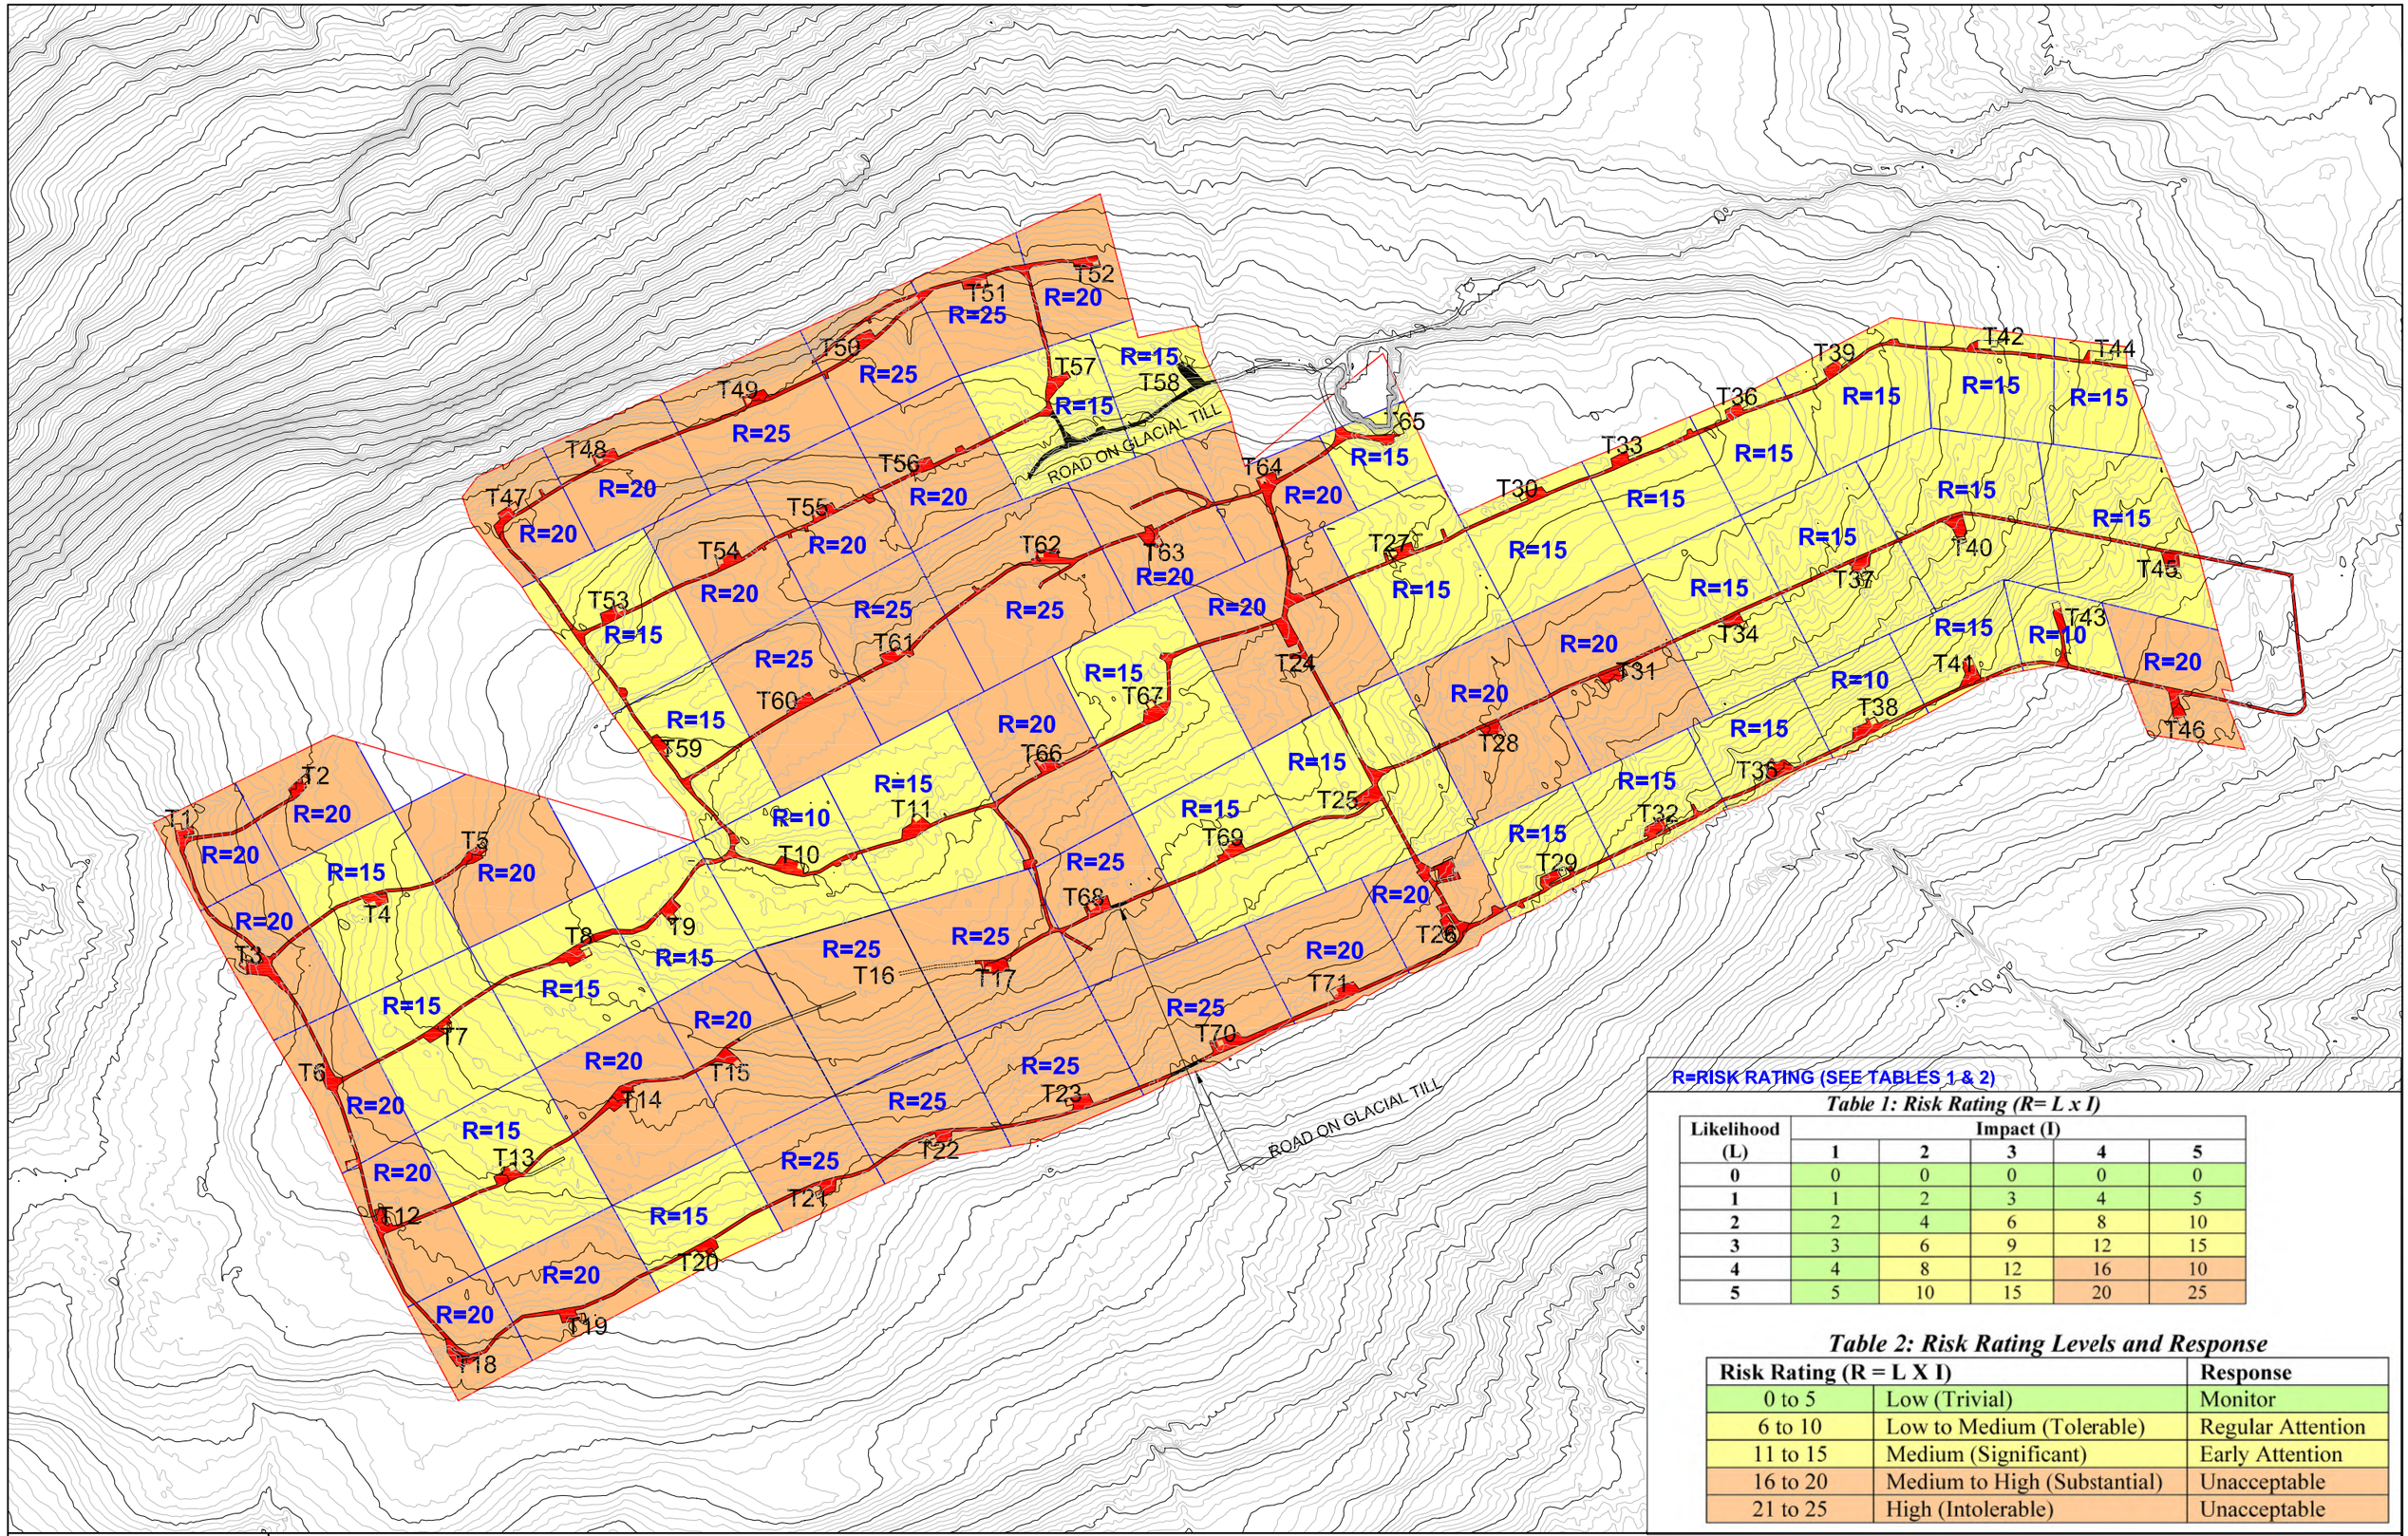
Scales	Date	Page no.	Drawing No.:
1:10,000	30/10/2019	1 of 1	Figure B–1
Version: Final	Drawn: NMF	Checked: COD

Title: Baseline PSRA of site in original condition in 1998 prior to construction
