Derrybrien Wind Farm Development Decommissioning Project – Retained Development

GEOTECHNICAL STABILITY REPORT - WIND FARM SITE (PART I)

DERRYBRIEN WIND FARM
GEOTECHNICAL STABILITY REPORT & ASSESSMENT OF STABILITY IMPACTS OF ON-SITE ACTIVITIES

Document No:	**11-147-R04**	**Issue 02 (Rev. 0)**
Made:	Conor O'Donnell / Niamh Farrell	
Checked:	Conor O'Donnell

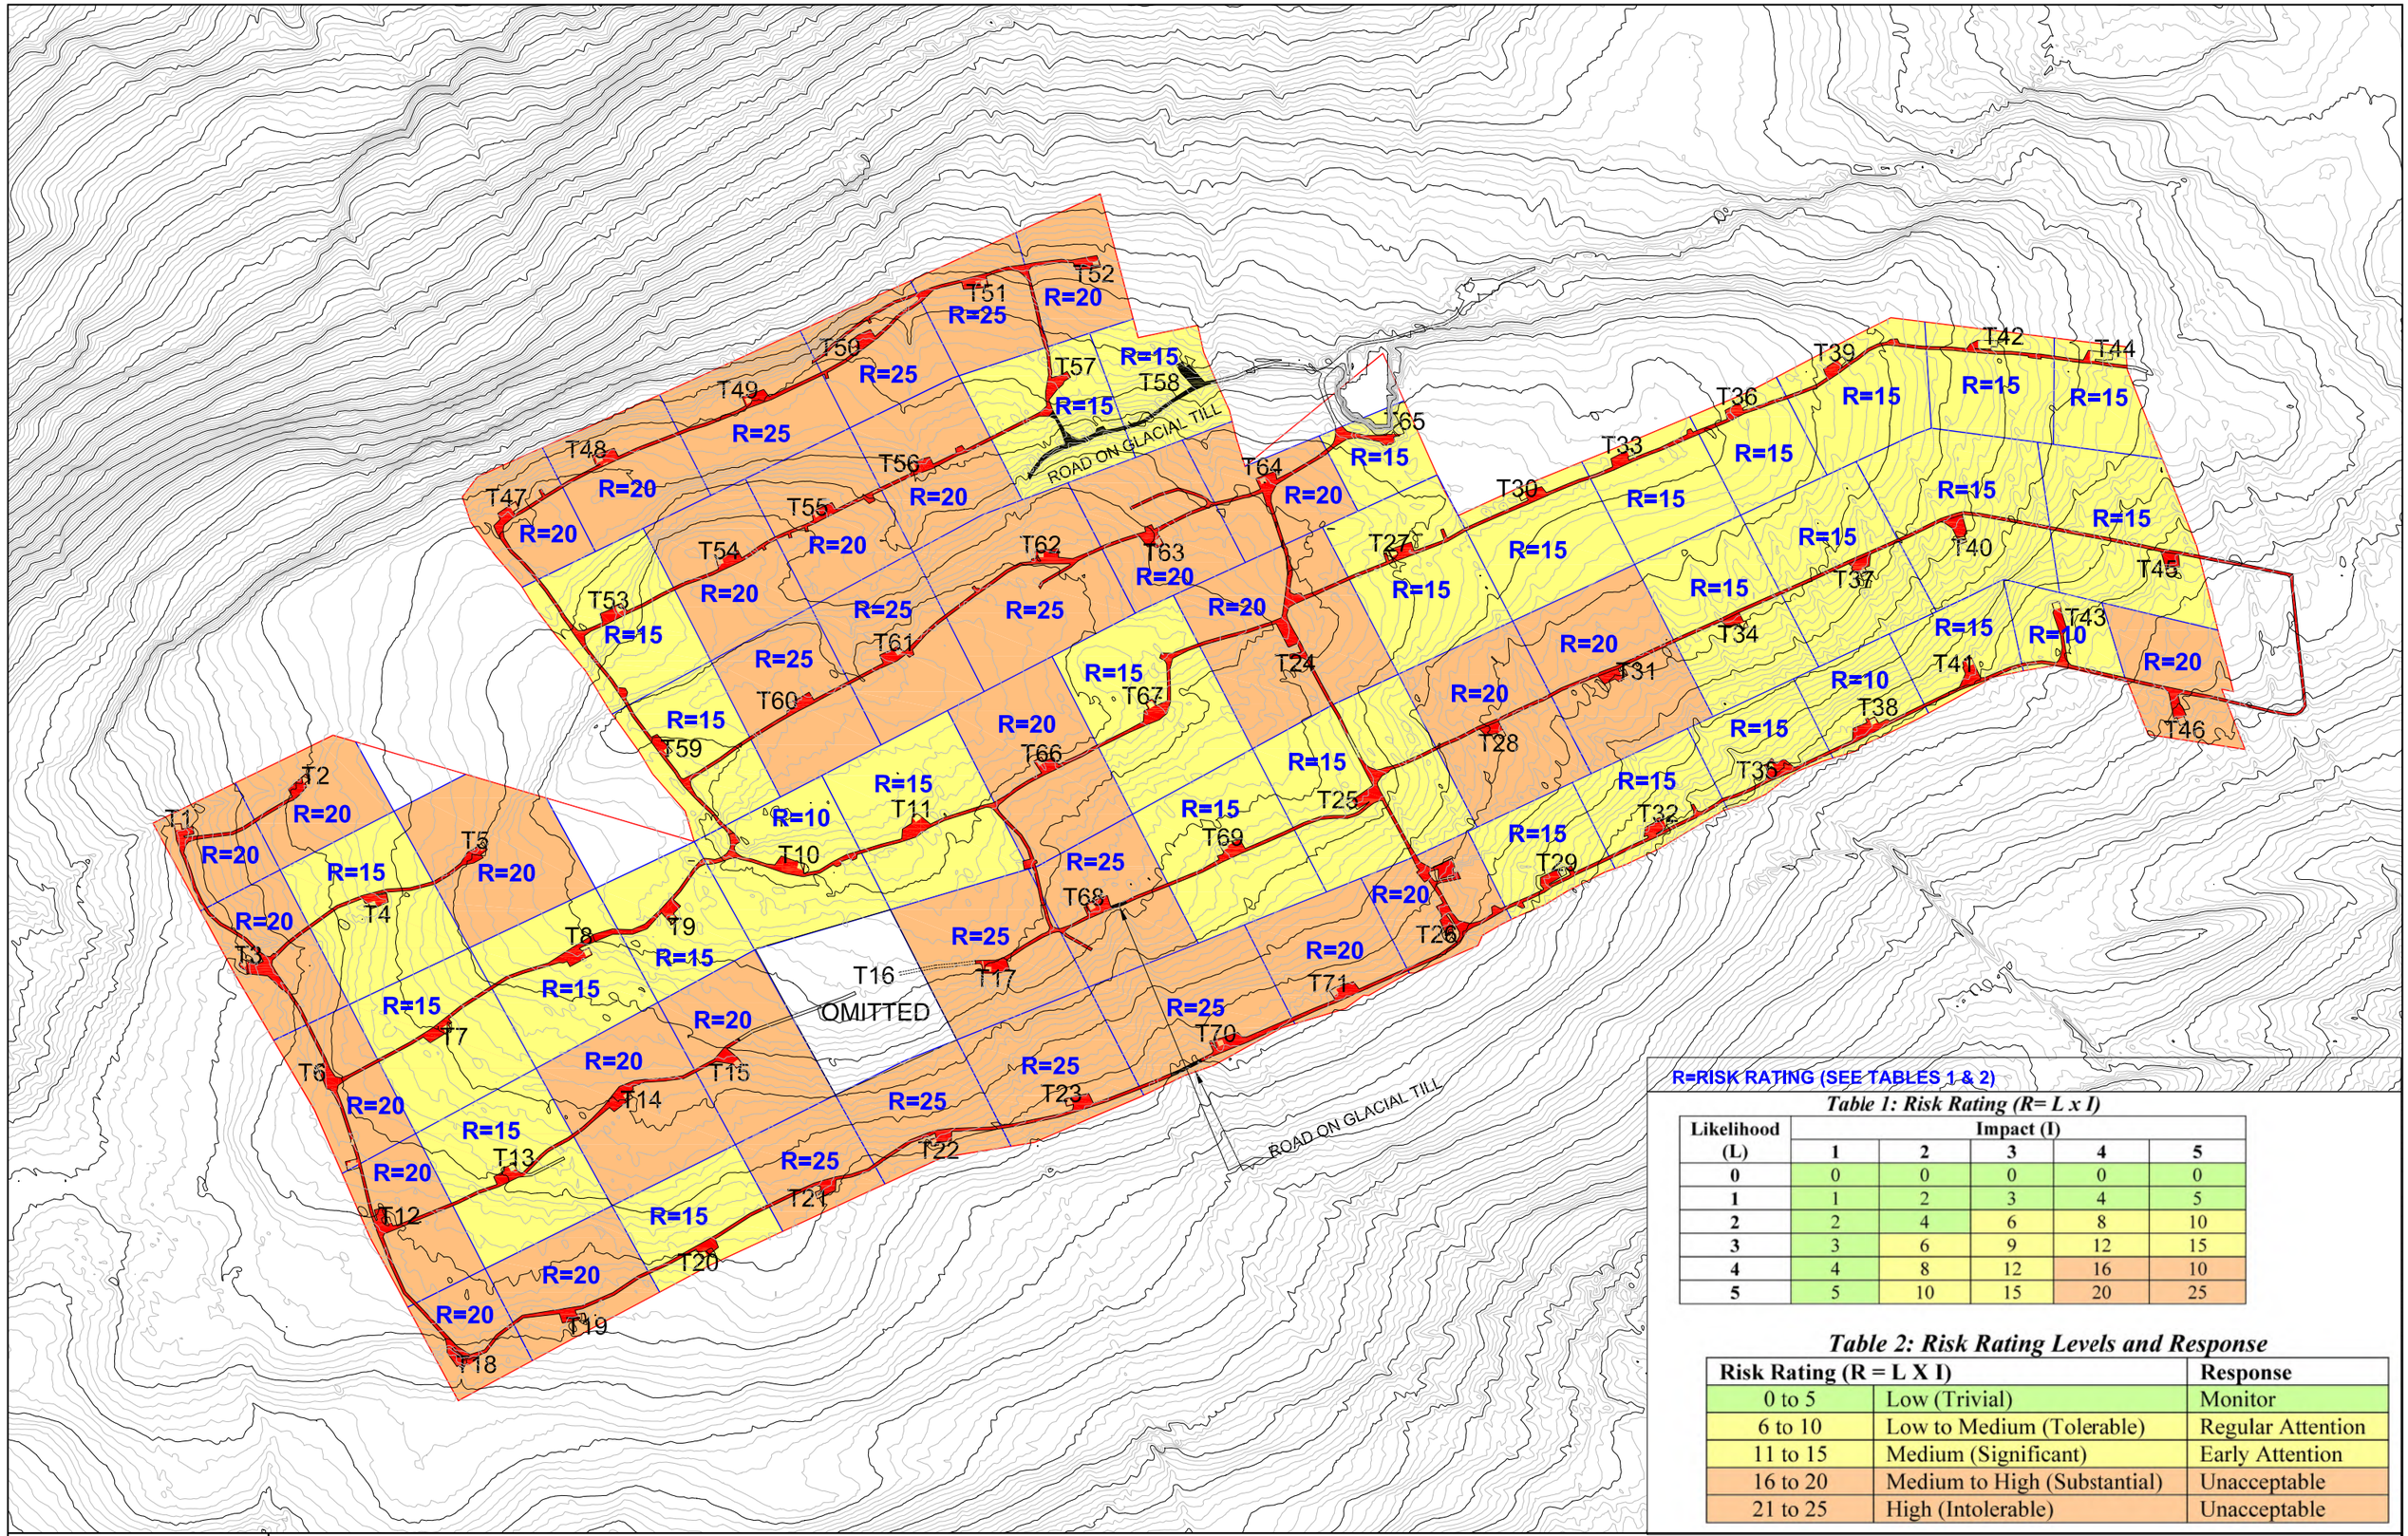
Scales	Date	Page no.	Drawing No.:
1:10,000	30/10/2019	1 of 1	Figure B–2
Version: Final	Drawn: NMF	Checked: COD

Title: PSRA for End of Construction in 2005 - Prior to Mitigation Measures

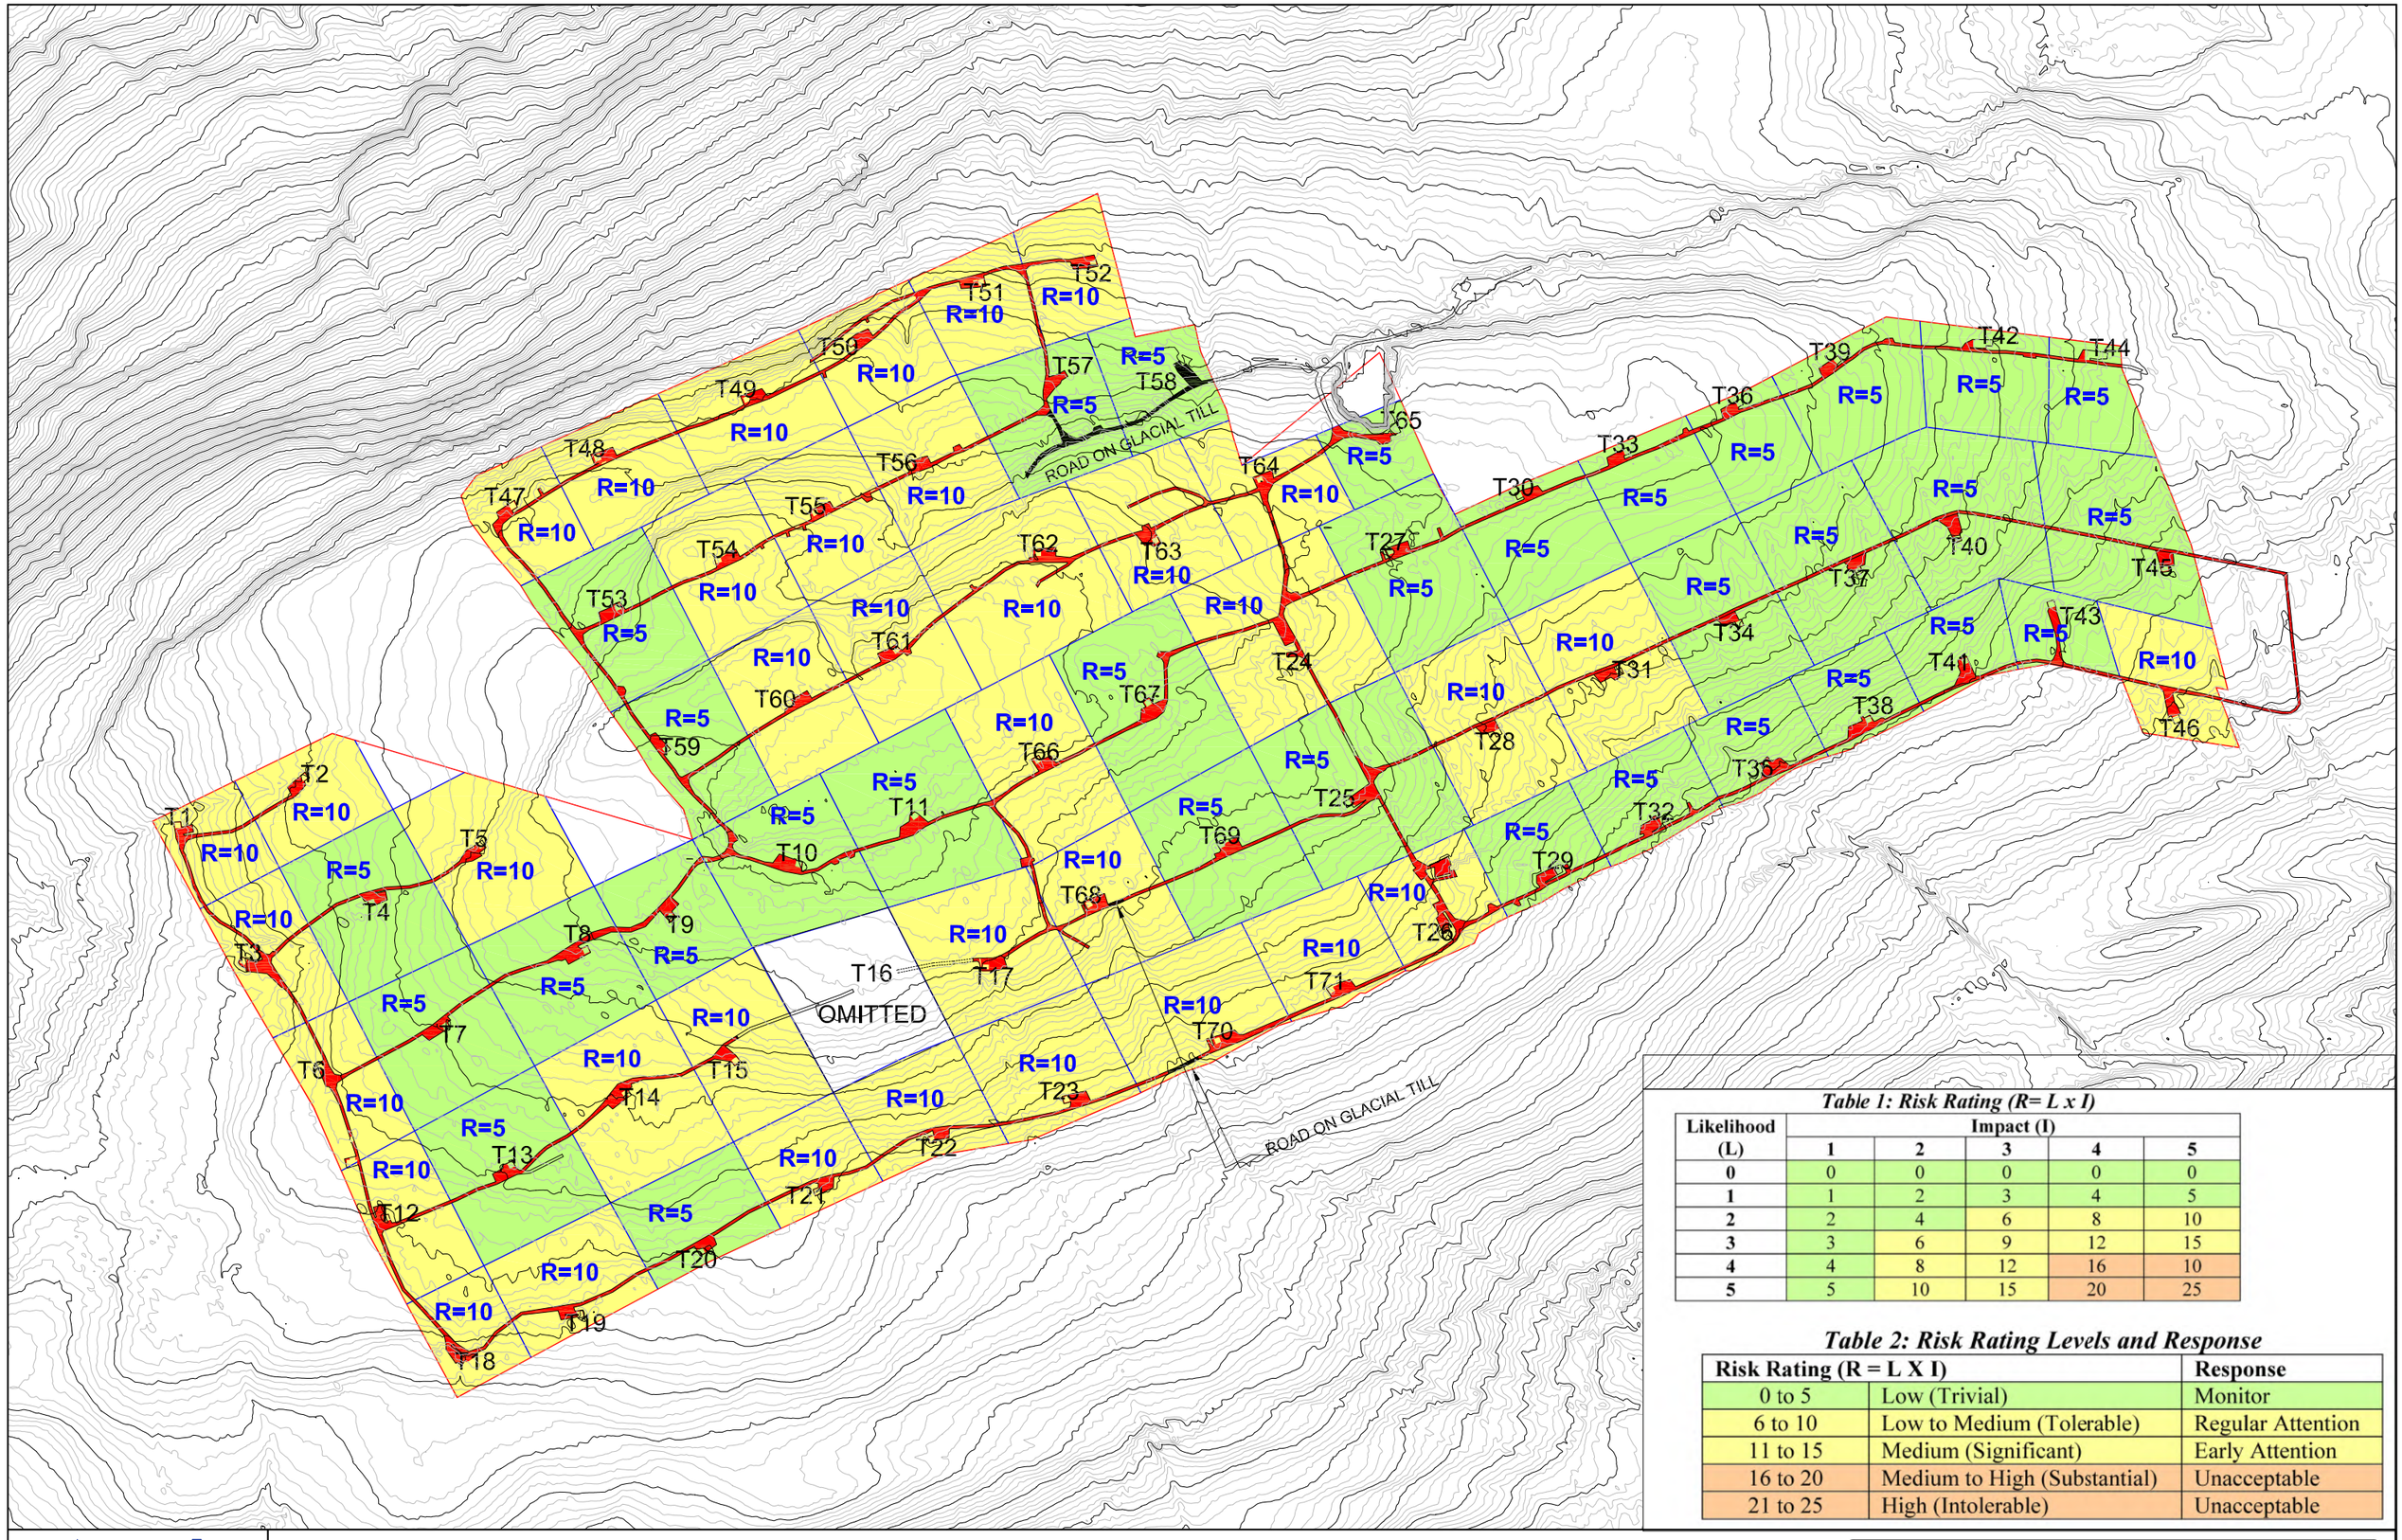
Scales	Date	Page no.	Drawing No.:
1:10,000	30/10/2019	1 of 1	Figure B–3
Version: Final	Drawn: NMF	Checked: COD

Title: Updated PSRA for Site Activities 2005-2018 - after Mitigation Measures

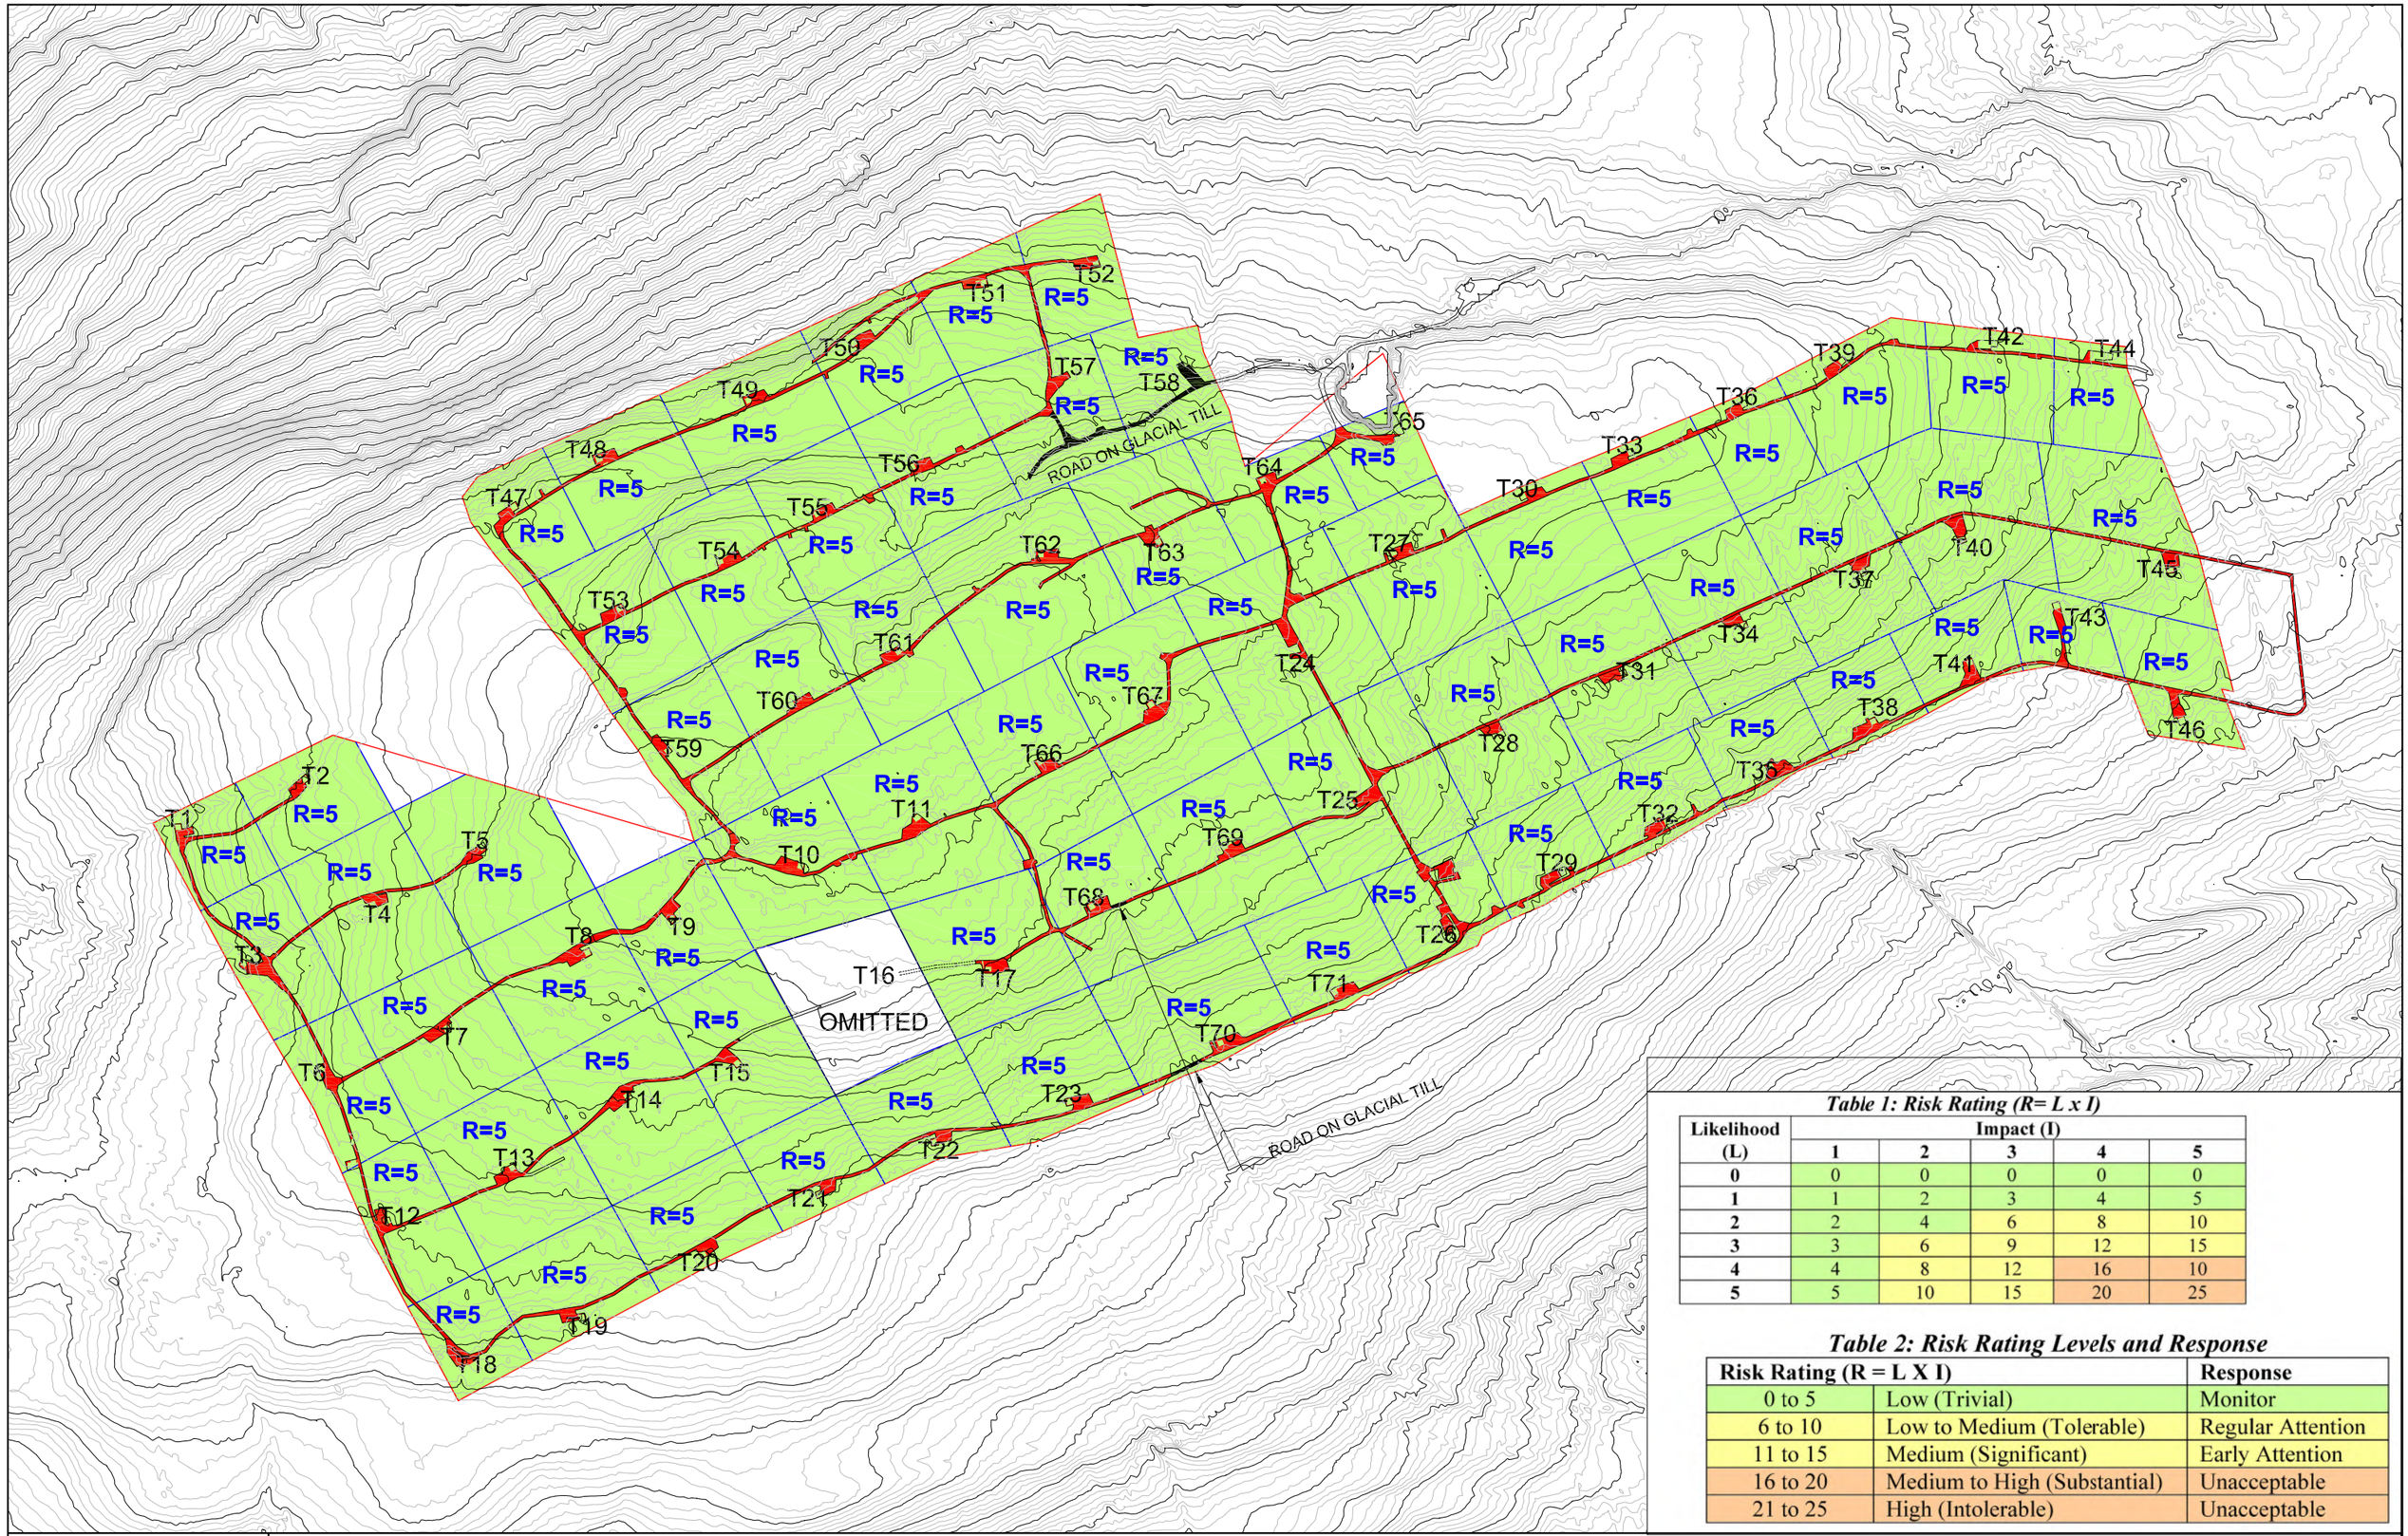
Scales	Date	Page no.	Drawing No.:
1:10,000	30/10/2019	1 of 1	Figure B-4
Version: Final	Drawn: NMF	Checked: COD

Title: Updated Baseline PSRA for Site Activities 2018-End of Operation - after Mitigation Measures

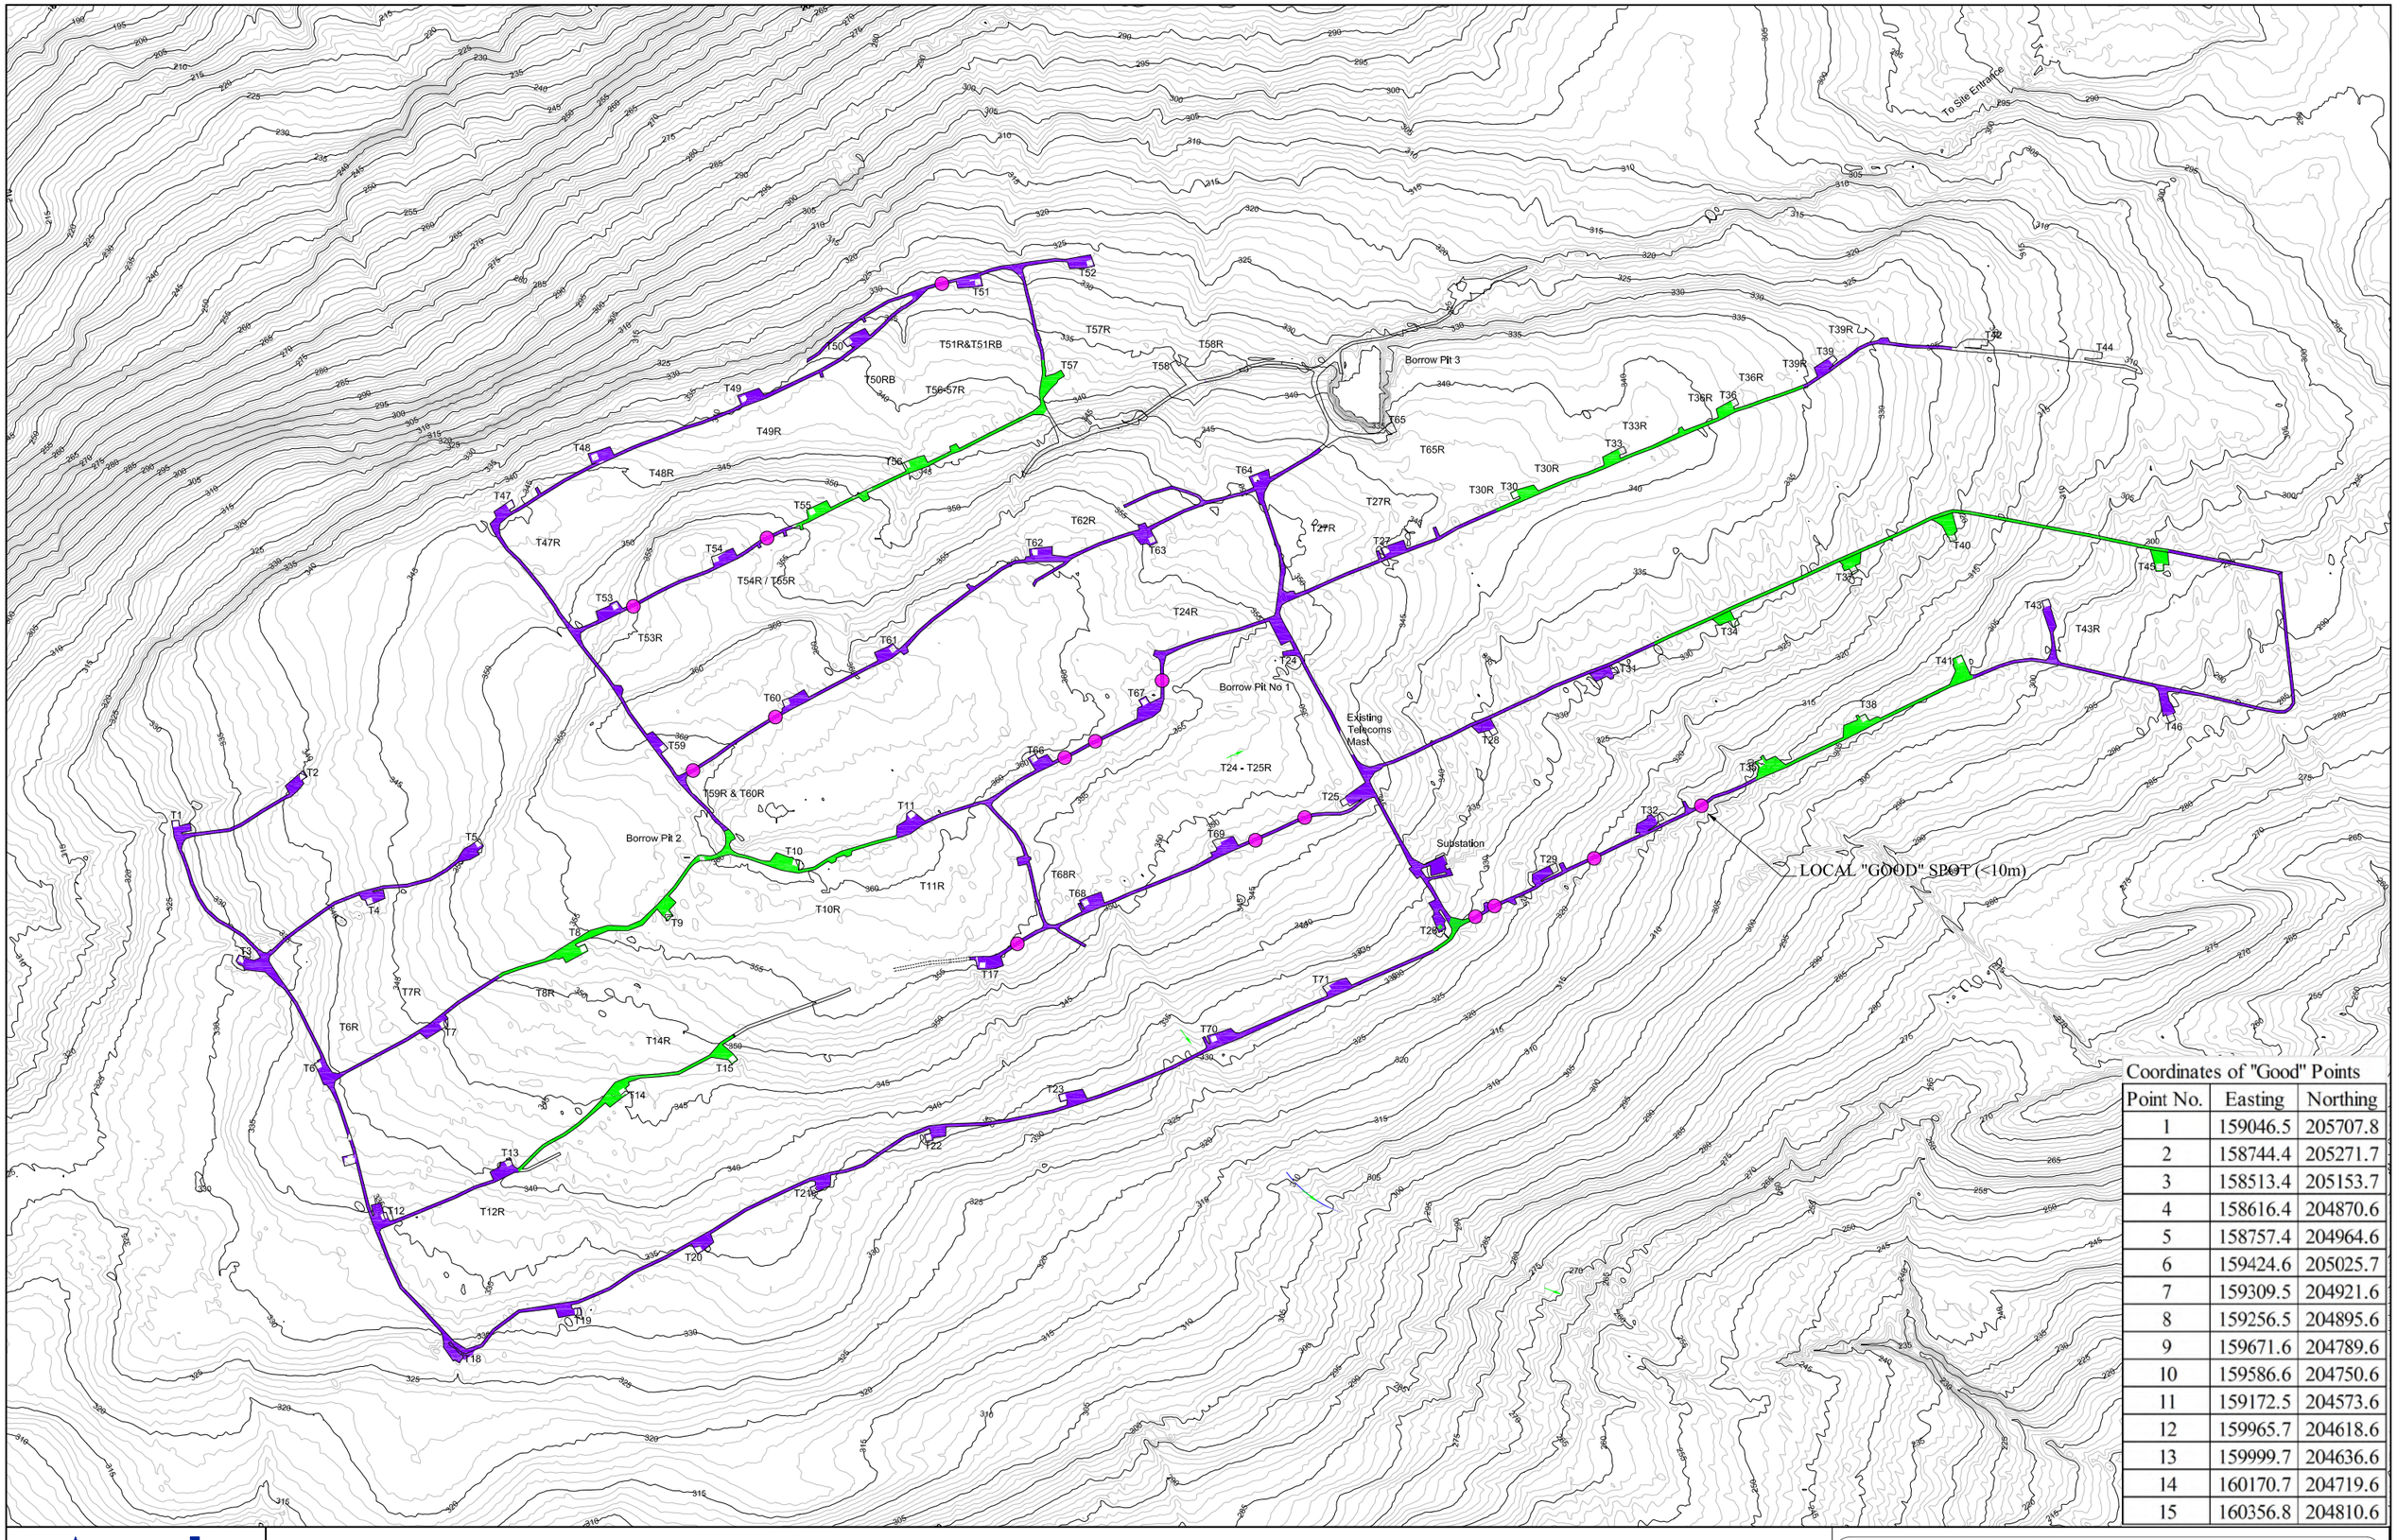
All of the floating roads were successfully proof tested for the design crane load without any indication of bearing failure or shear failure in the peat under the roads.

The observations made during the road test indicate that the majority of the access roads perform to a “Very Good” standard. The road was observed to deflect rigidly under the crane load and the road surface was even with no rutting/loose rockfill noted.

In the few areas where there was a more continuous stretch of road where slight deflections were noted under the applied axle loads, such as along the Turbary road between Turbines T34 and T45, the performance of the floating road has still been classified as “Good”.

There were 15 No. local “Good” spots on the road (<10m) within the “Very Good” sections. These are classified as section of the road which either showed a slight increase in deflection (<10mm) under the wheel load of the crane, had a slightly uneven surface due to localised potholes on the road or had a rough surface which reduce the driving quality.

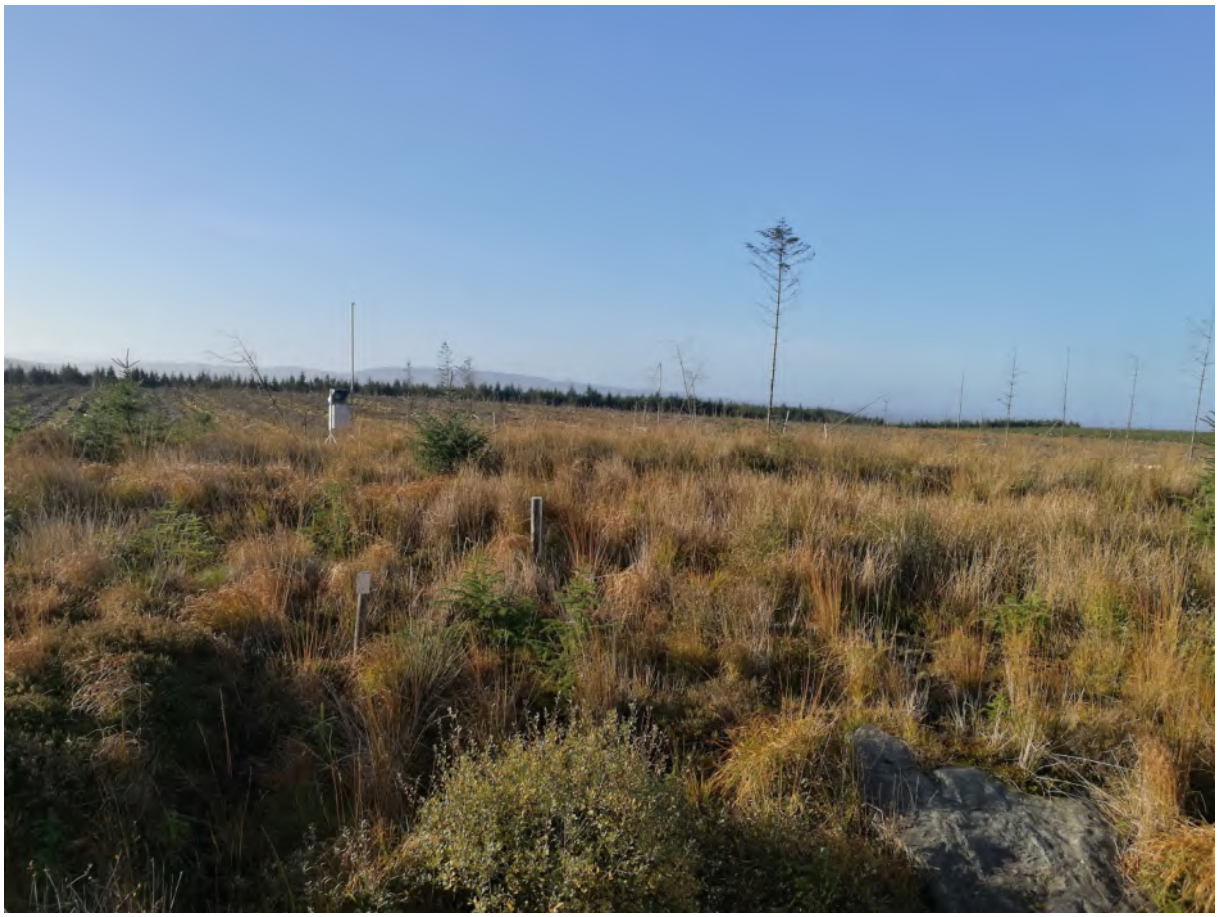
Photo No. C-60: T18R Peat Repository West facing northwest

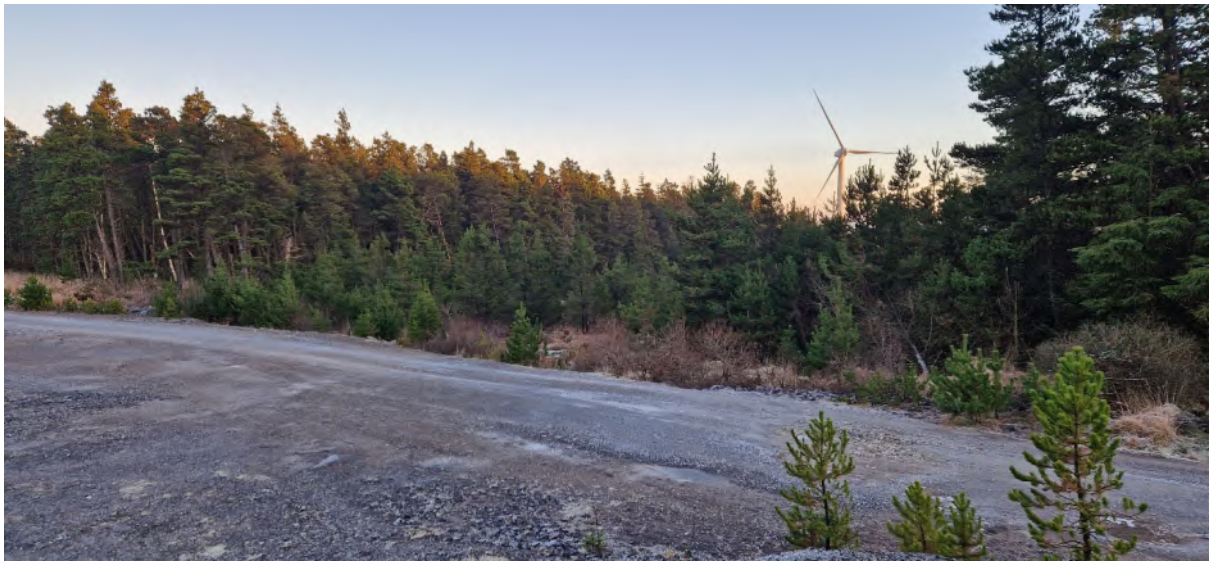
Photo E-119: Head of slide area downslope from Turbine T68

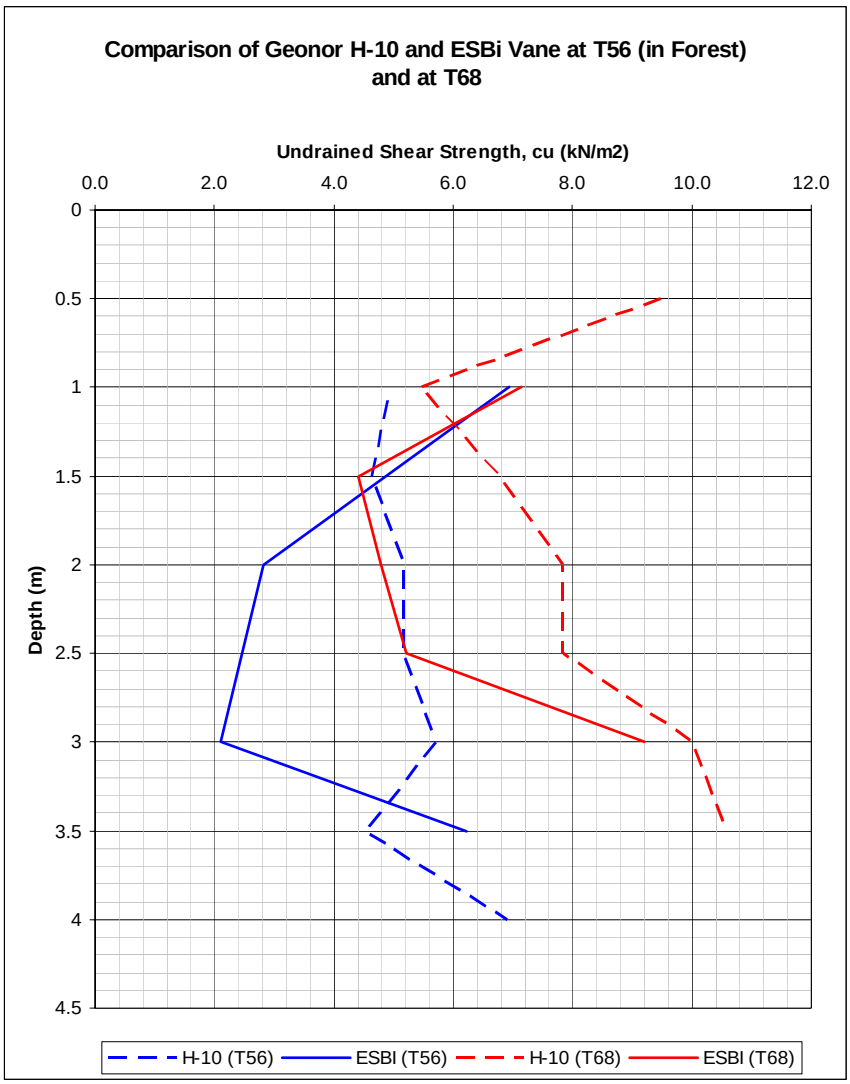
2 No. comparative tests were carried out on the Derrybrien site between the Geonor H-10 with the 65 mm x 135 mm vane, and the larger 135mm by 270mm vane used by ESBI. The results are compared on Figure No. 3.1. These tests would seem to indicate that the interpreted c_{uvane} below a depth of 1.0 m and above the base of the peat are higher for the Geonor H-10 penetration vane than the larger 135mm by 270mm vane used by ESBI. The ratio of strengths between the Geonor H-10 and ESBI Vanes generally ranges from 1.5 to 1.85, but one value up to 2.7 was calculated at a depth of 3.0 m in the forest in cell T56.

Figure No. 3.1 Comparison between H-10 vane and ESBI vane.

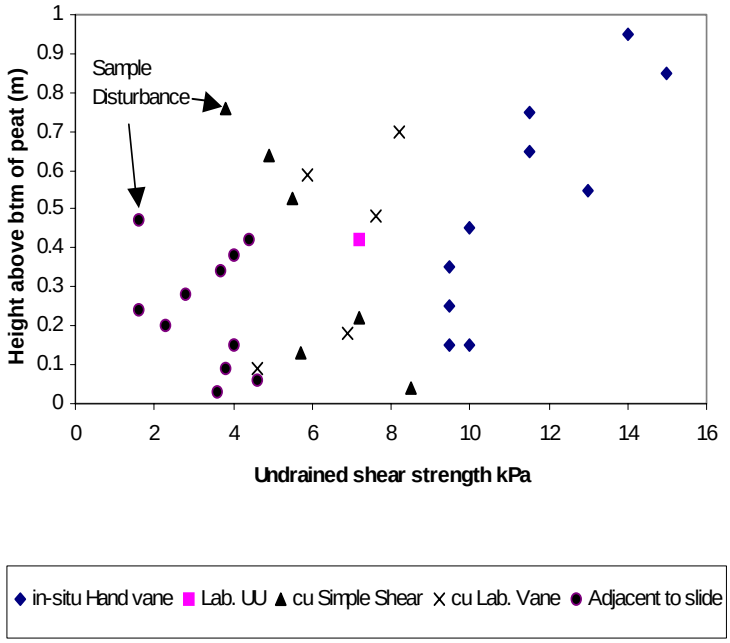
The results of a variety of laboratory undrained shear strength tests on samples of the peat recovered from adjacent to and away from the slide that occurred in Derrybrien in October ’03 are shown on Figure No. 3.2. These tests included small laboratory vanes,

small ELE Hand vanes, laboratory unconsolidated undrained triaxial testing and laboratory simple shear tests. These results show that c_u of the peat away from the slide was in excess of 4kPa, with the in-situ hand vane indicating higher values of the order of 9 to 15kPa. Exceptionally low shear strengths were recorded in simple shear tests on samples taken adjacent to the slide in material which is considered to represent a pre-existing failure plane where a major discontinuity formed in the peat.

Figure No. 3.2 Undrained shear strengths recorded on undisturbed samples of the peat

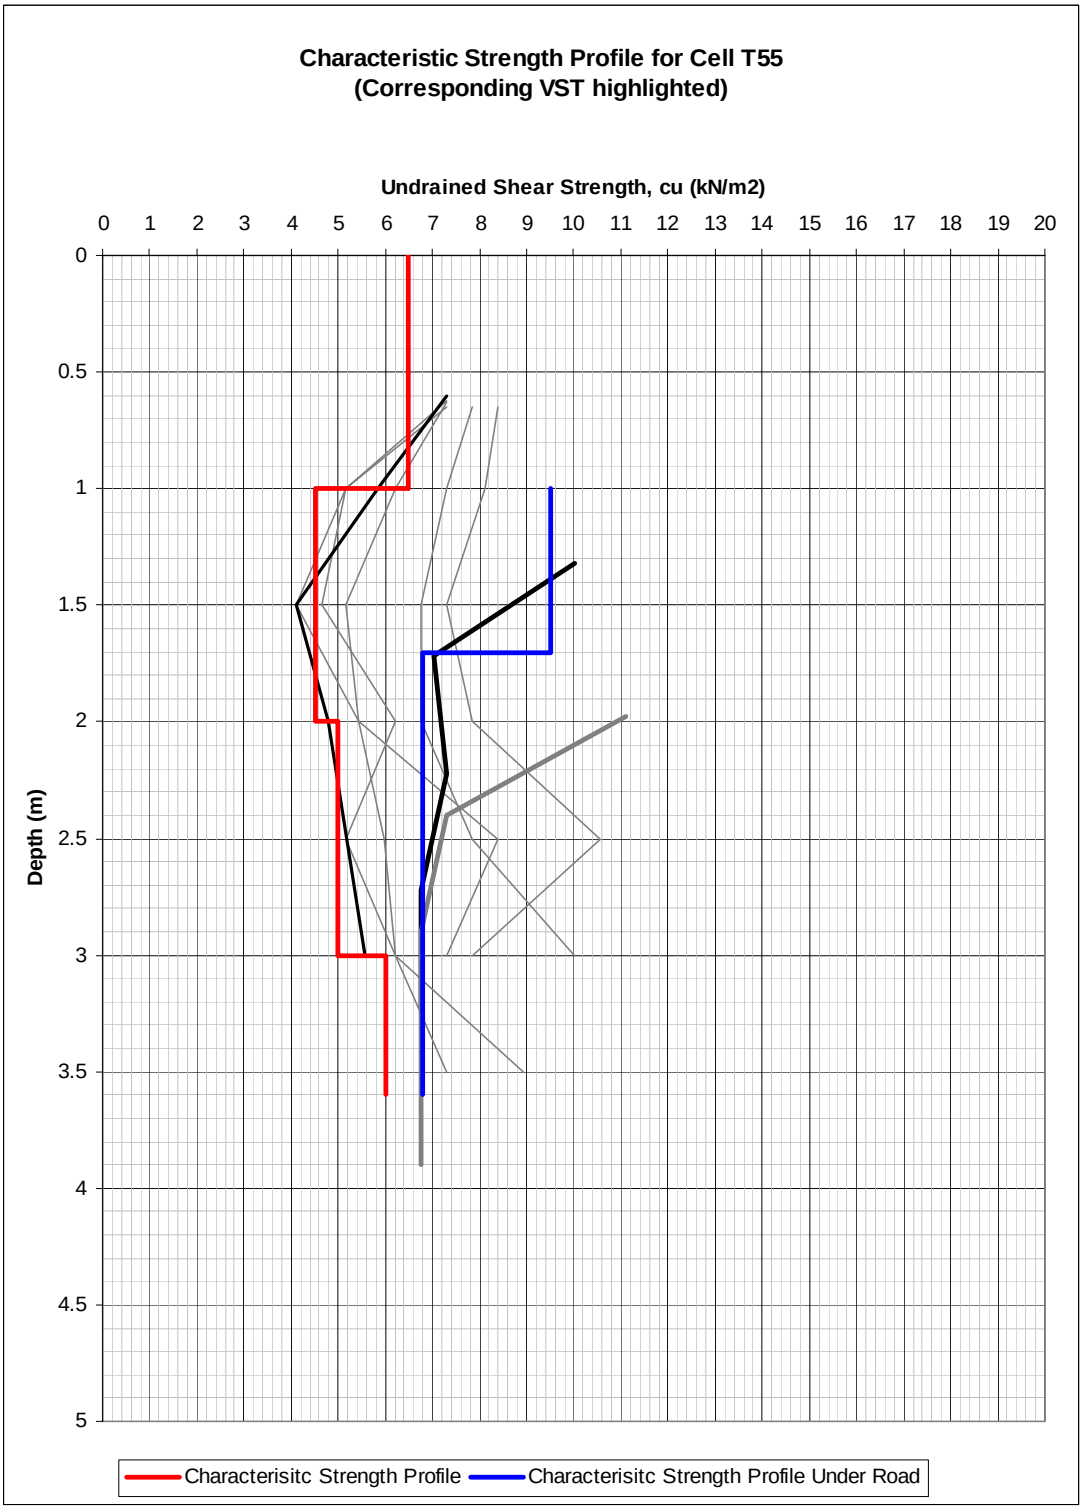
The characteristic undrained shear strength profiles for T55, T56 and T57 are plotted against the recorded VST data in Figures Nos. 3.3, 3.4 and 3.5, respectively. The profiles for T55 and T57 are plotted against a typical range in the VST data in Figure No. 3.6. The lowest recorded shear strength profile in each section was used in the analysis.

Figure No. 3.3 Characteristic undrained shear strength profile for T55

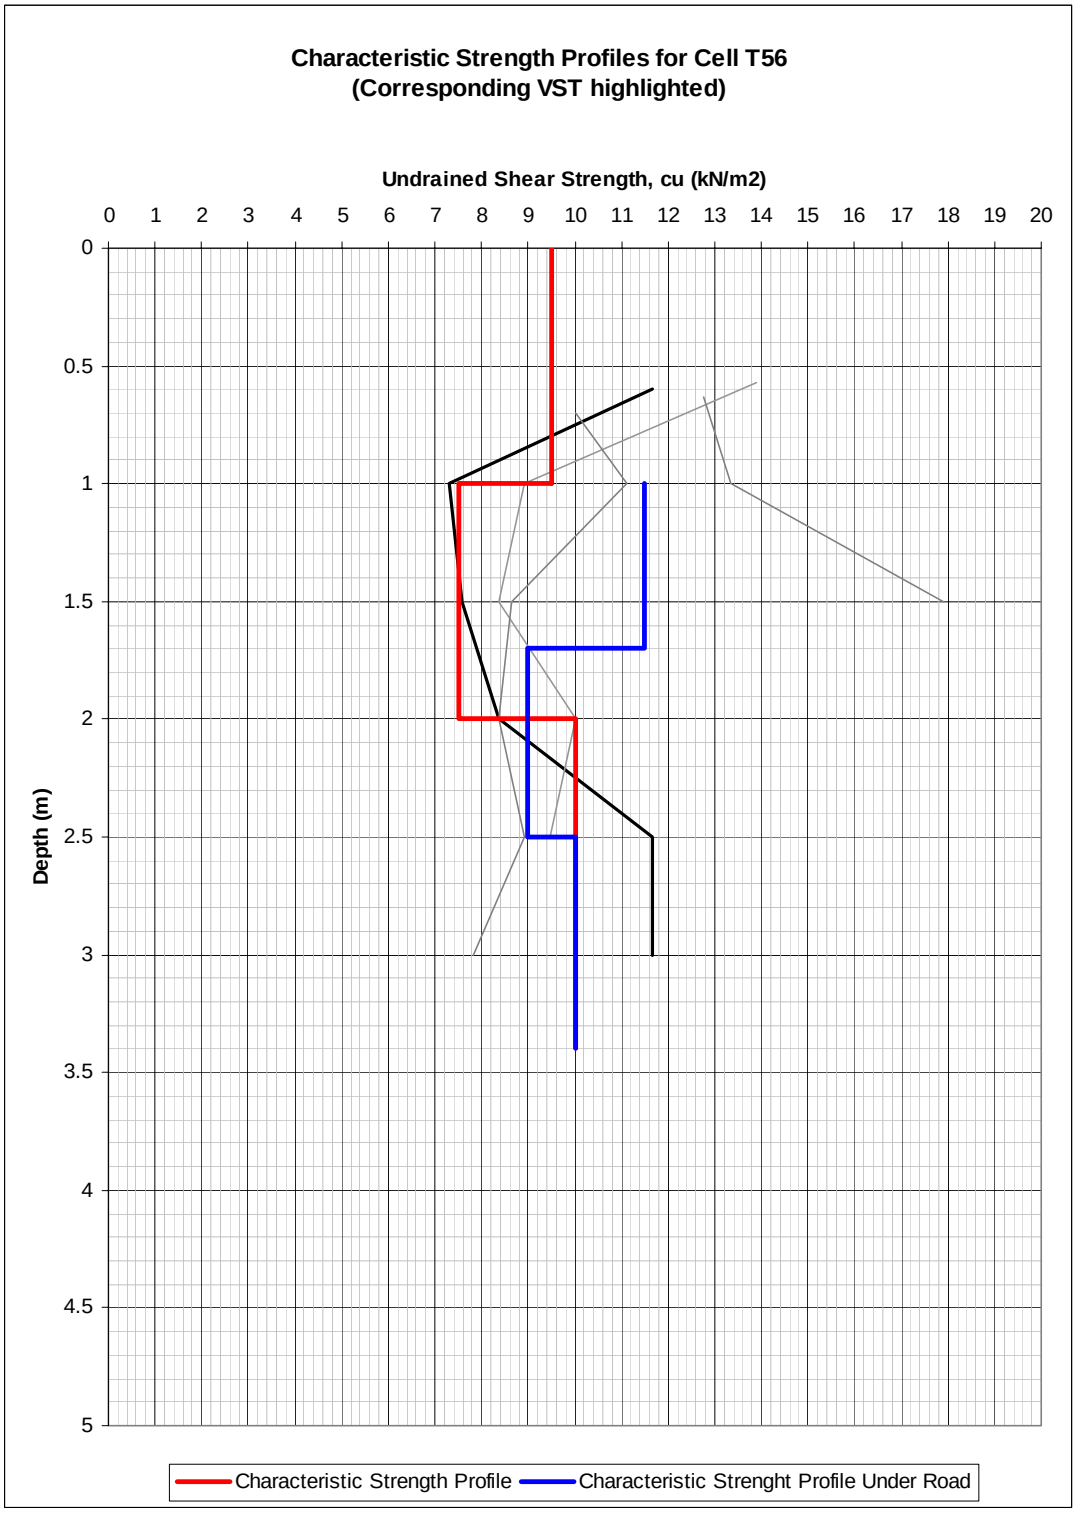
Figure No. 3.4 Characteristic undrained shear strength profile for T56
