Derrybrien Wind Farm Development Decommissioning Project – Retained Development

GEOTECHNICAL STABILITY REPORT - WIND FARM SITE (PART I)

DERRYBRIEN WIND FARM
GEOTECHNICAL STABILITY REPORT & ASSESSMENT OF STABILITY IMPACTS OF ON-SITE ACTIVITIES

Document No:	**11-147-R04**	**Issue 02 (Rev. 0)**
Made:	Conor O'Donnell / Niamh Farrell	
Checked:	Conor O'Donnell

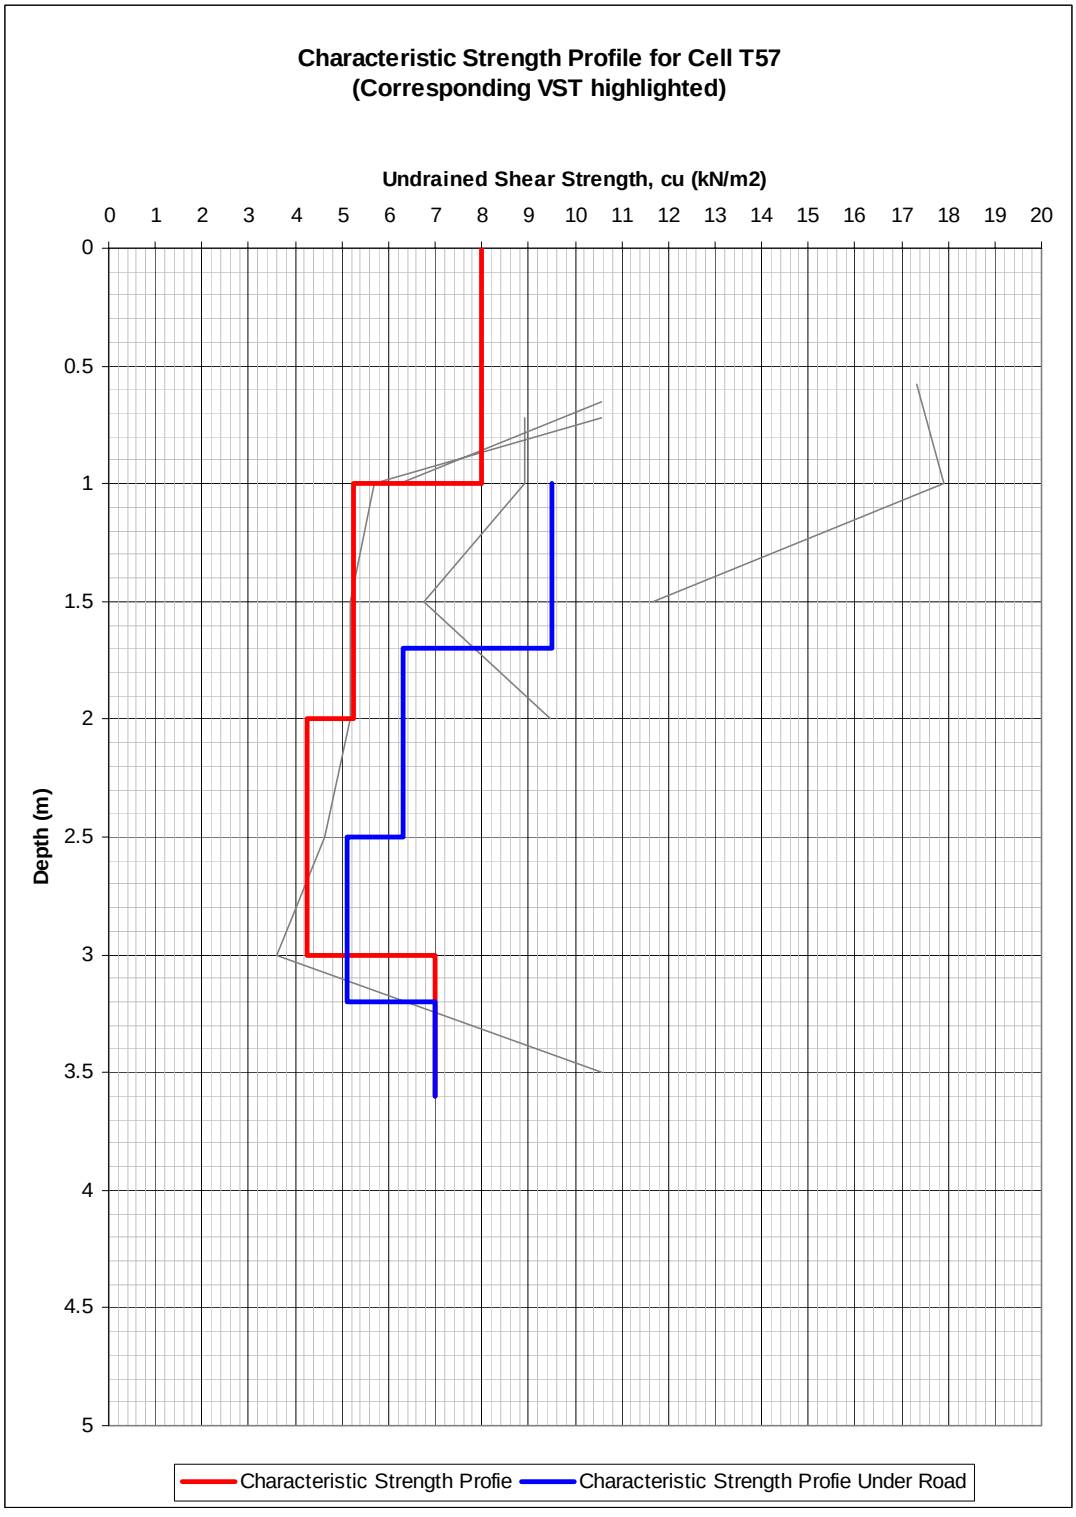
The characteristic undrained shear strength profiles for T55, T56 and T57 are plotted against the recorded VST data in Figures Nos. 3.3, 3.4 and 3.5, respectively. The profiles for T55 and T57 are plotted against a typical range in the VST data in Figure No. 3.6. The lowest recorded shear strength profile in each section was used in the analysis.

Figure No. 3.5 Characteristic undrained shear strength profile for T57

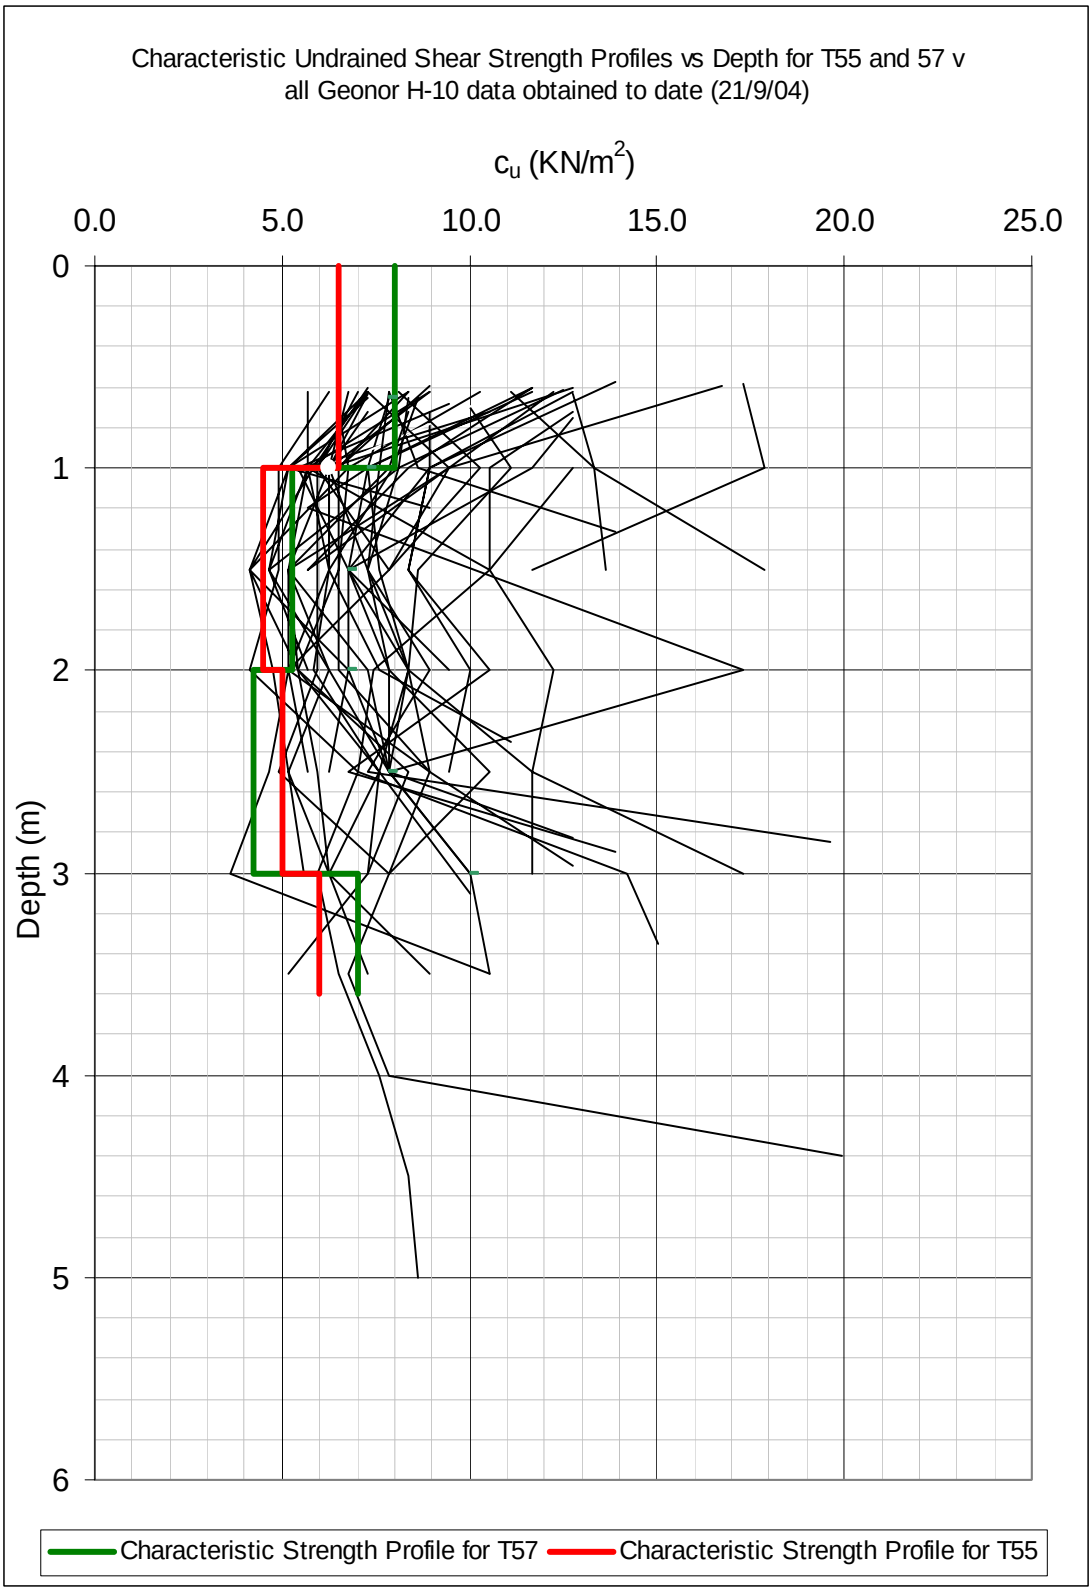
Figure No. 3.6 Characteristic undrained shear strength profile for T57

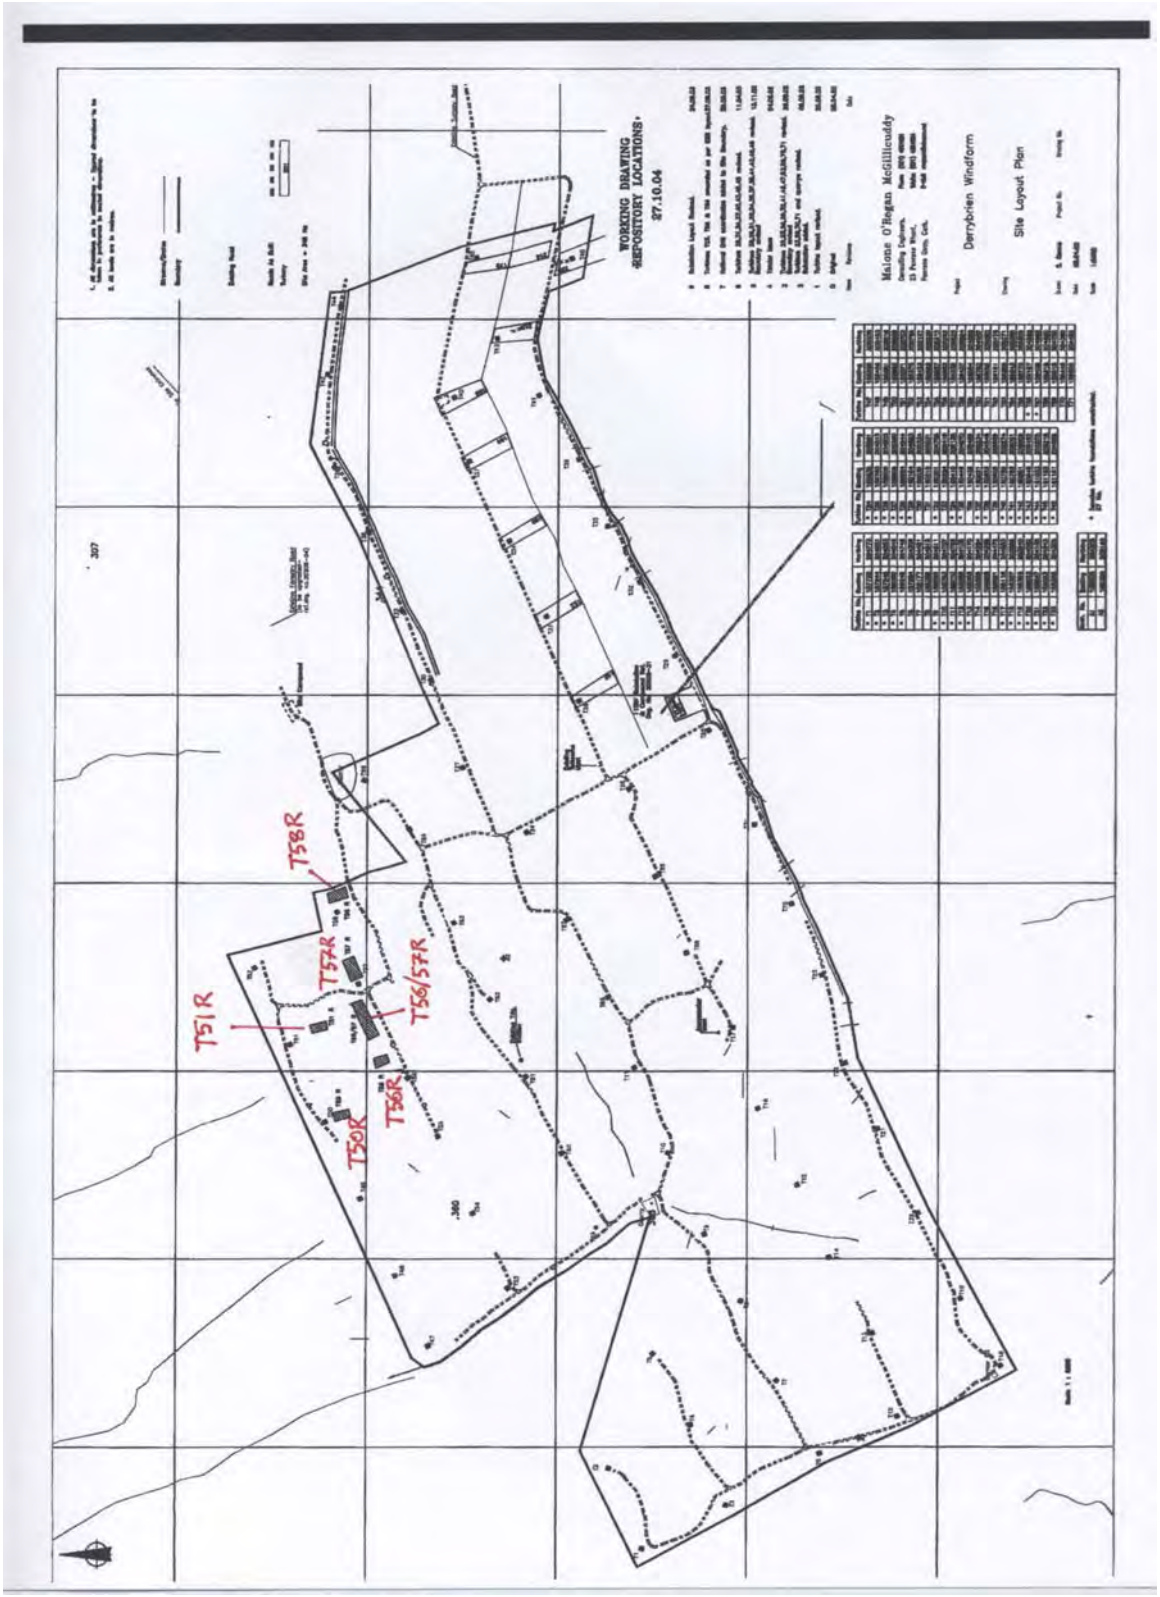
Figure No. 4.1 shows the location of 6 No. repository sites that have been selected for the first phase of work when construction activity resumes on the site. The sites are named after the cells in which they are located:

Figure No. 4.1 – Location of proposed peat repository sites.

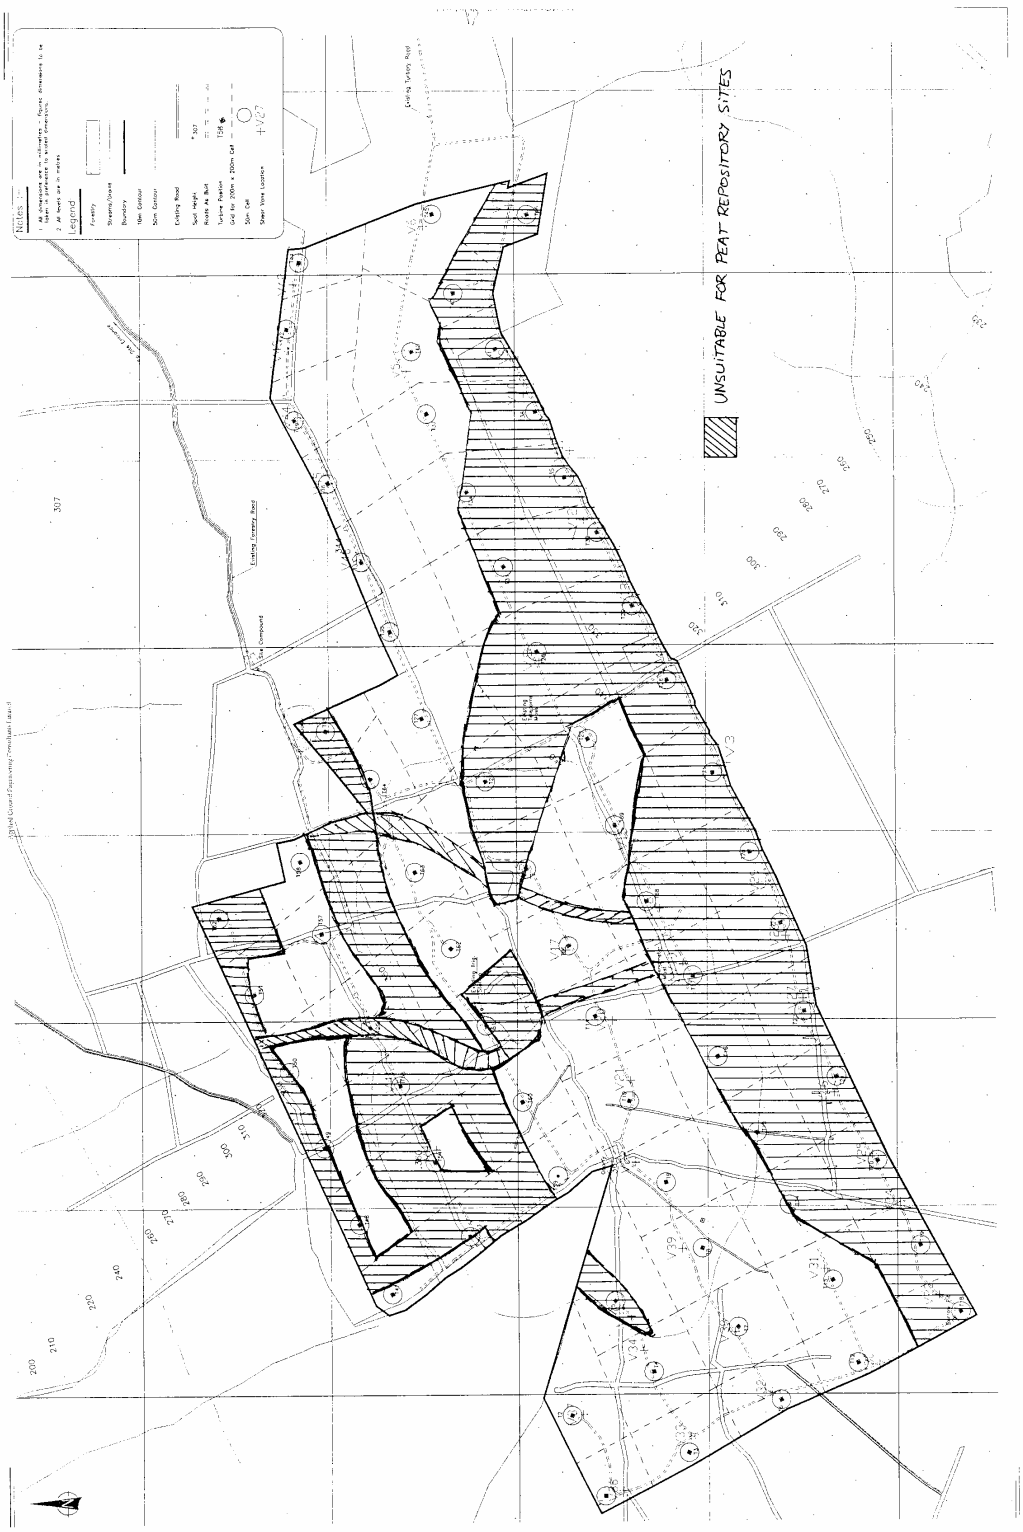
The general areas that are considered unsuitable for repository sites are illustrated on Figure No. 4.2. The sites will also be kept at least 25 m from the natural drainage courses on the site. The drainage courses will be used to improve the drainage on the site.

Figure No. 4.2 – Areas excluded from consideration for peat repository sites based on aerial photos.

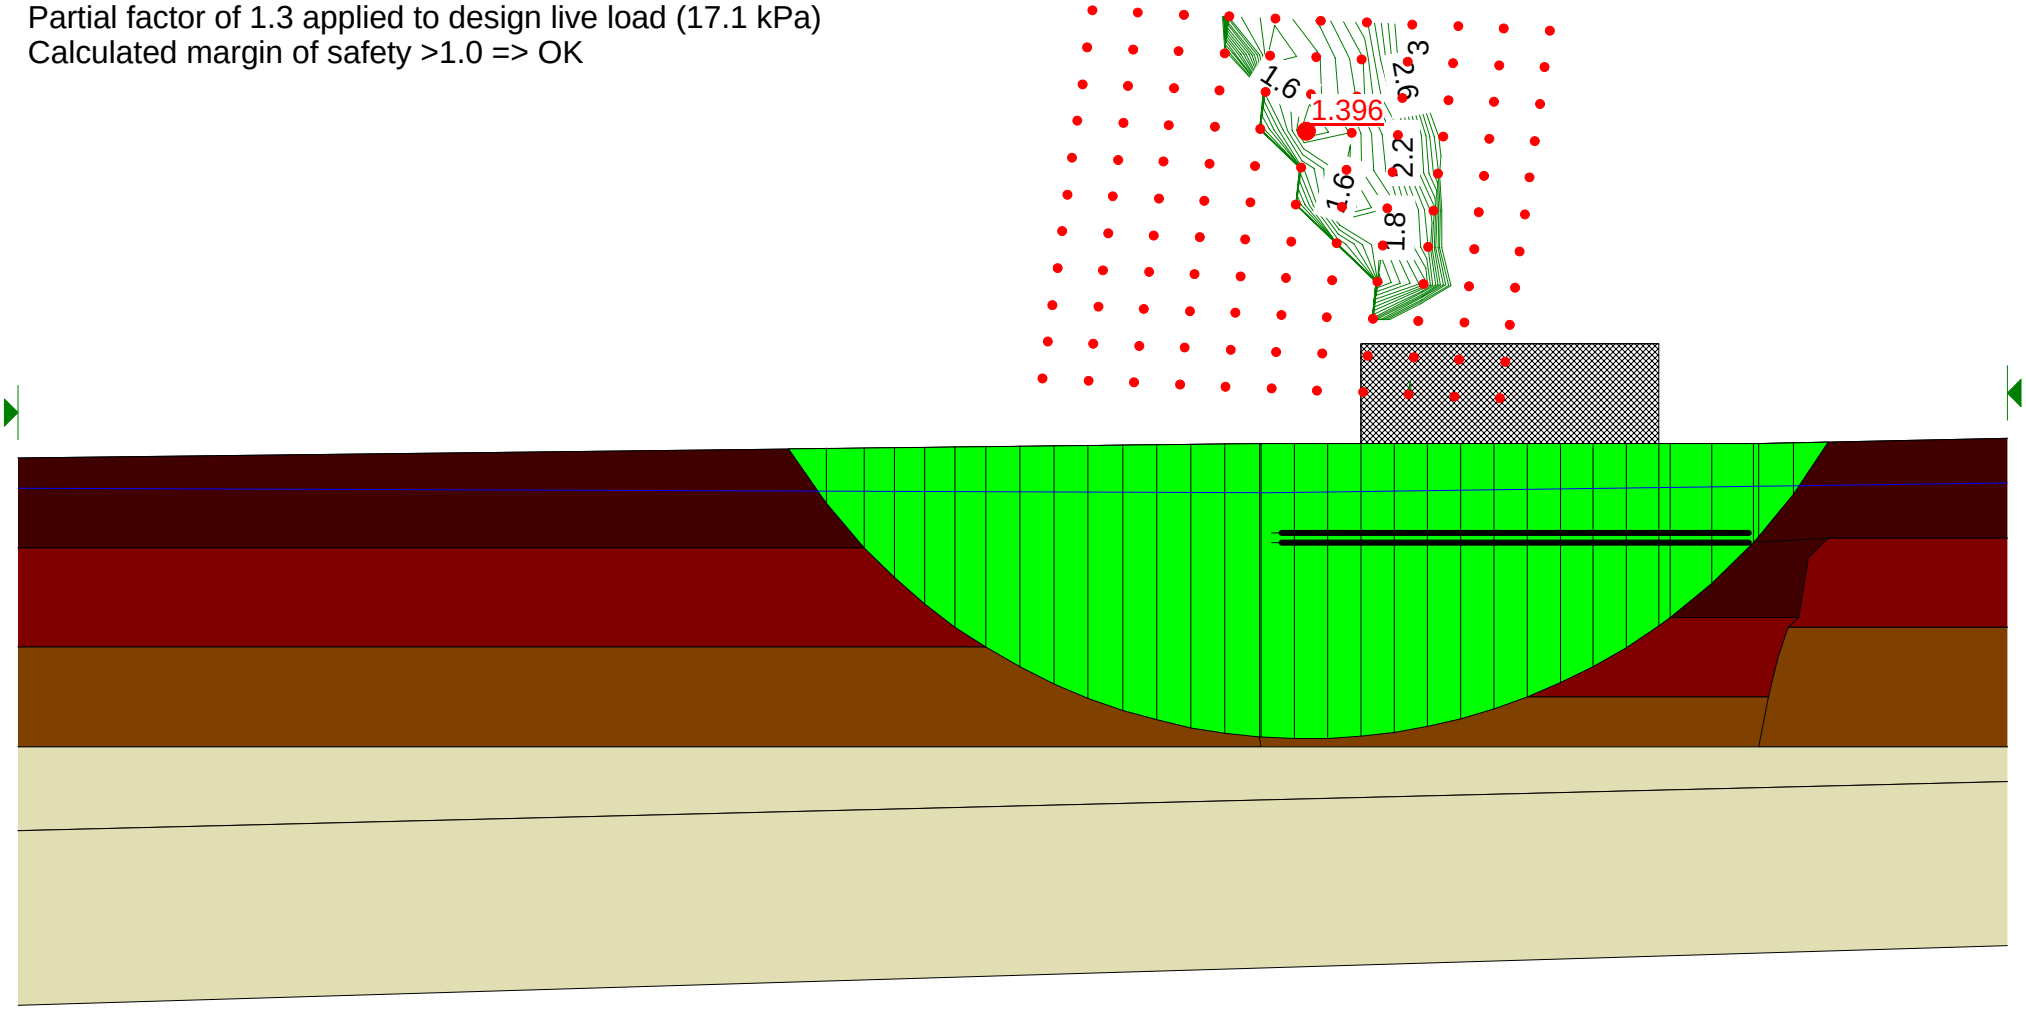
Derrybrien Windfarm - Floating Road Analysis: Cell T47NR (New Road alignment)

Depth of peat = 3.1m on downslope side of road
Slope angle = 0.8 Deg at surface, 0.0 Deg at base of peat

Partial factor of 1.4 applied to undrained shear strength of peat
No allowance taken for increase in strength under road

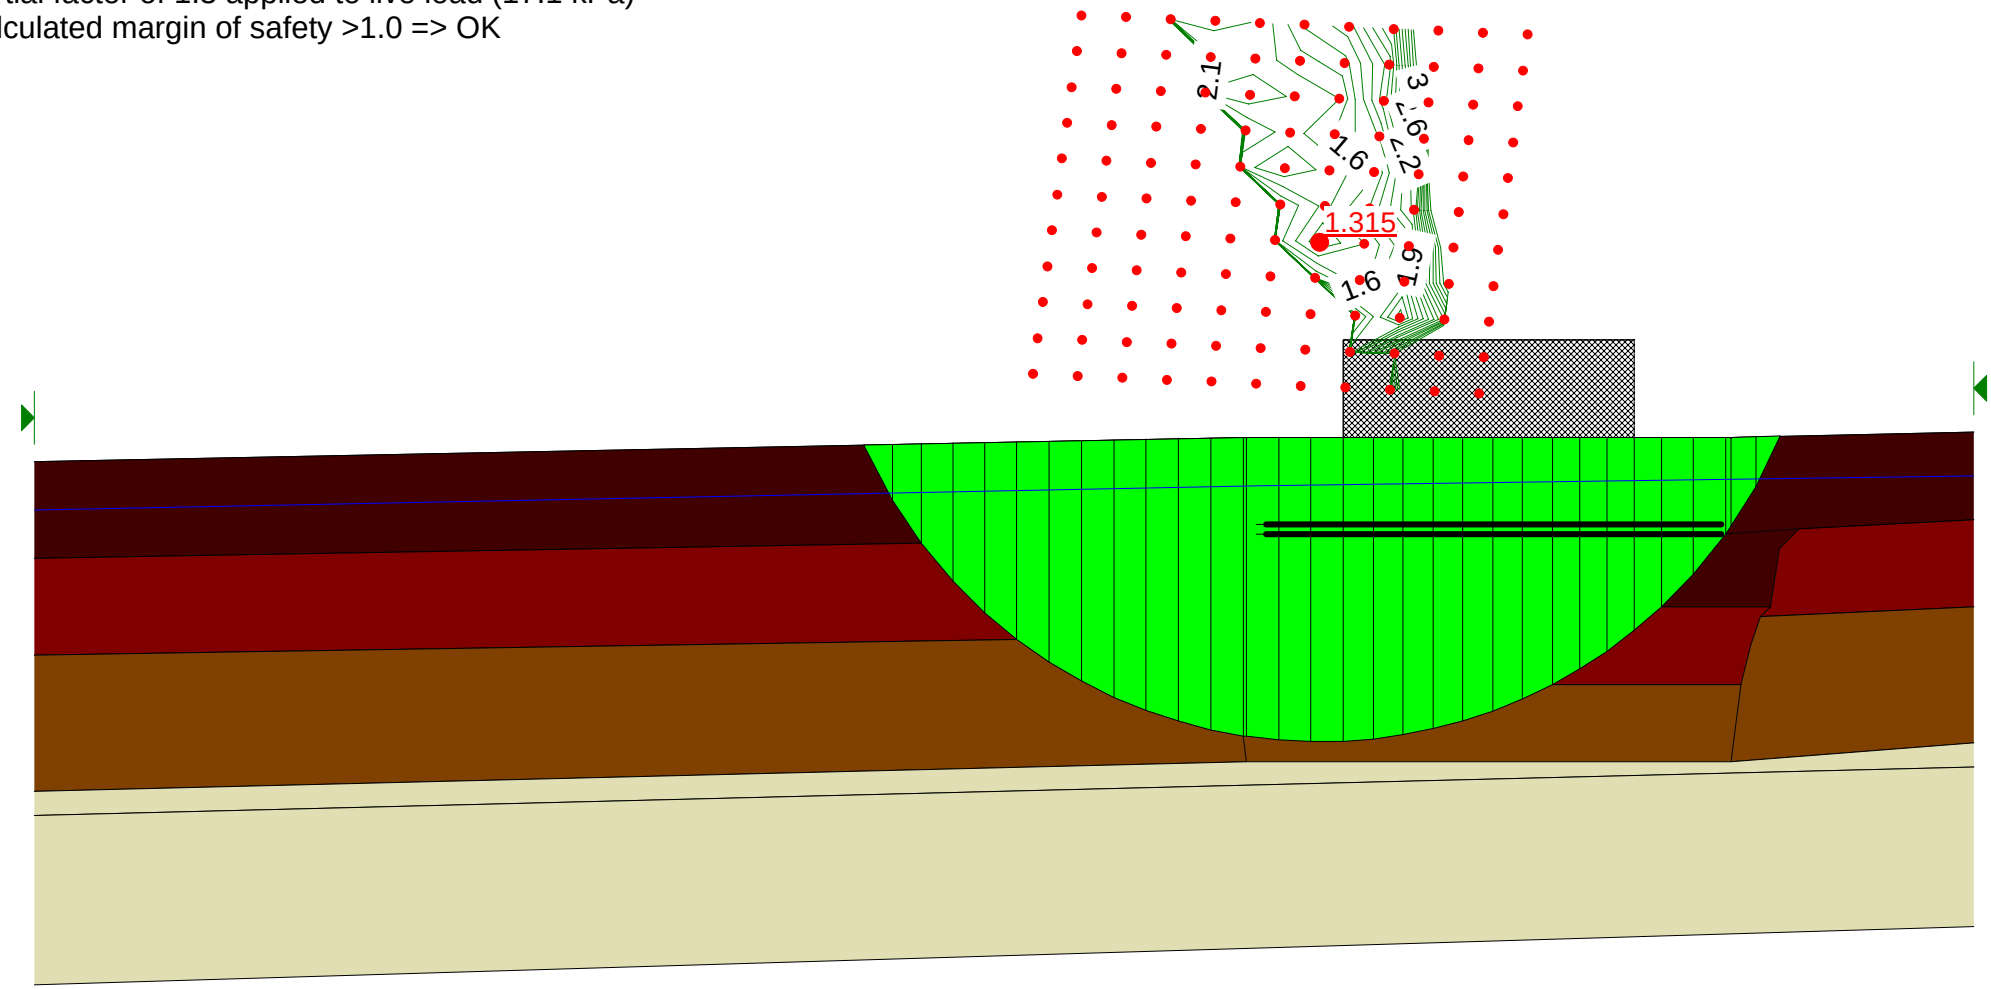
Derrybrien Windfarm - Floating Road Analysis: Cell T48NR (New Road alignment)

Depth of peat = 3.34 on downslope side of road
Slope angle = 1 Deg at surface, 1.5 Deg at base of peat

Partial factor of 1.4 applied to undrained shear strength of peat
No allowance taken for increase in strength under road

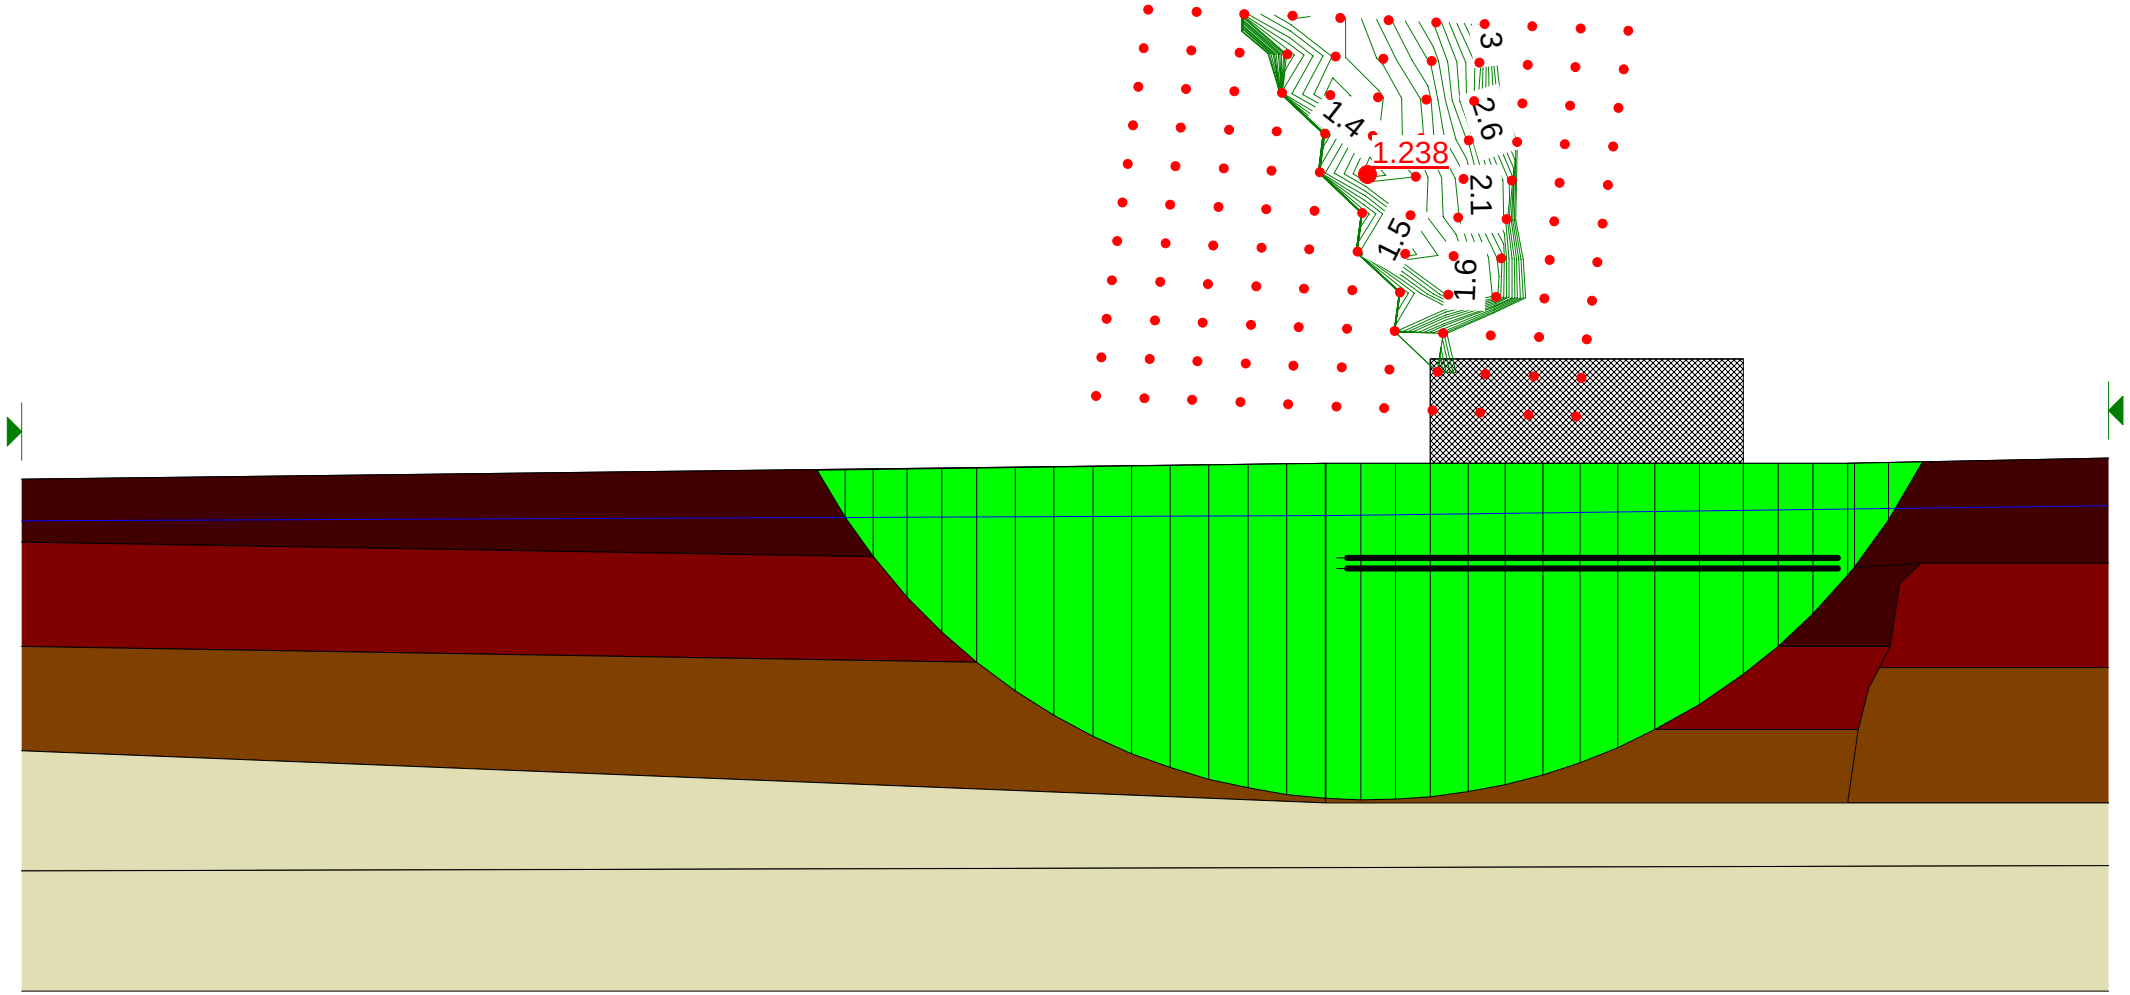
Derrybrien Windfarm - Floating Road Analysis: Cell T49NR (New Road alignment)

Depth of peat = 3.3 m on downslope side of road
Slope angle = 1 Deg at surface, 2.2 Deg at base of peat

Partial factor of 1.4 applied to undrained shear strength of peat
No allowance taken for increase in strength under road

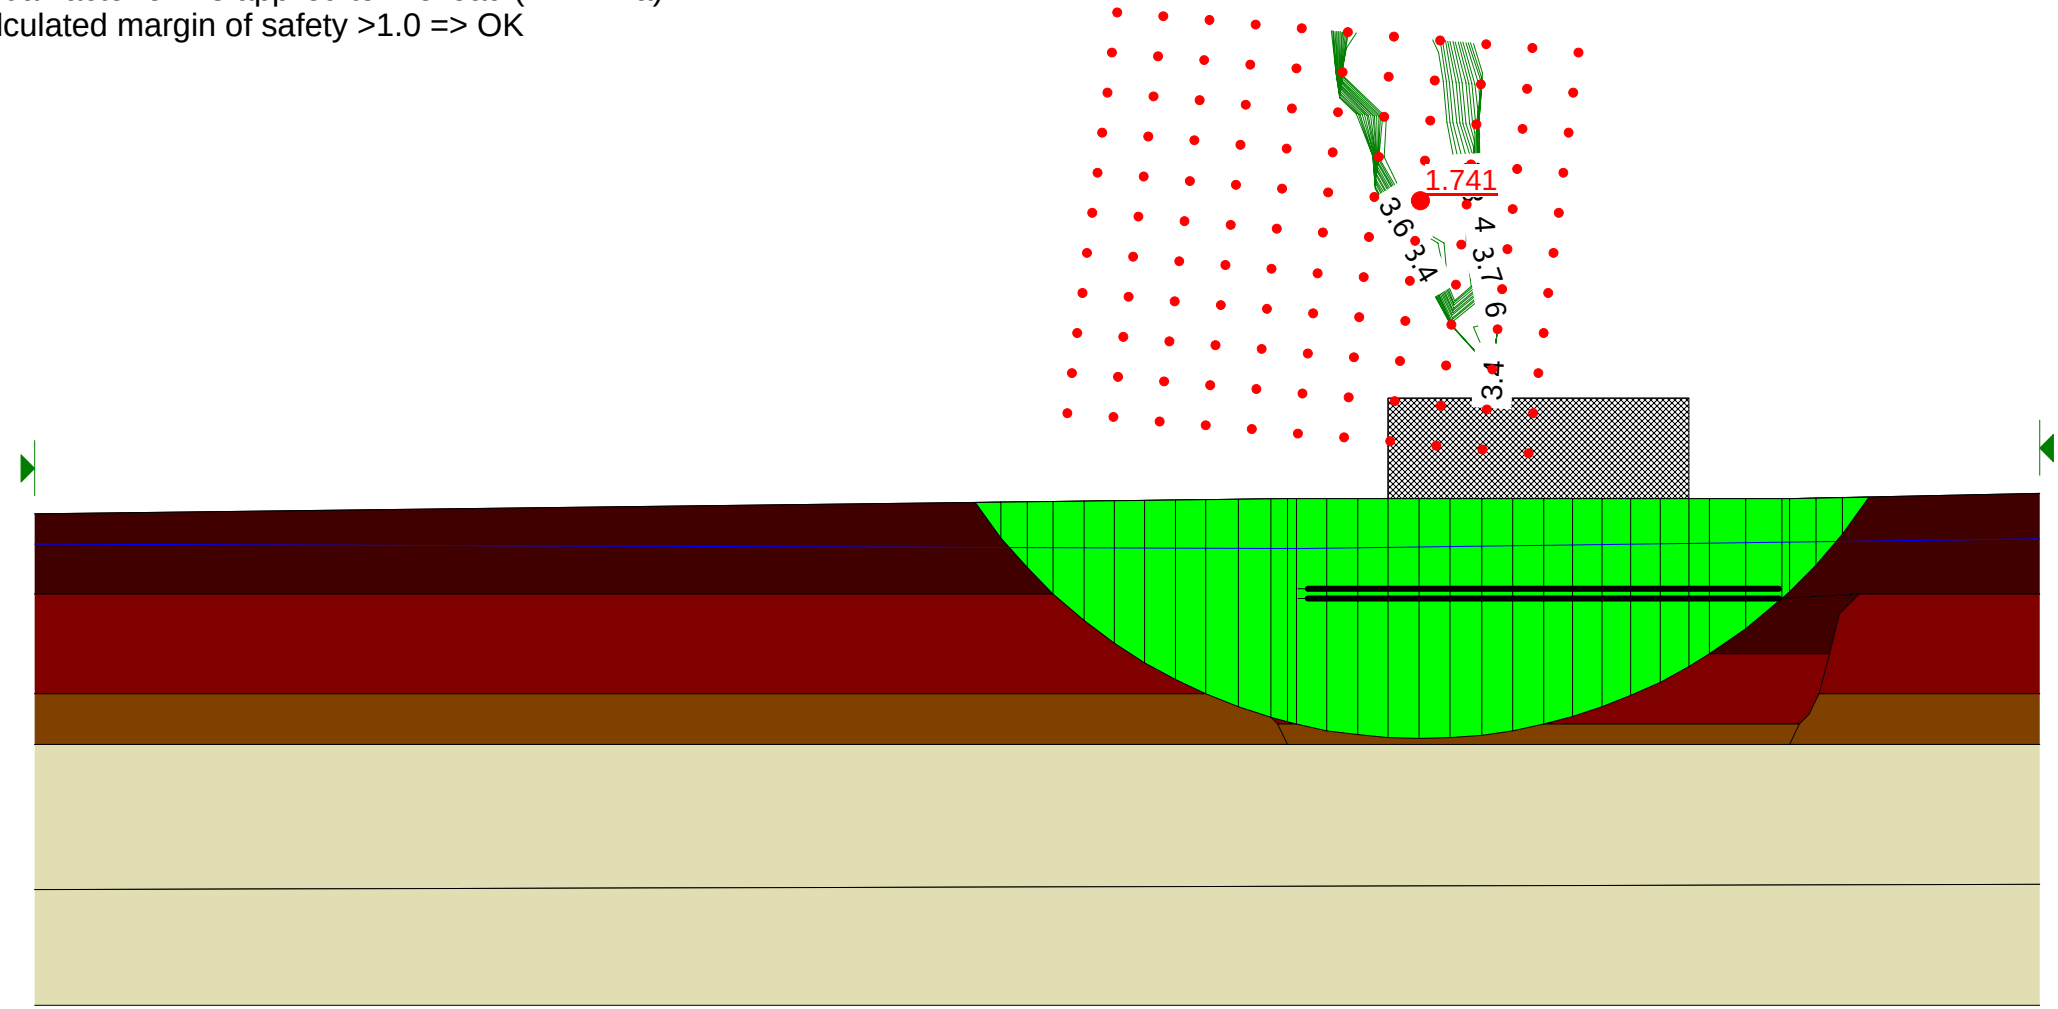
Derrybrien Windfarm - Floating Road Analysis: Cell T50NR (New Road Alignment)

Depth of peat = 2.5 m on downslope side of road
Slope angle = 1 Deg at surface, 0.2 Deg at base of peat

Partial factor of 1.4 applied to undrained shear strength of peat
No allowance taken for increase in strength under road

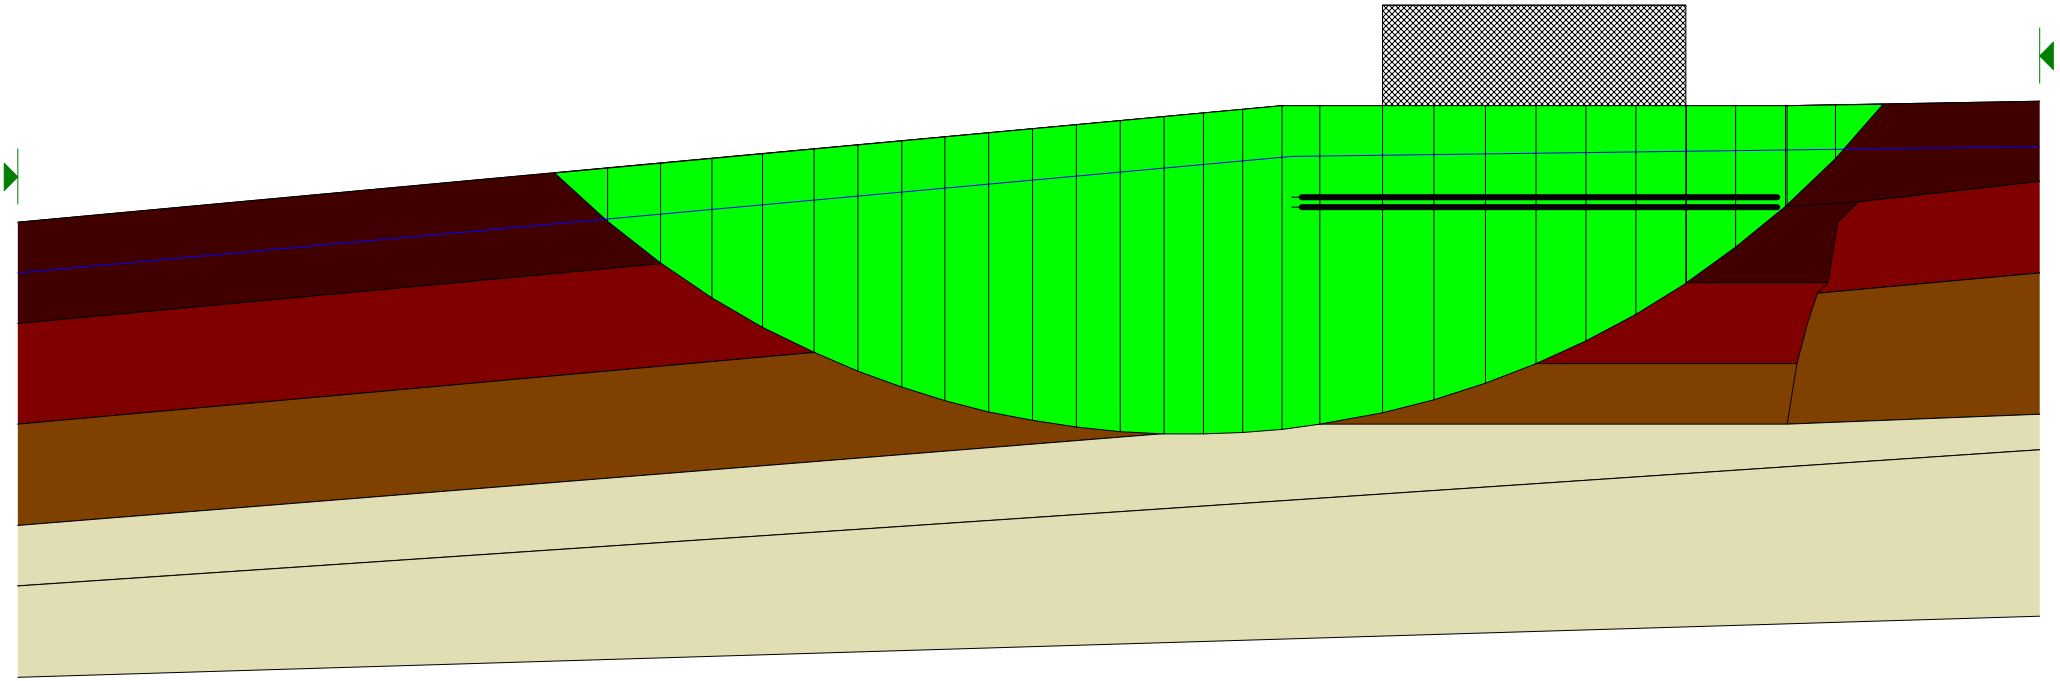
Derryrien Windfarm - Floating Road Analysis: Cell T51

Depth of peat = 3.08 meters on downslope side of road
Slope angle = 5.2 Deg at surface, 4.7 Deg at base of peat

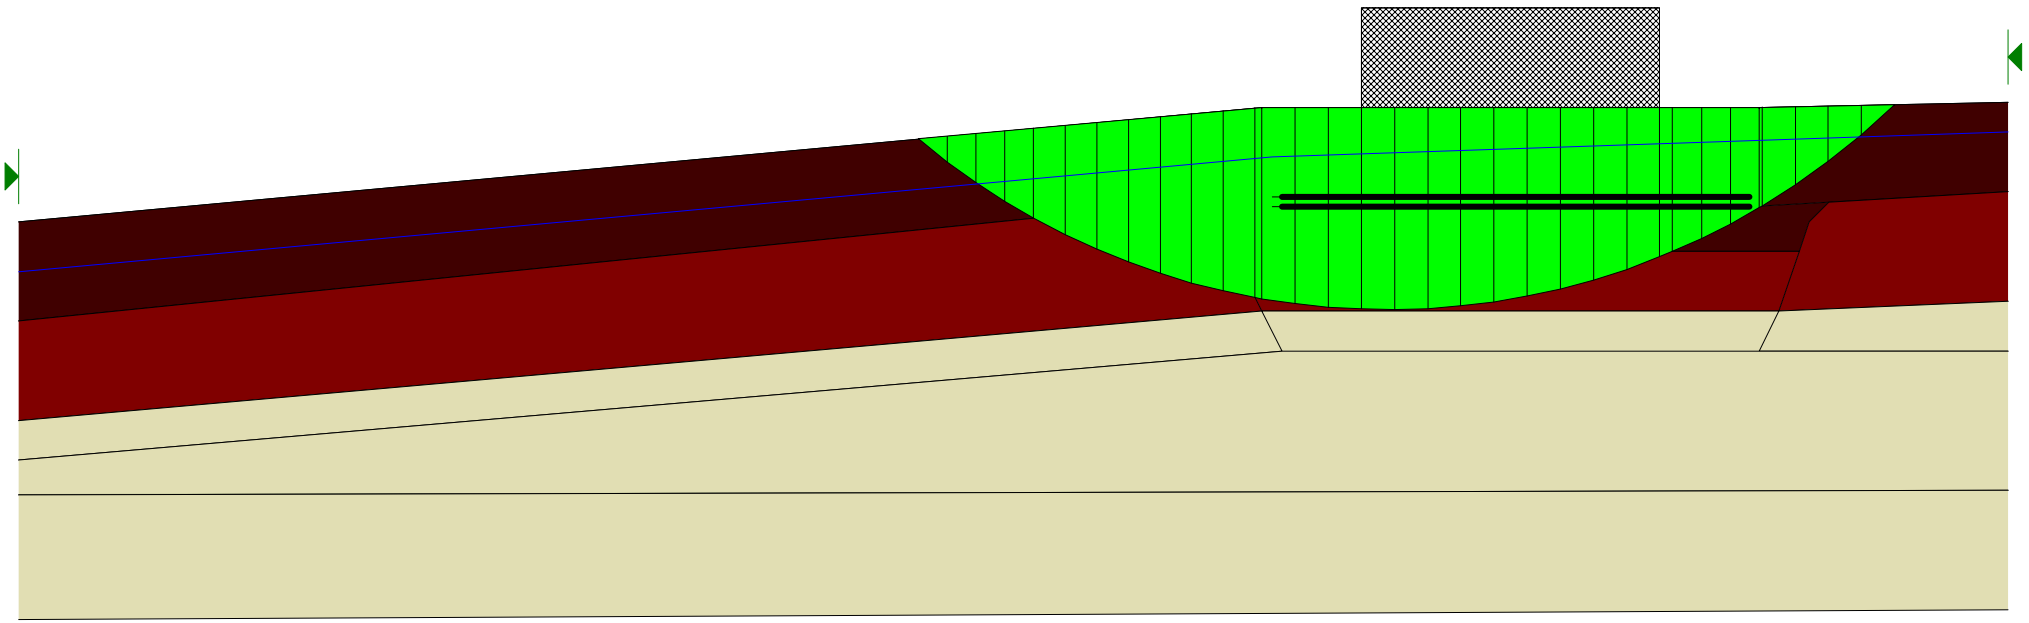
Derrybrien Windfarm - Floating Road analysis: Cell T52

Depth of peat = 2.0 m on downslope side of road
Slope angle = 5.7 Deg at surface, 5.7 Deg at base of peat

Partial factor of 1.3 applied to live load (17.1 kPa)
Calculated margin of safety > 1.0 = OK

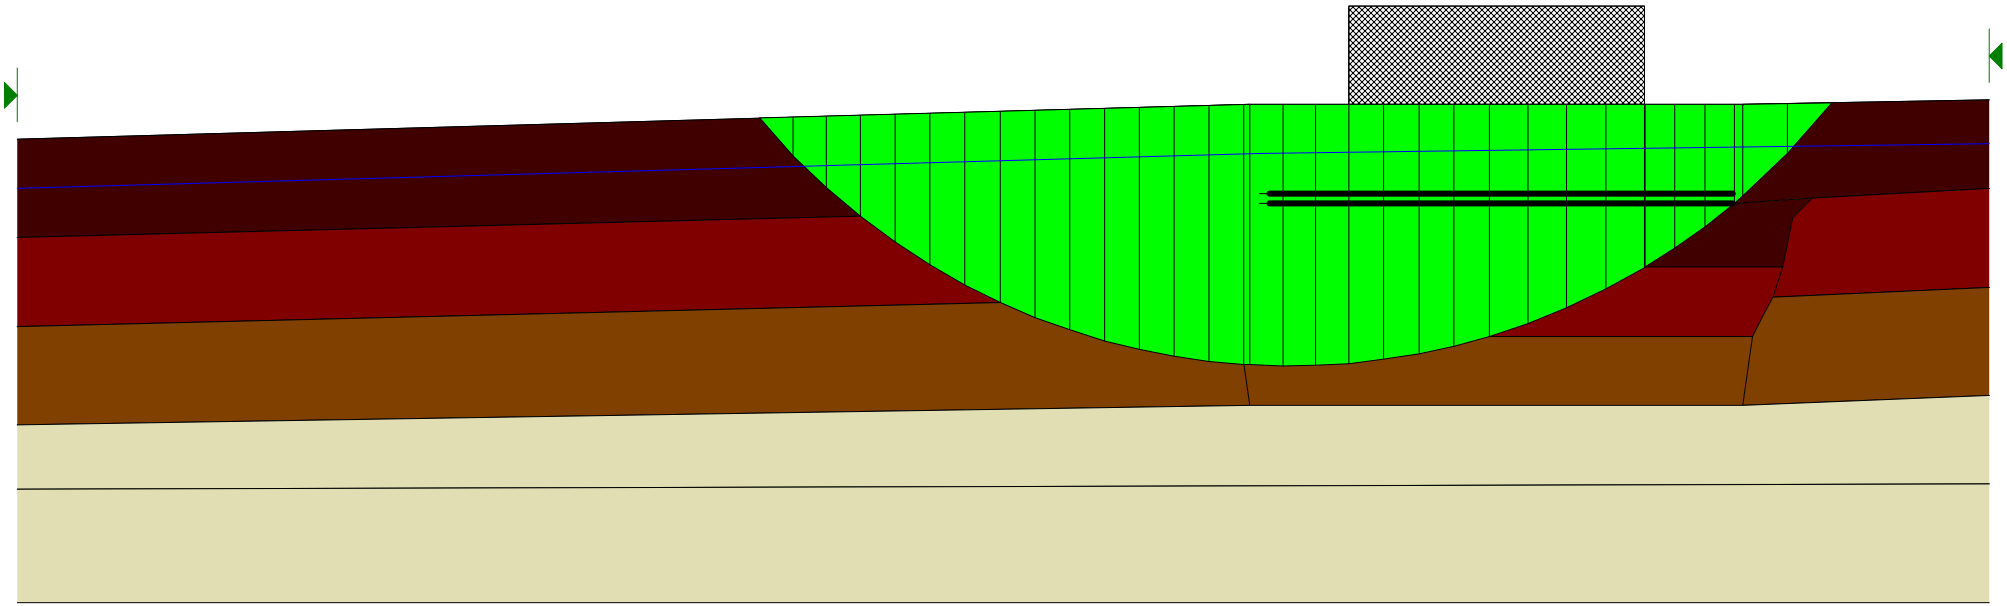
Derrybrien Windfarm - Floating Road Analysis: Cell T53NR (New Road alignment)

Depth of peat = 3.0 m on downslope side of road
Slope angle = 1.5 Deg at surface, 1.0 Deg at base of peat

Partial factor of 1.4 applied to undrained shear strength of peat
No allowance taken for increase in strength under road

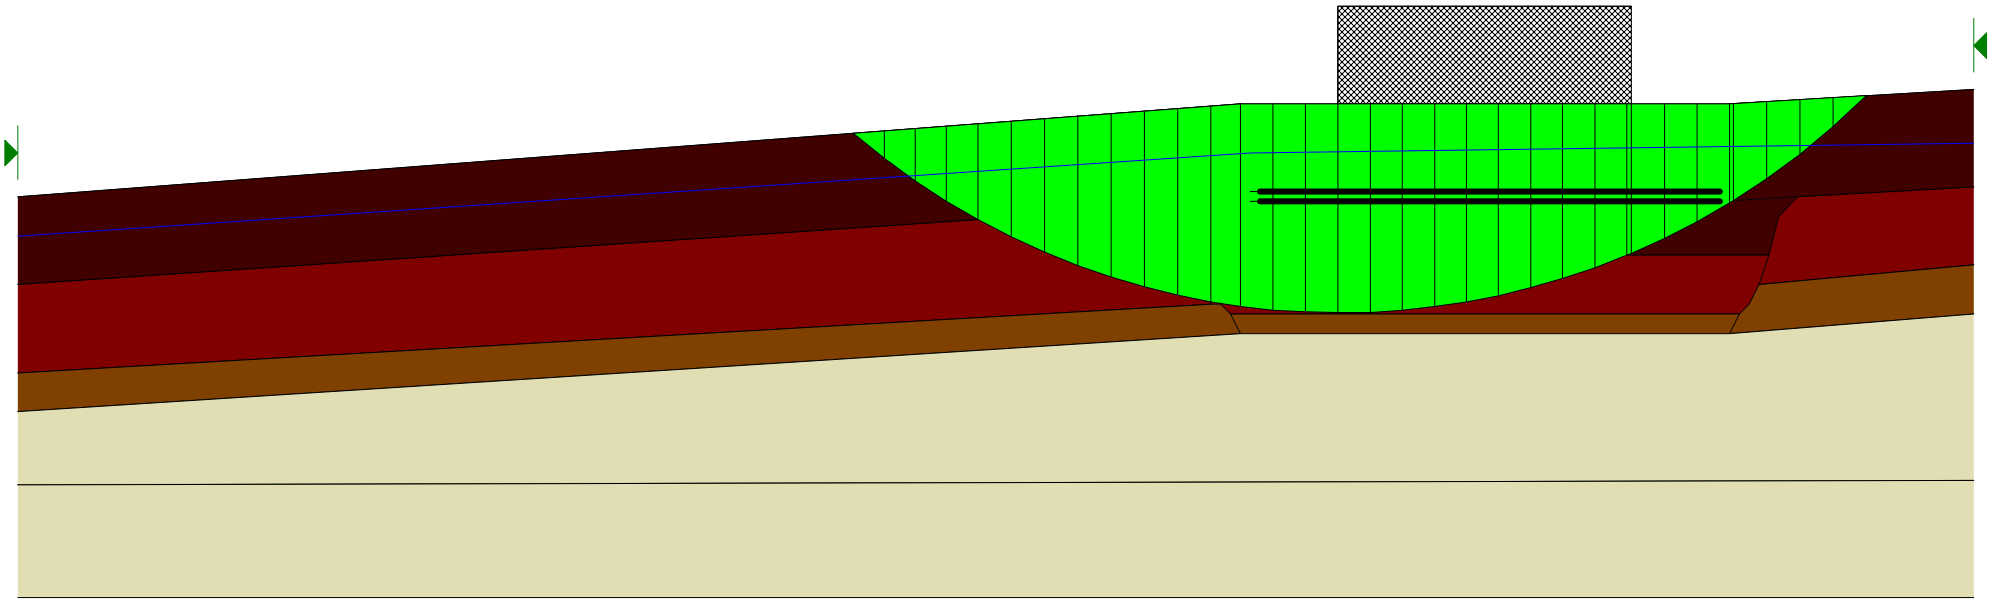
Derrybrien Windfarm - Floating Road Analysis: Cell T53NR (New Road alignment)

Depth of peat = 2.35 m on downslope side of road
Slope angle = 4.5 Deg at surface, 3.7 Deg at base of peat

Partial factor of 1.3 applied to design live load (17.1 kPa)
Calculated margin of safety >1.0 => OK

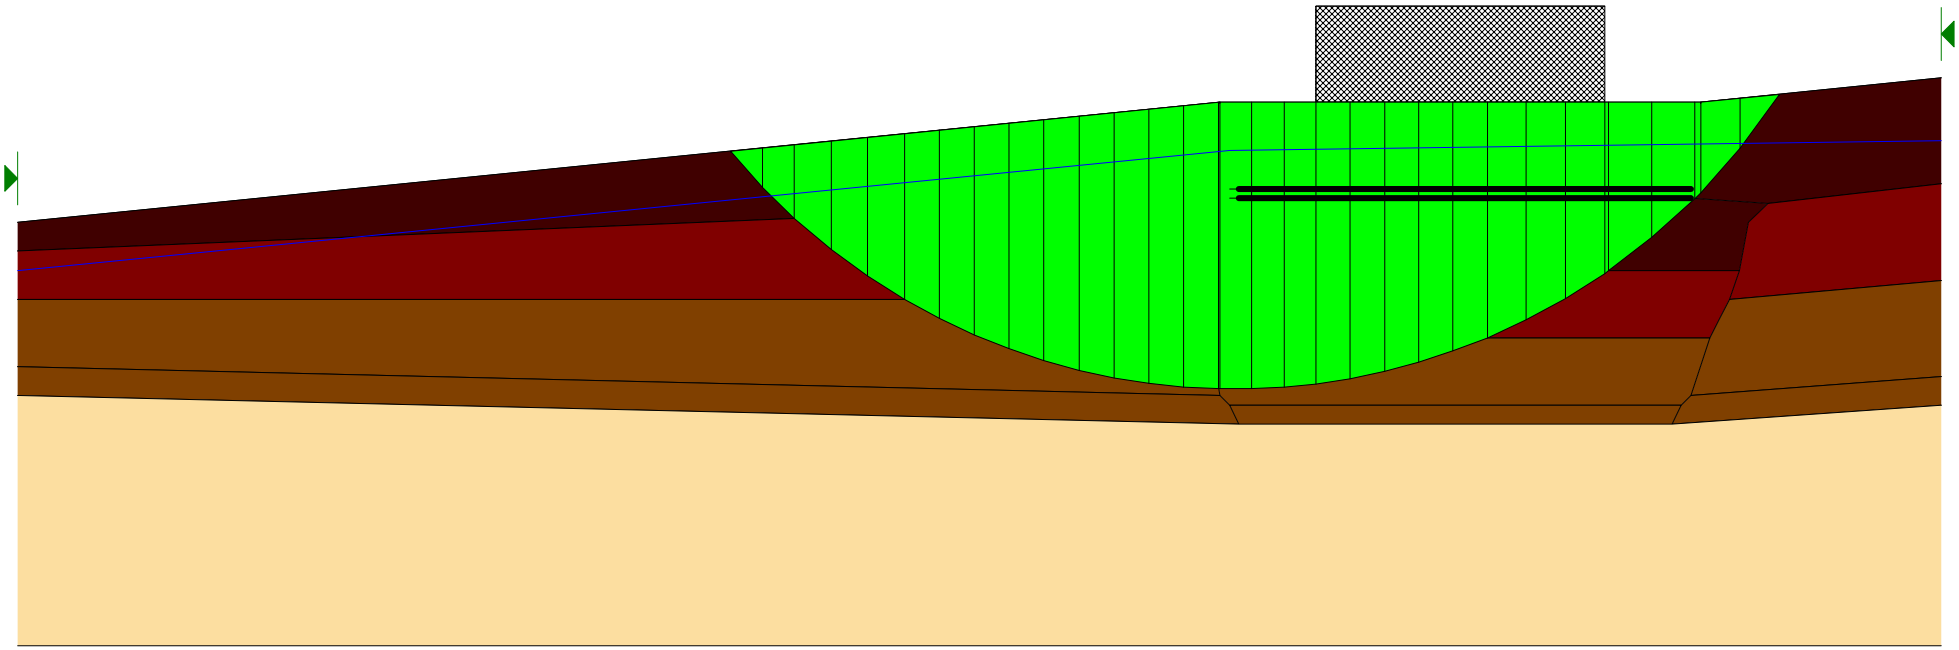
Derrybrien Windfarm - Floating Road Analysis: Cell T54NR (New Road alignment)

Depth of peat = 3.3 m on downslope side of road
Slope angle = 1.5 Deg at surface, 0.6 Deg at base of peat

Partial factor of 1.4 applied to undrained shear strength of peat
No allowance taken for increase in strength under road
