Derrybrien Wind Farm Development Decommissioning Project – Retained Development

GEOTECHNICAL STABILITY REPORT - WIND FARM SITE (PART I)

DERRYBRIEN WIND FARM
GEOTECHNICAL STABILITY REPORT & ASSESSMENT OF STABILITY IMPACTS OF ON-SITE ACTIVITIES

Document No:	**11-147-R04**	**Issue 02 (Rev. 0)**
Made:	Conor O'Donnell / Niamh Farrell	
Checked:	Conor O'Donnell

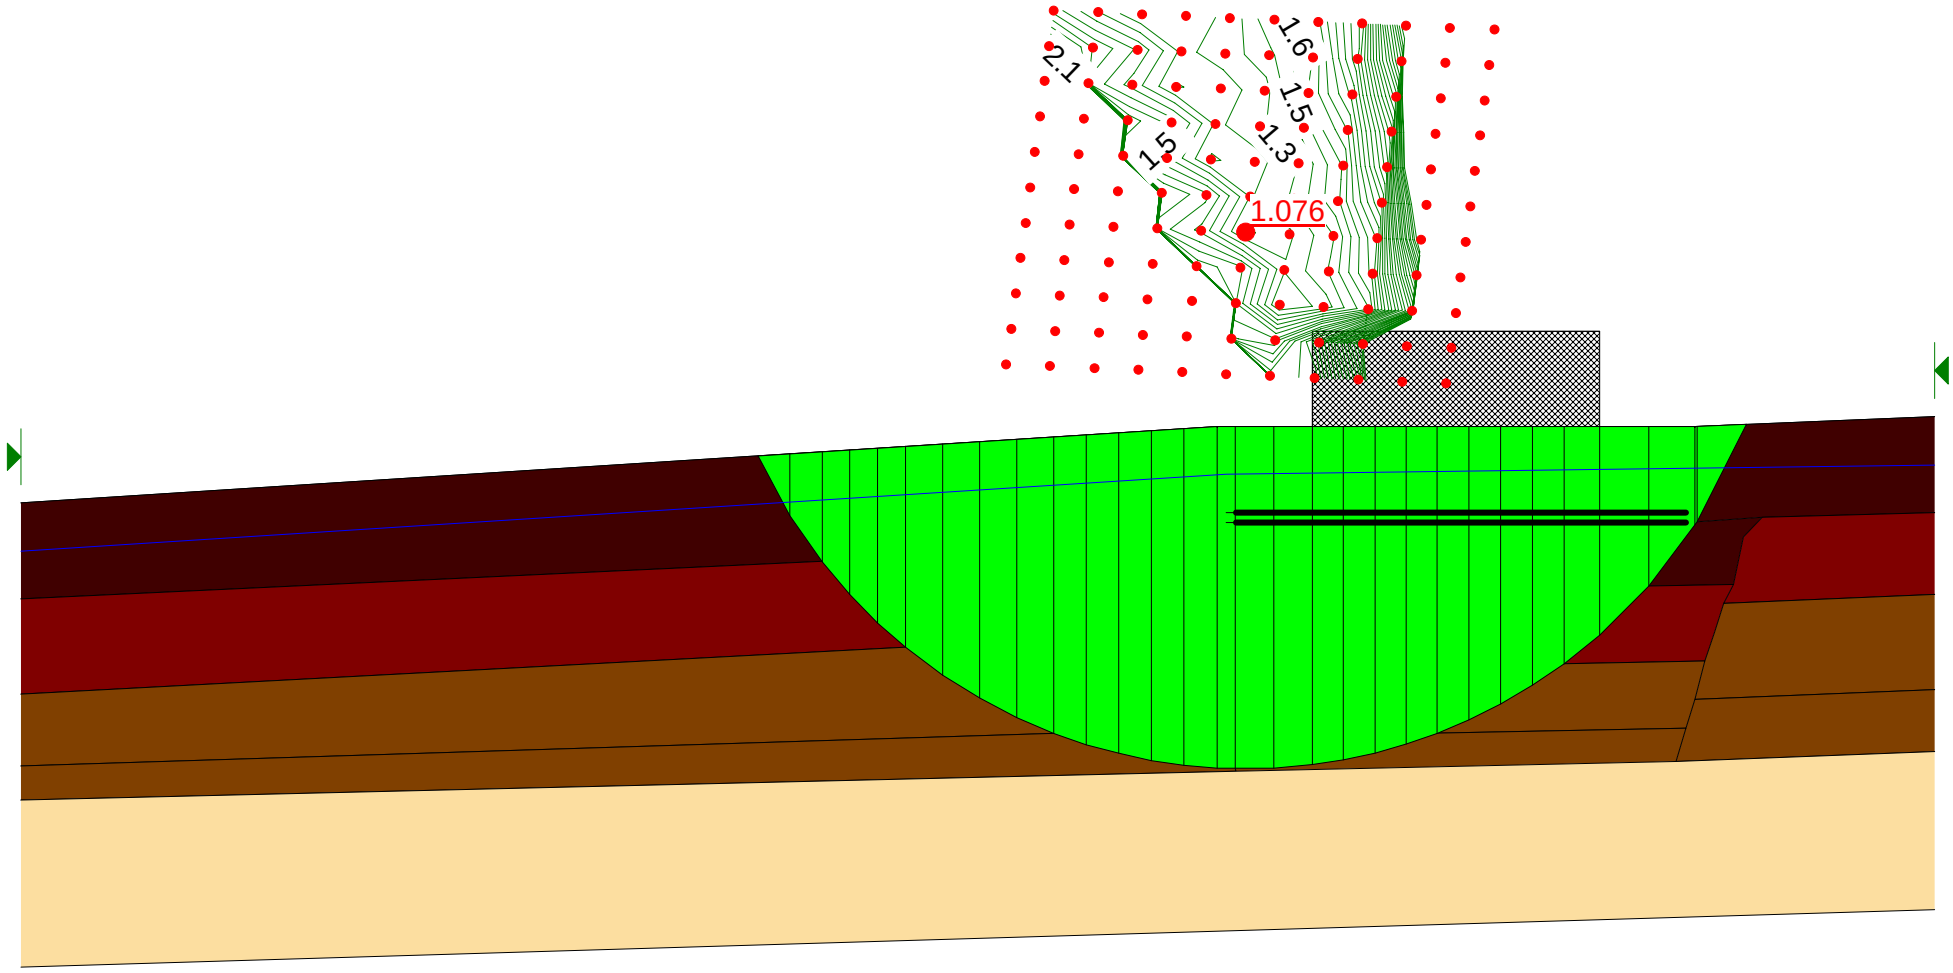
Derrybrien Windfarm - Floating Road Analysis: Cell T55

Depth of peat = 3.75 m on downslope side of road
Slope angle = 3.7 Deg at surface, 1.4 Deg at base of peat

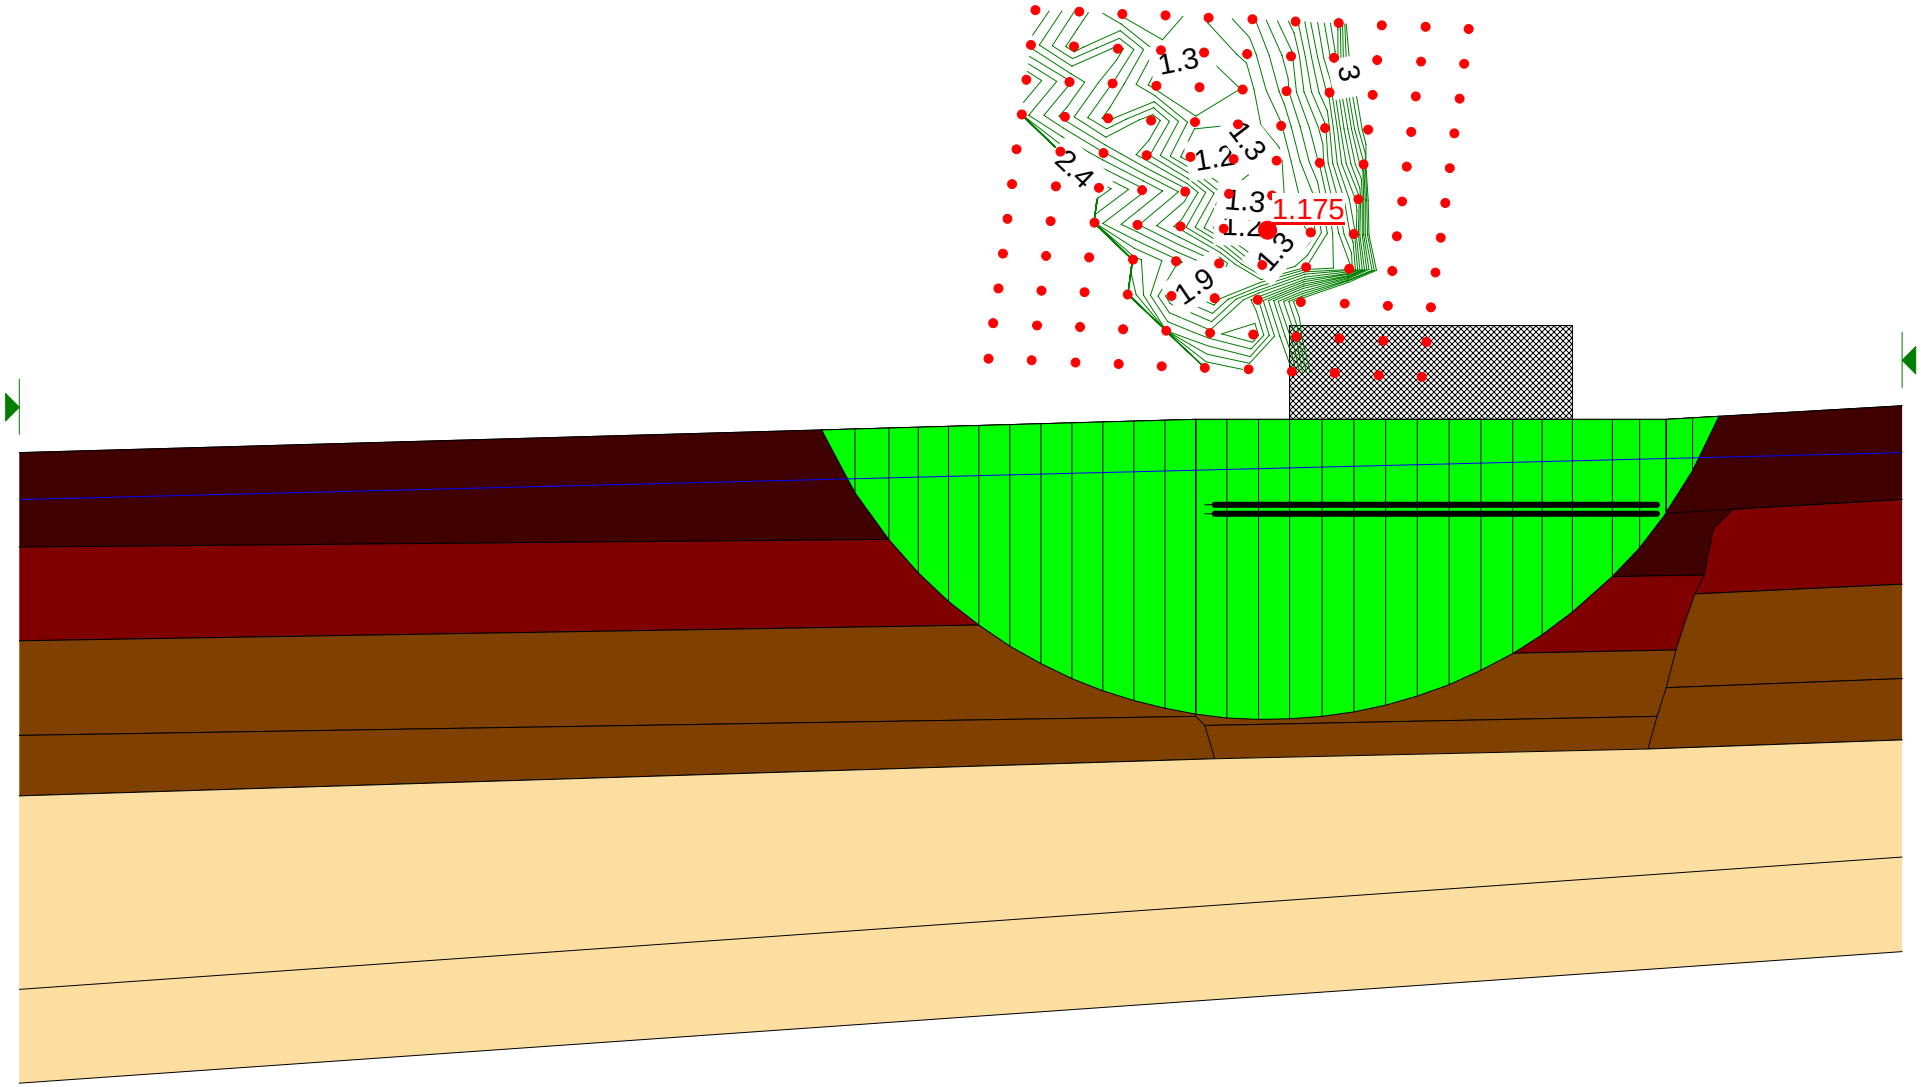
Derrybrien Windfarm - Floating Road Analysis: Cell T57

Partial factor of 1.3 applied to live load (17.1 kPa)
Calculated margin of safety >1.0 => OK

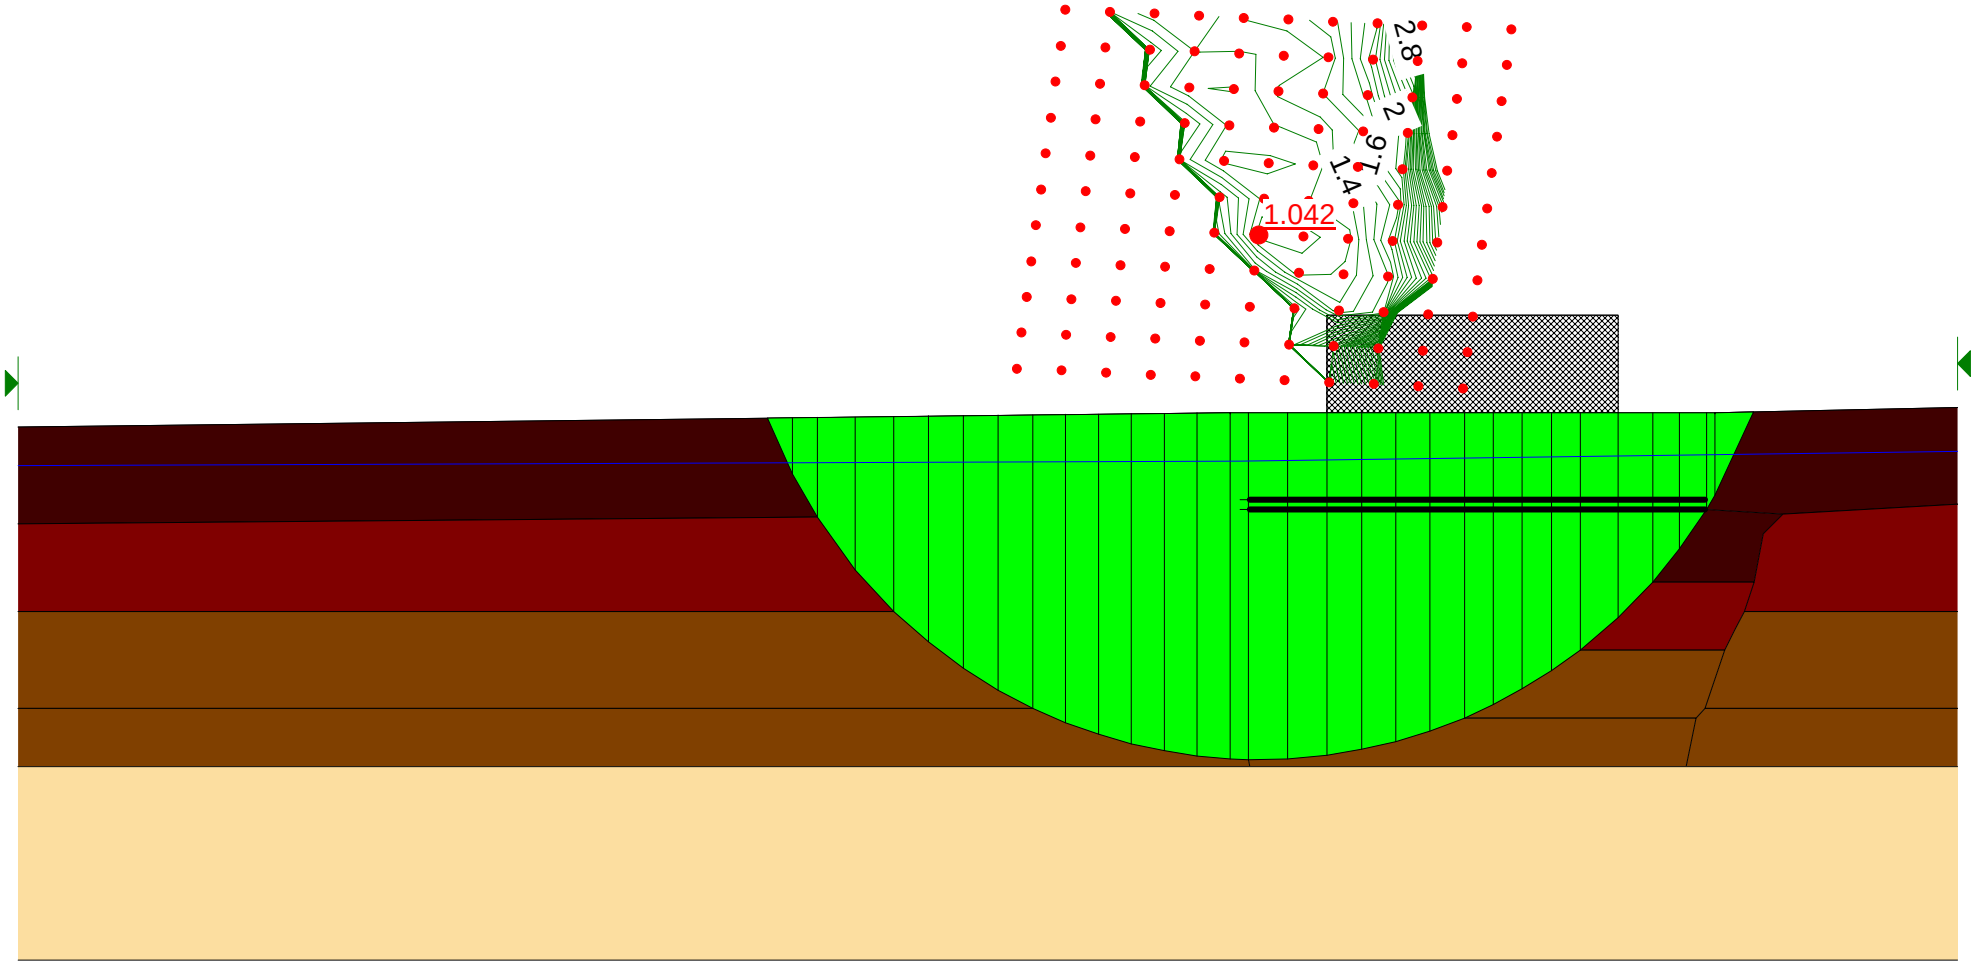
Derrybrien Windfarm - Floating Road Analysis: Cell T59

Depth of peat = 3.6 m on downslope side of road
Slope angle = 0.5 Deg at surface, 0 Deg at base of peat

Partial factor of 1.3 applied to live load (17.1 kPa)
Calculated margin of safety >1.0 => OK

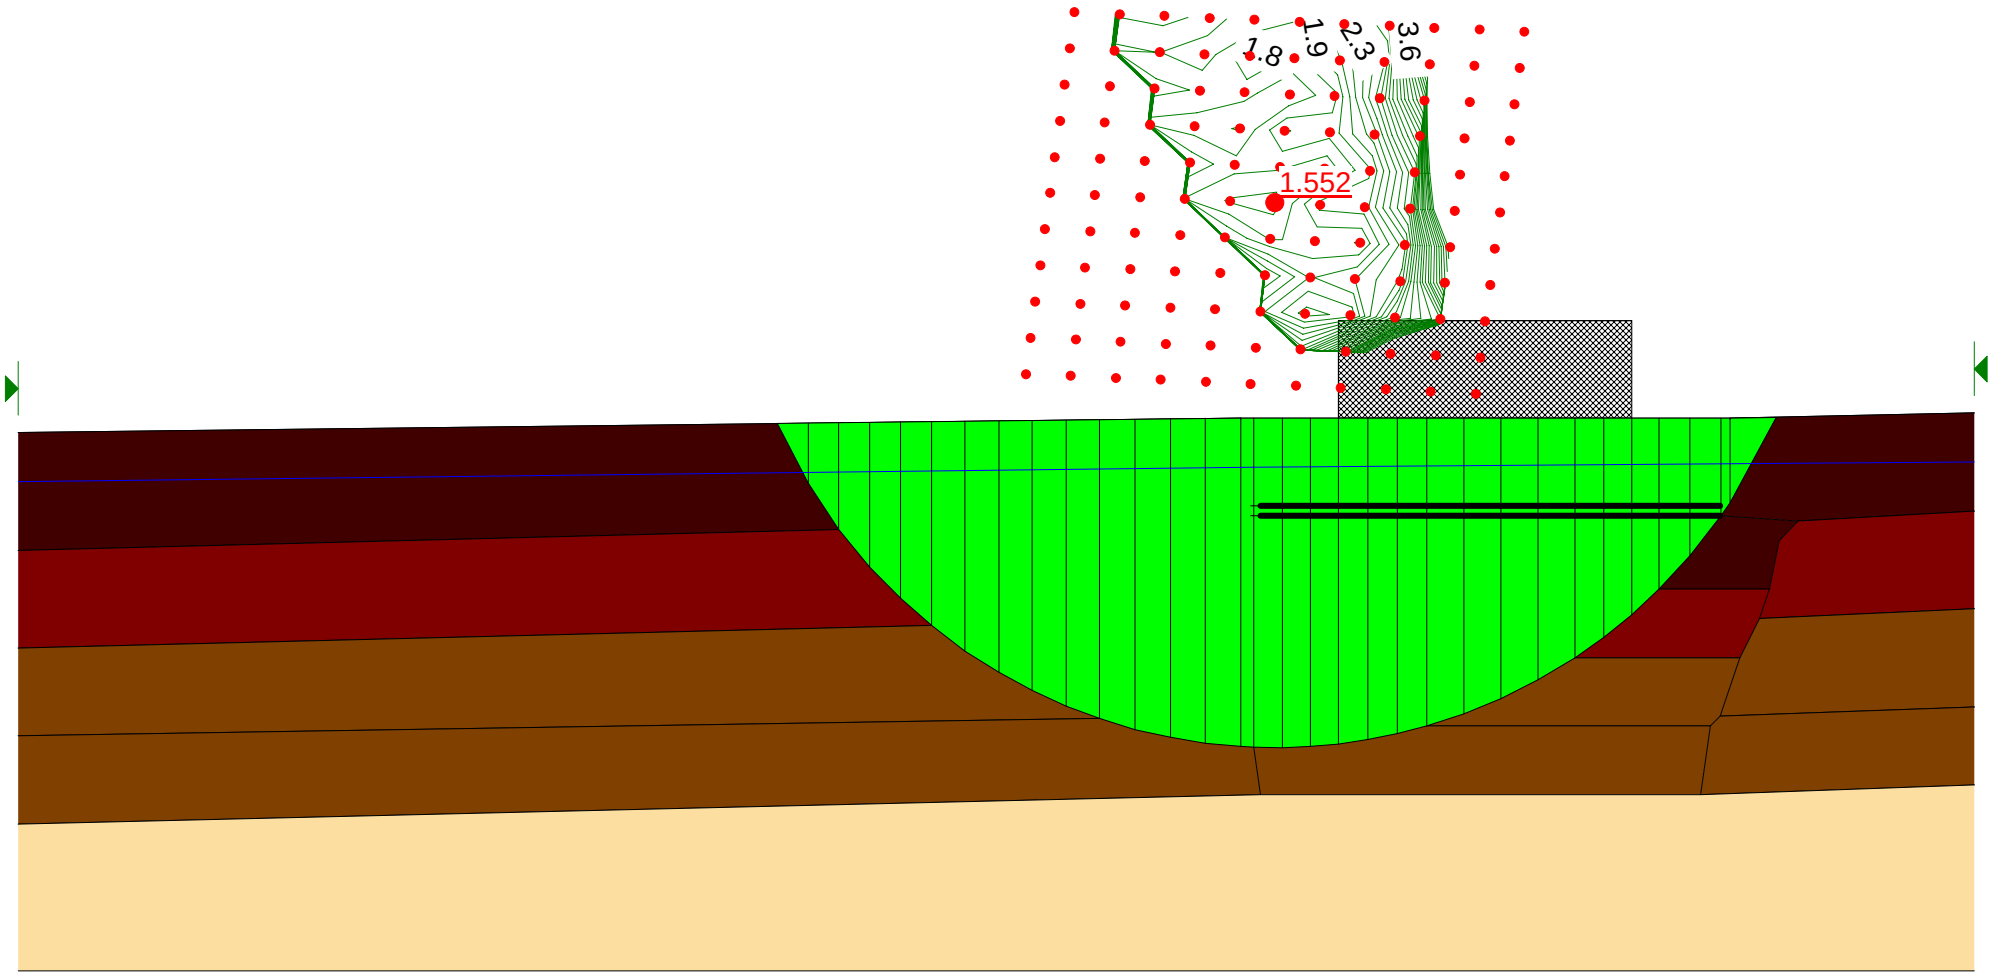
Derrybrien Windfarm - Floating Road Analysis: Cell T60

Depth of peat = 3.8 m on downslope side of road
Slope angle = 0.5 Deg at surface, 1.6 Deg at base of peat

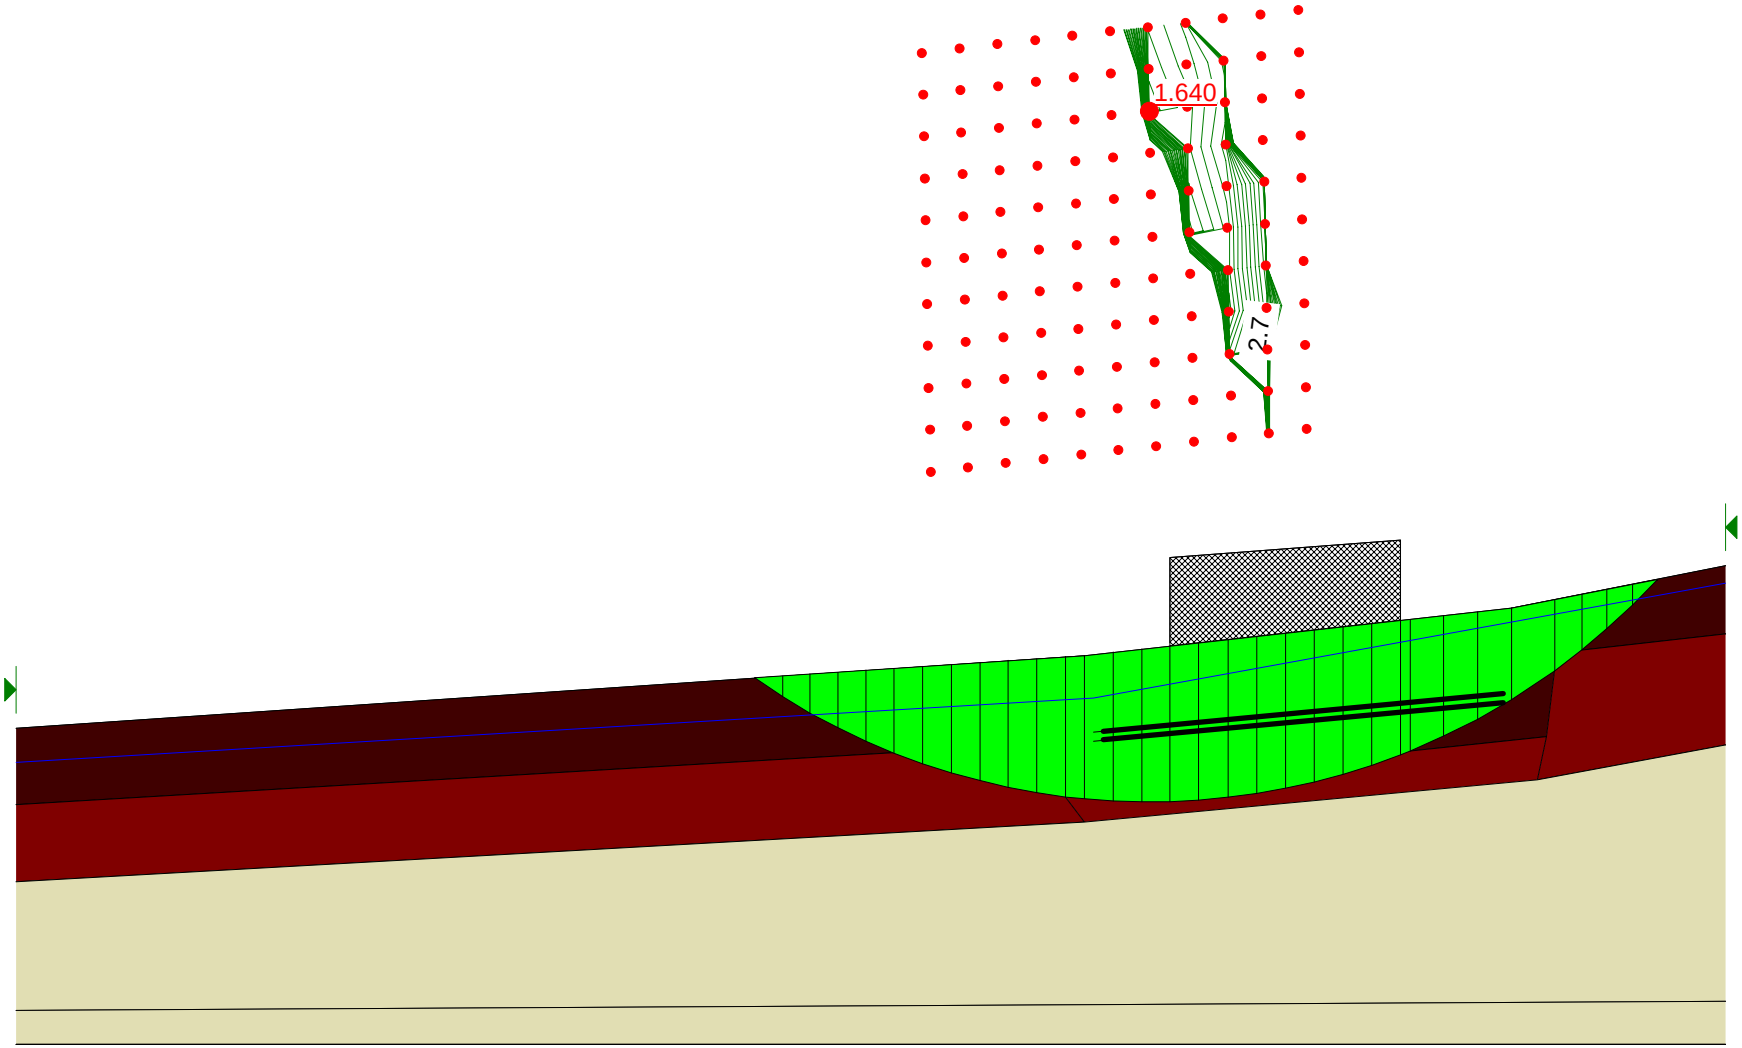
Derrybrien Windfarm - Floating Road Analysis: Cell T61

5.0 m wide road - 1.0 m thick
Basal reinforcement with trees and 1 layer of Tensar SS30 Geogrid

Depth of peat = 1.9 m on downslope side of road
Slope angle = 3.5 Deg at surface, 3.1 Deg at base of peat

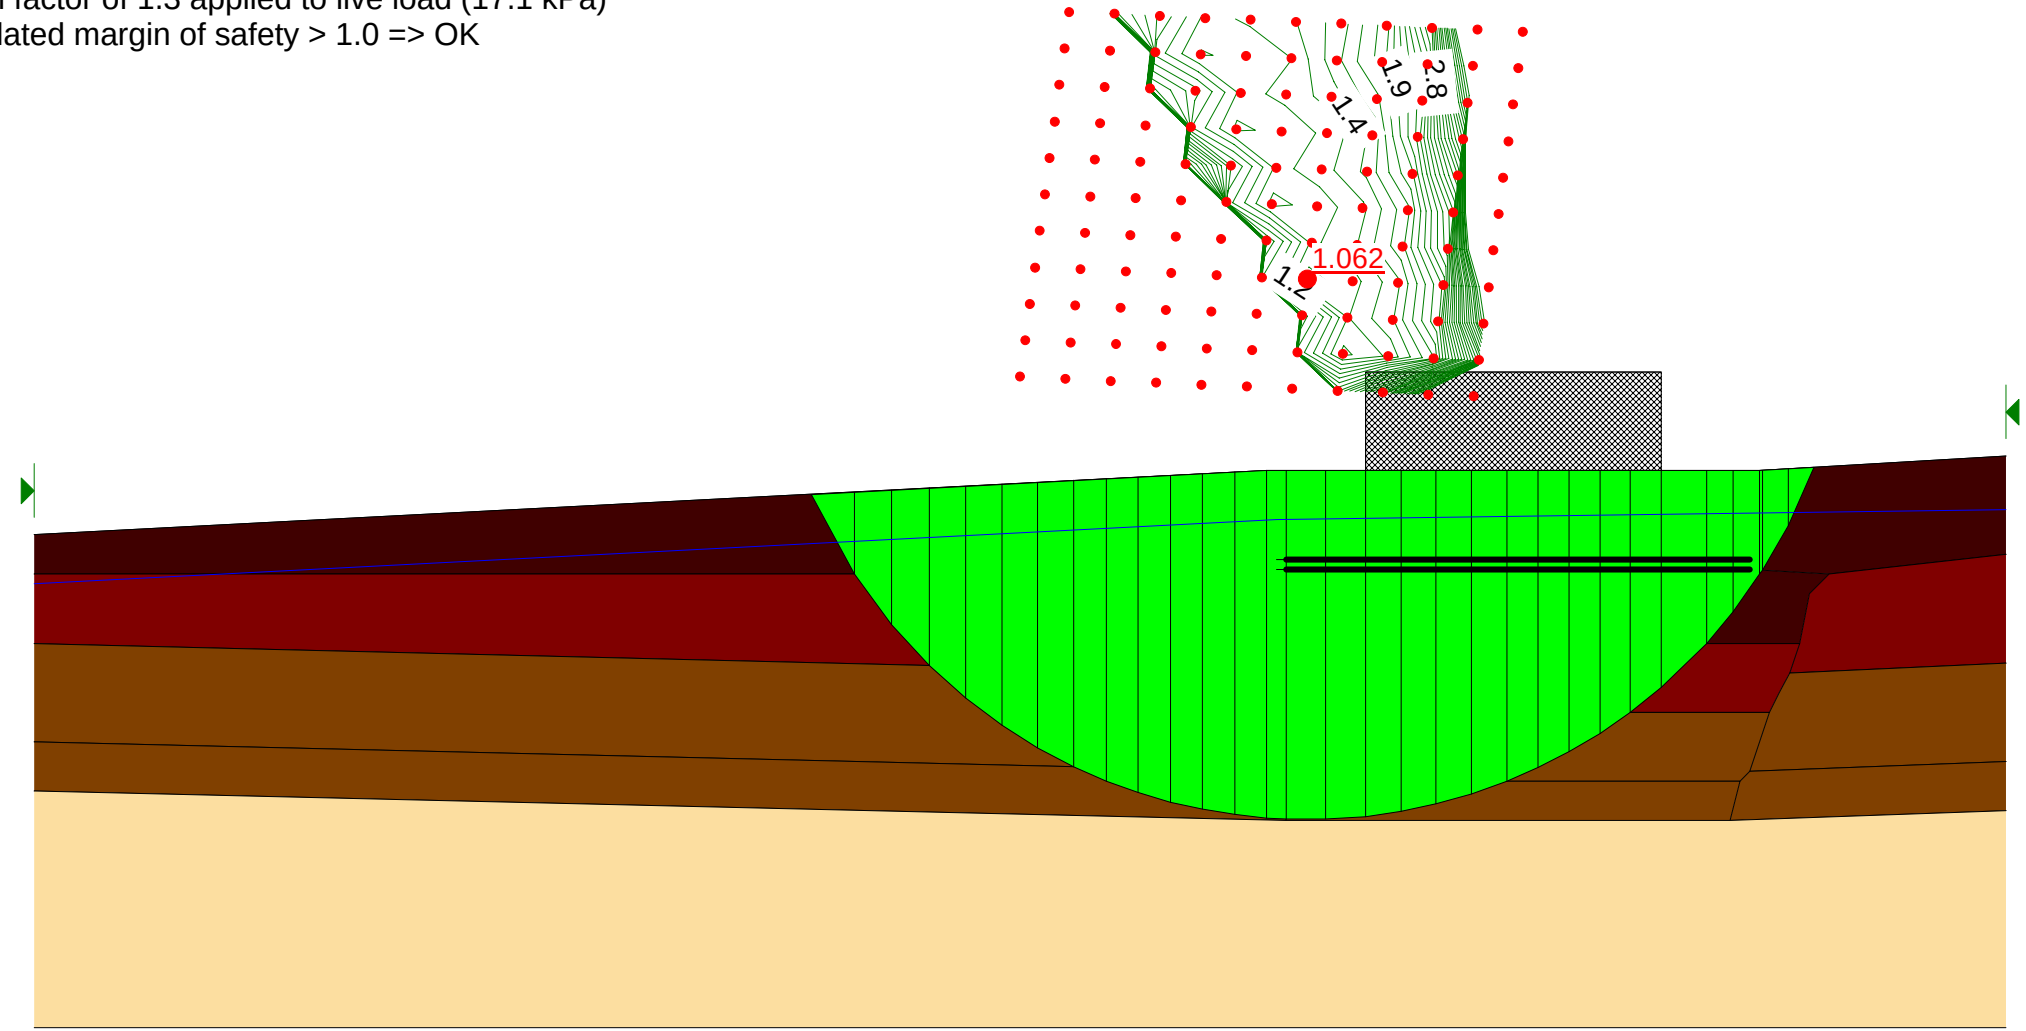
Derrybrien Windfarm - Floating Road Analysis: Cell T62

5.0 m wide road - 1.0 m thick
Basal reinforcement with trees and 1 layer of Tensar SS30 Geogrid

Depth of peat = 2.8 m on downslope side of road
Slope angle 3.5 Deg at surface, 0.8 deg at base of peat

Partial factor of 1.3 applied to design live load (17.1 kPa)
Calculated margin of safety >1.0 => OK

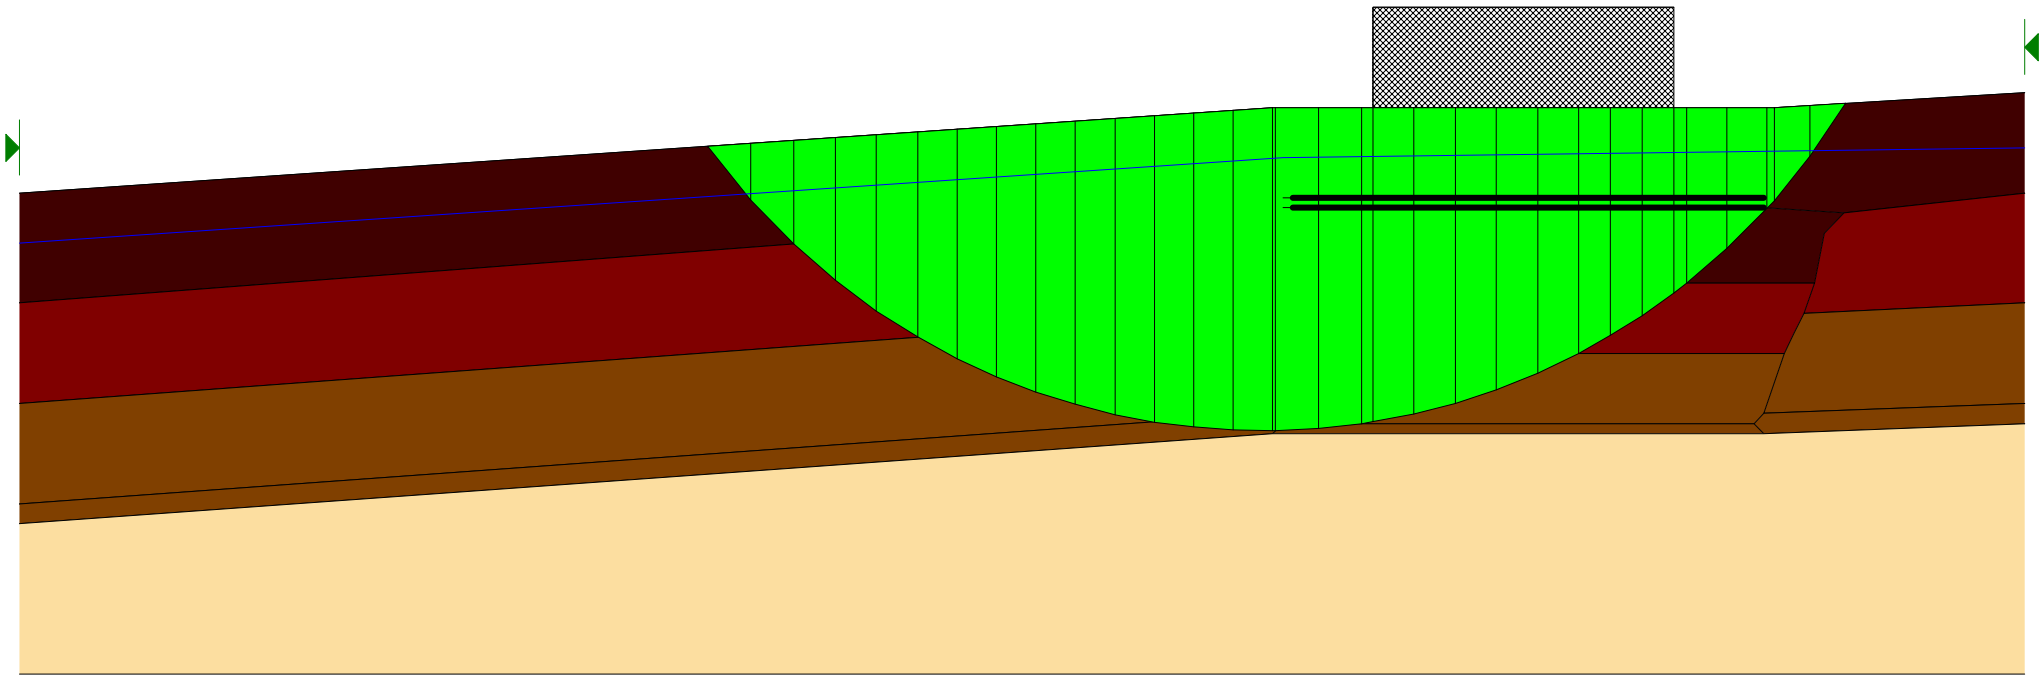
Derrybrien Windfarm - Floating Road Analysis: Cell T63

5.0 m wide road - 1.0 m thick
Basal reinforcement with trees and 1 layer of Tensar SS30 Geogrid

Depth of peat = 3.2 m on downslope side of road
Slope angle = 3.5 Deg at surface, 4.0 Deg at base of peat

Partial factor of 1.3 applied to live load (17.1 kPa)
Calculated margin of safety >1.0 => OK

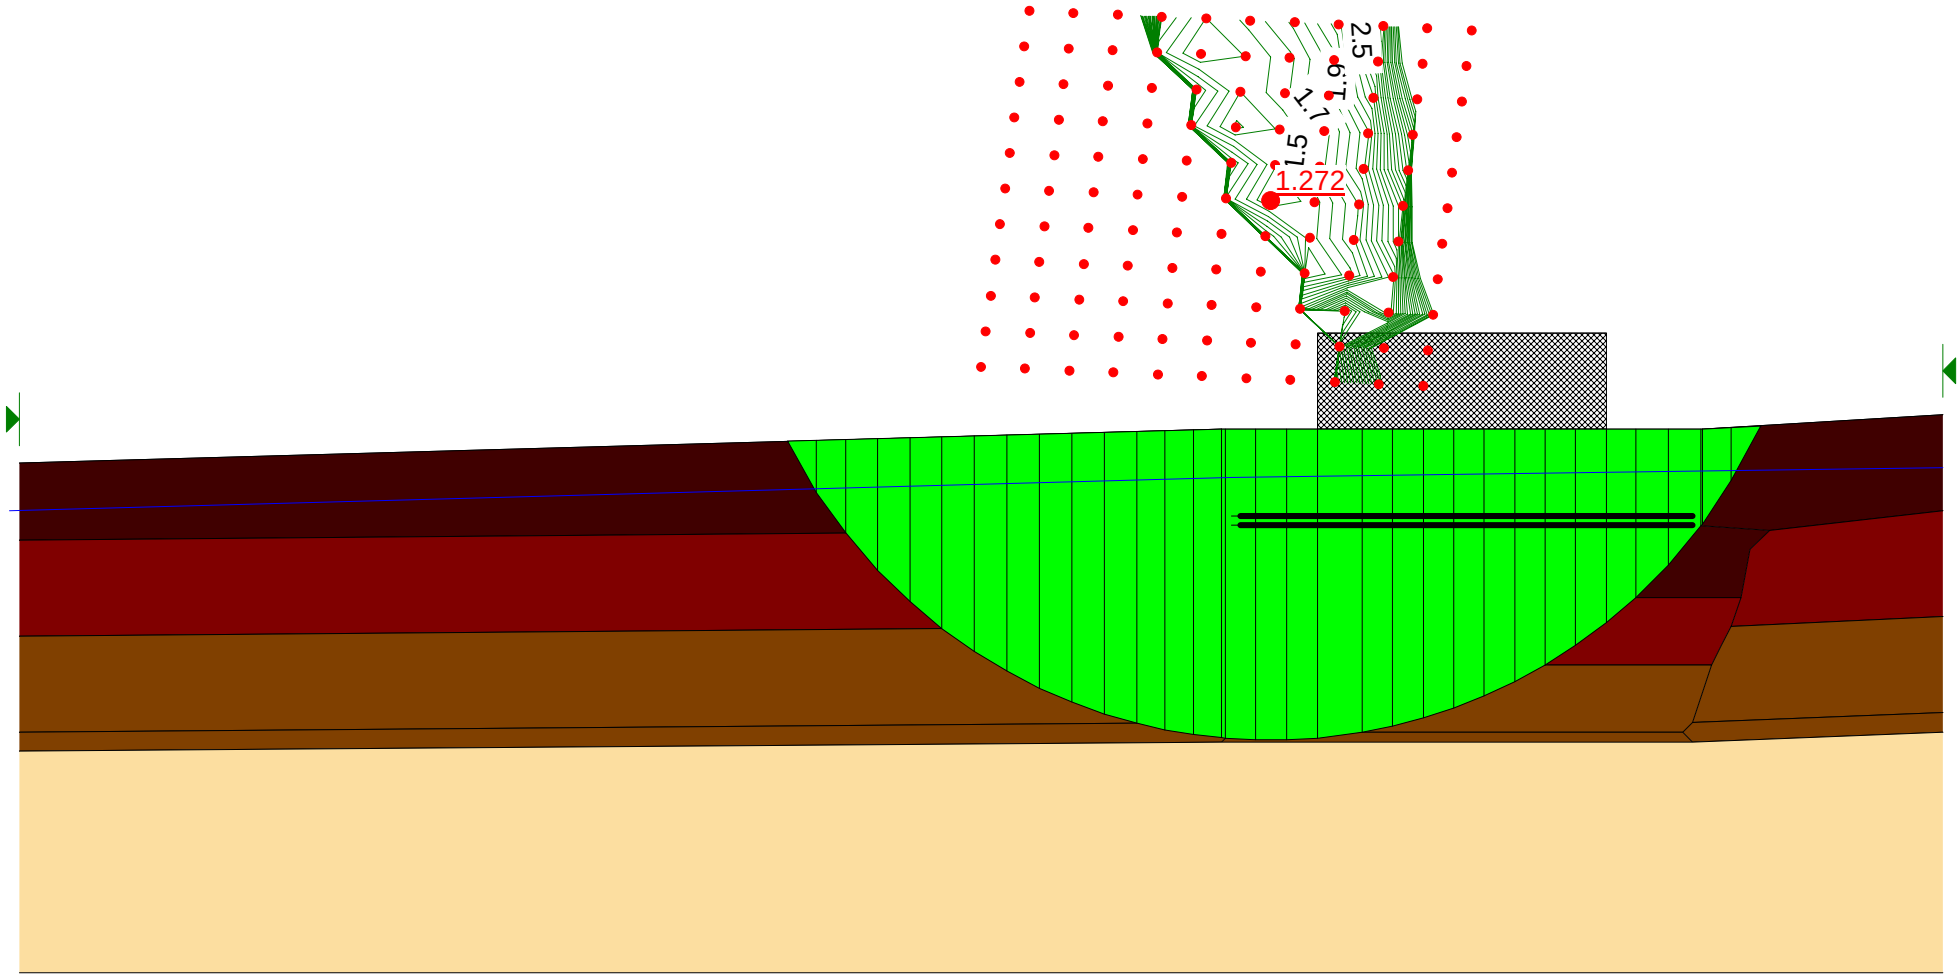
Derrybrien windfarm - Floating Road Analysis: Cell T64

5.0 m wide road - 1.0 m thick
Basal reinforcement with trees and 1 layer of Tensar SS30 Geogrid

Depth of peat = 3.2 m on downslope side of road
Slope angle = 1.5 Deg at surface, 0.6 Deg at base of peat

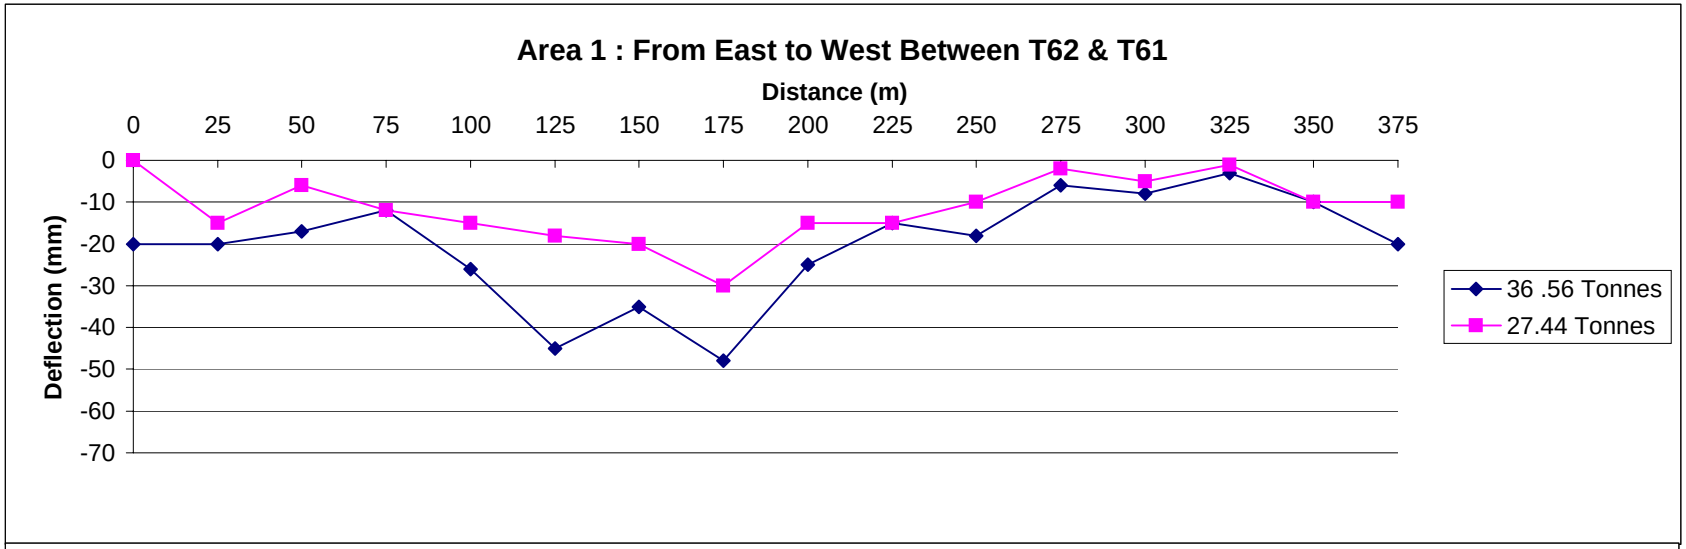
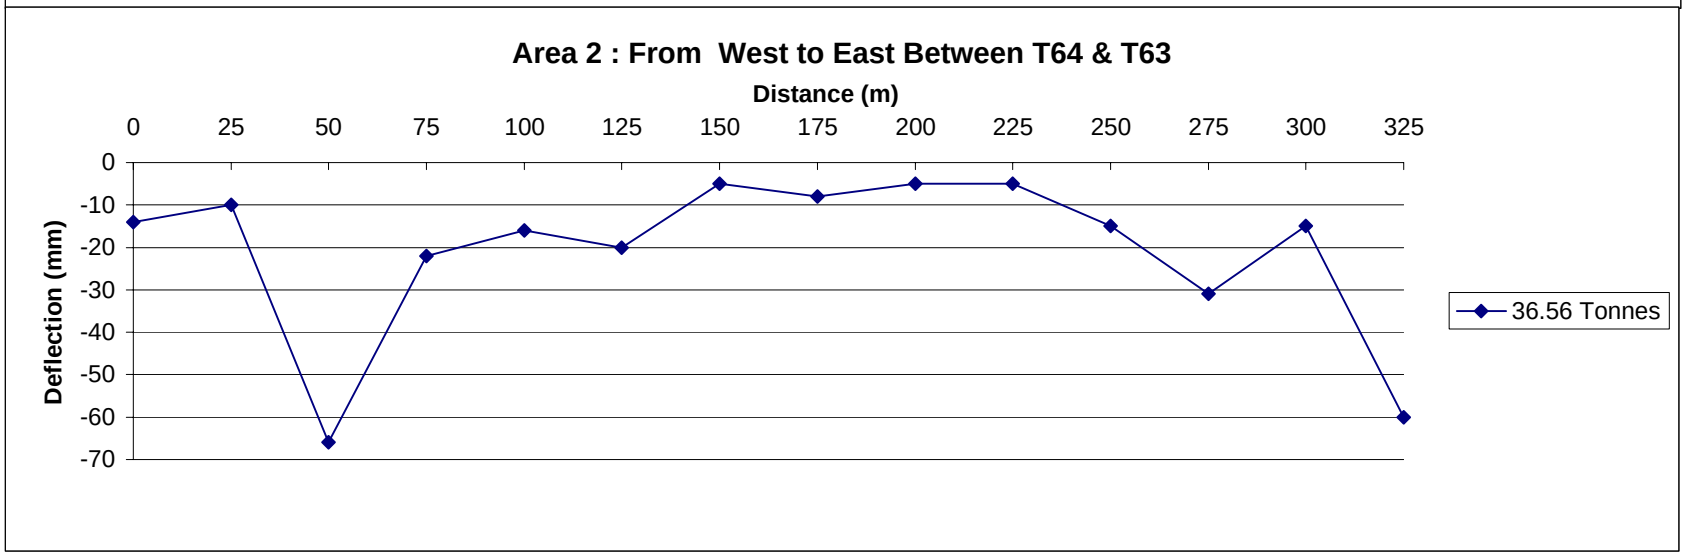
Road Deflection Measurements from Field Load Tests on Floating Roads

Area 1 : From East to West Between T62 & T61
Distance (m)
0 25 50 75 100 125 150 175 200 225 250 275 300 325 350 375
Deflection (mm)
0 -10 -20 -30 -40 -50 -60 -70
36 .56 Tonnes
27.44 Tonnes

Area 2 : From West to East Between T64 & T63
Distance (m)
0 25 50 75 100 125 150 175 200 225 250 275 300 325
Deflection (mm)
0 -10 -20 -30 -40 -50 -60 -70
36.56 Tonnes

Deflection of the floating roads was monitored at representative sections where the road performance was "fair" or "poor". The recorded deflection of these sections roads is included in Appendix C for Phase 1, 2 and 3 of the road tests.

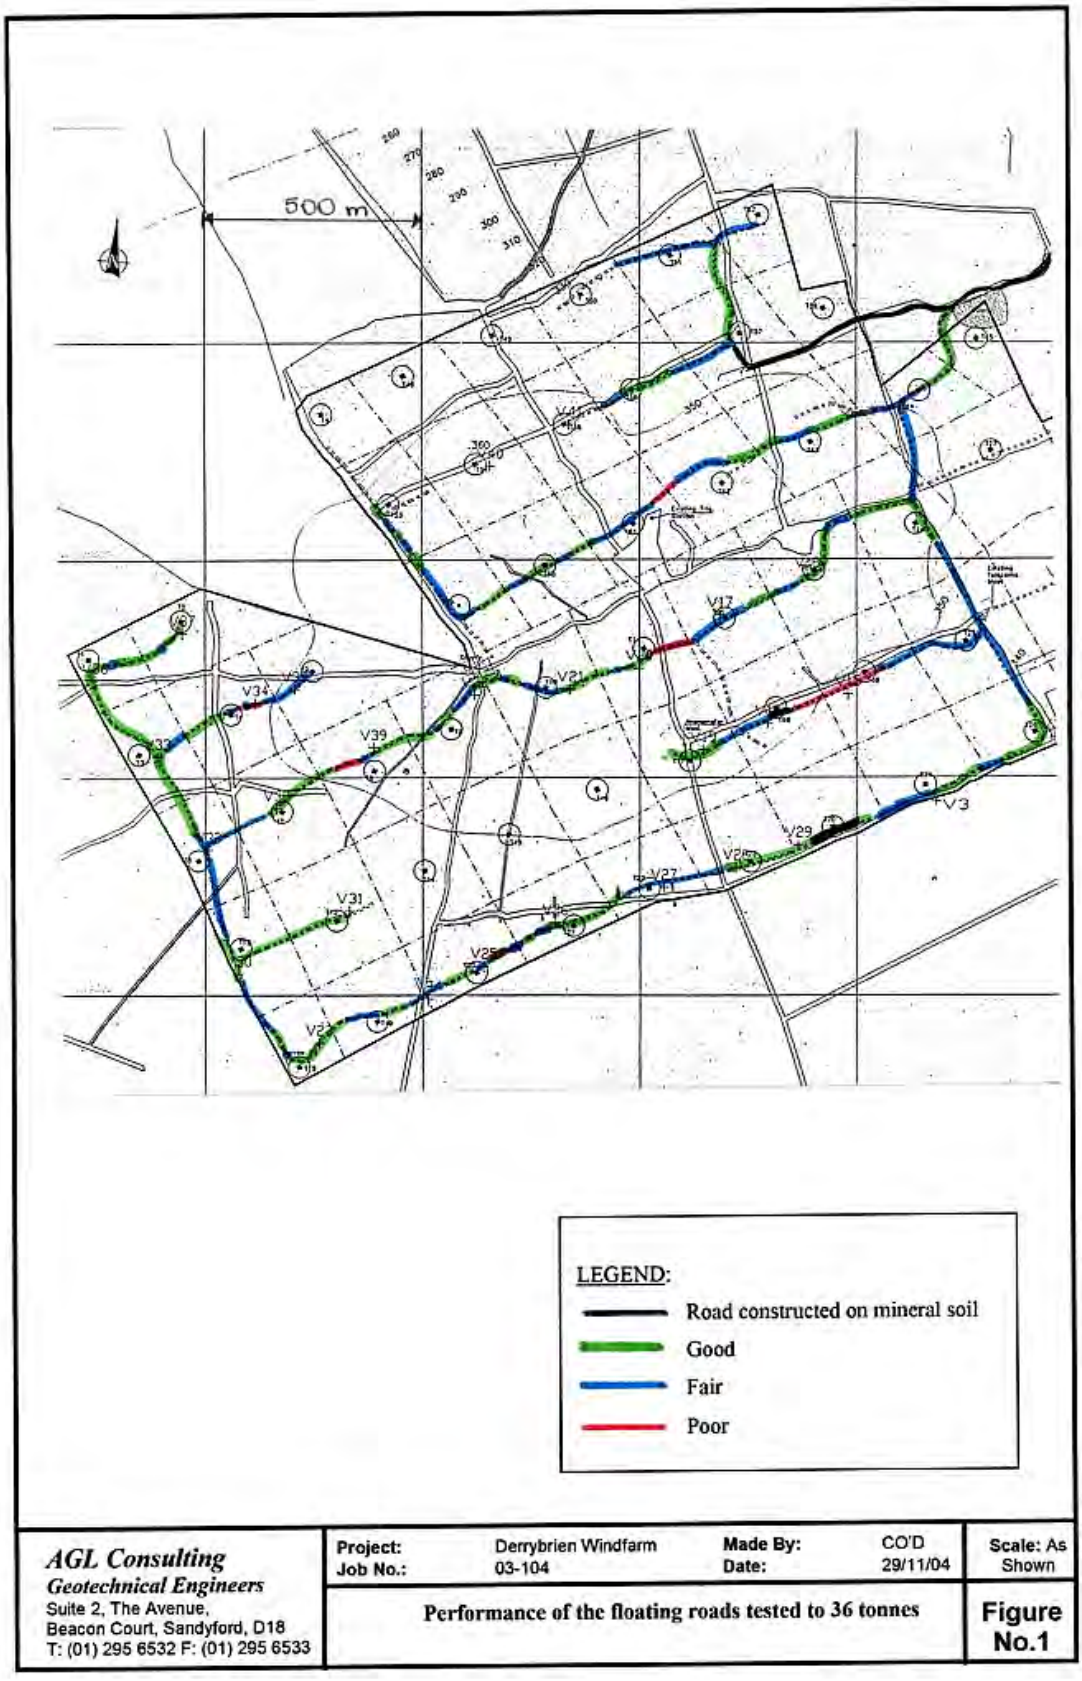
The performance of the majority of the roads was classified as "good" or "fair". These roads will be adequate for the proposed construction traffic loads. Remedial work should be carried out at local soft spots where it causes noticeable rutting in the road and deterioration of the road surface during construction.

Some short sections of the road were classified as "poor" based on the measured deflections and observed behaviour of the road under the maximum construction traffic load. Remedial work will be carried out in these areas to improve the performance of the road. The remedial work should be carried out in accordance with the AGL method statement dated in Appendix D.

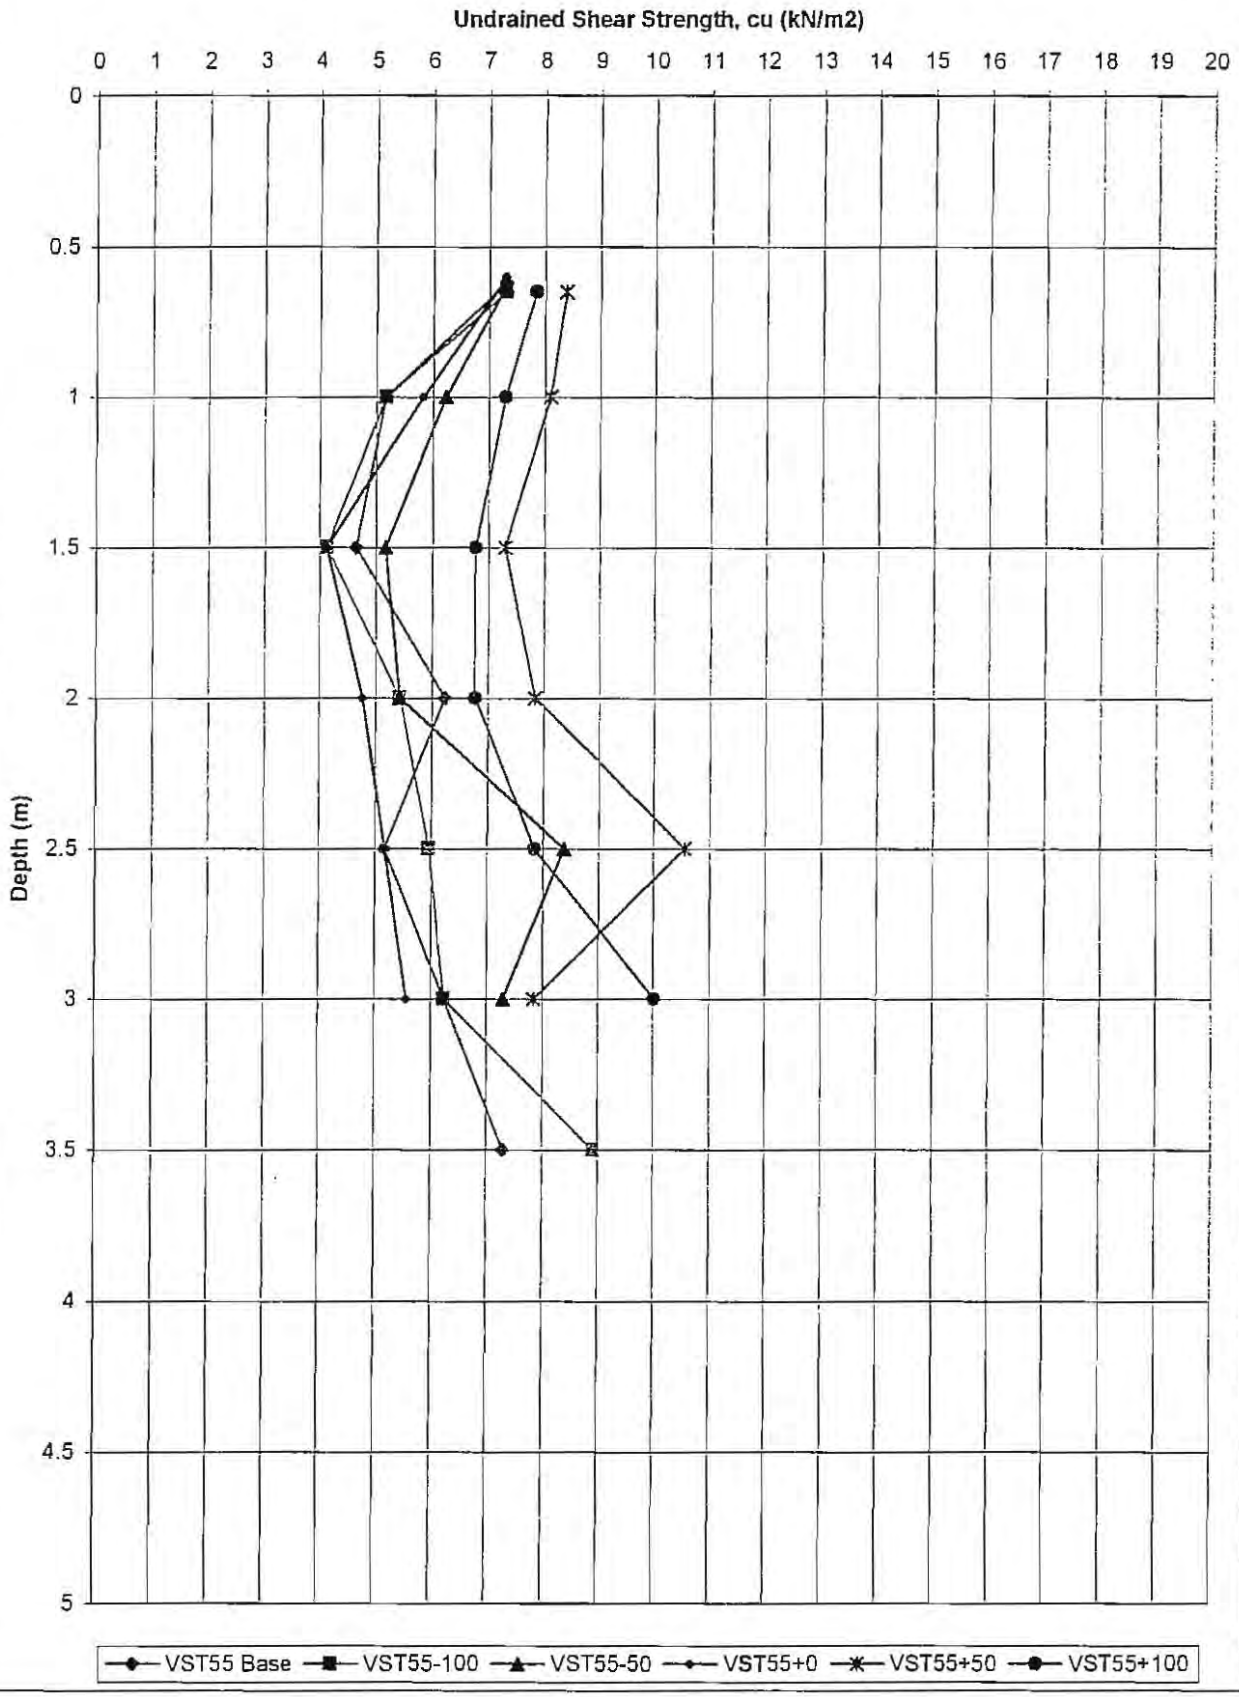
Points to Note: Road has been constructed from +100 meters to 0 meters. From 0 to -100 meters the trees for the floating roads have been put in place but no surface has yet been constructed. The land is sloping from west (higher) to east (lower) i.e from -100 to +100 and to the north.

VST Results along downslope of floating road in Cell T55
