Derrybrien Wind Farm Development Decommissioning Project – Retained Development

GEOTECHNICAL STABILITY REPORT - WIND FARM SITE (PART I)

DERRYBRIEN WIND FARM
GEOTECHNICAL STABILITY REPORT & ASSESSMENT OF STABILITY IMPACTS OF ON-SITE ACTIVITIES

Document No:	**11-147-R04**	**Issue 02 (Rev. 0)**
Made:	Conor O'Donnell / Niamh Farrell	
Checked:	Conor O'Donnell

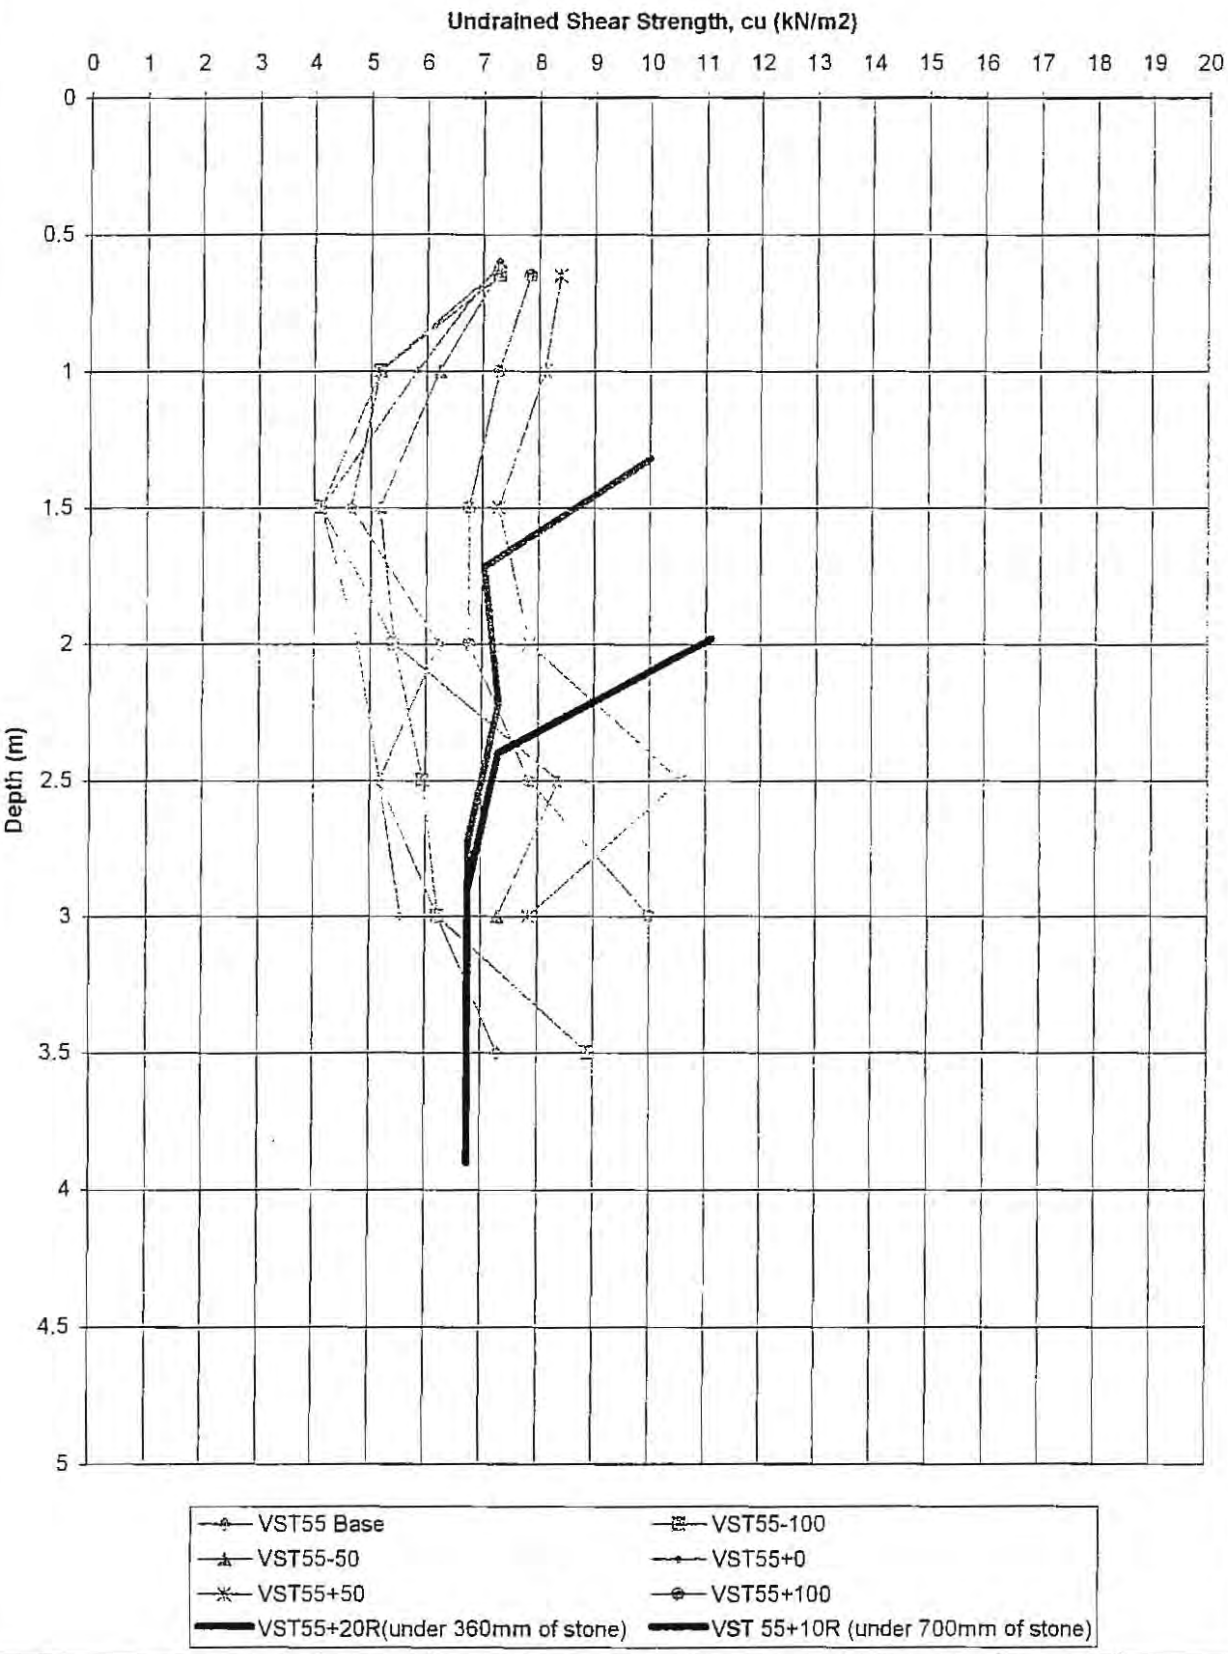
VST Results under floating road in Cell T55 (values along downslope shown in background)

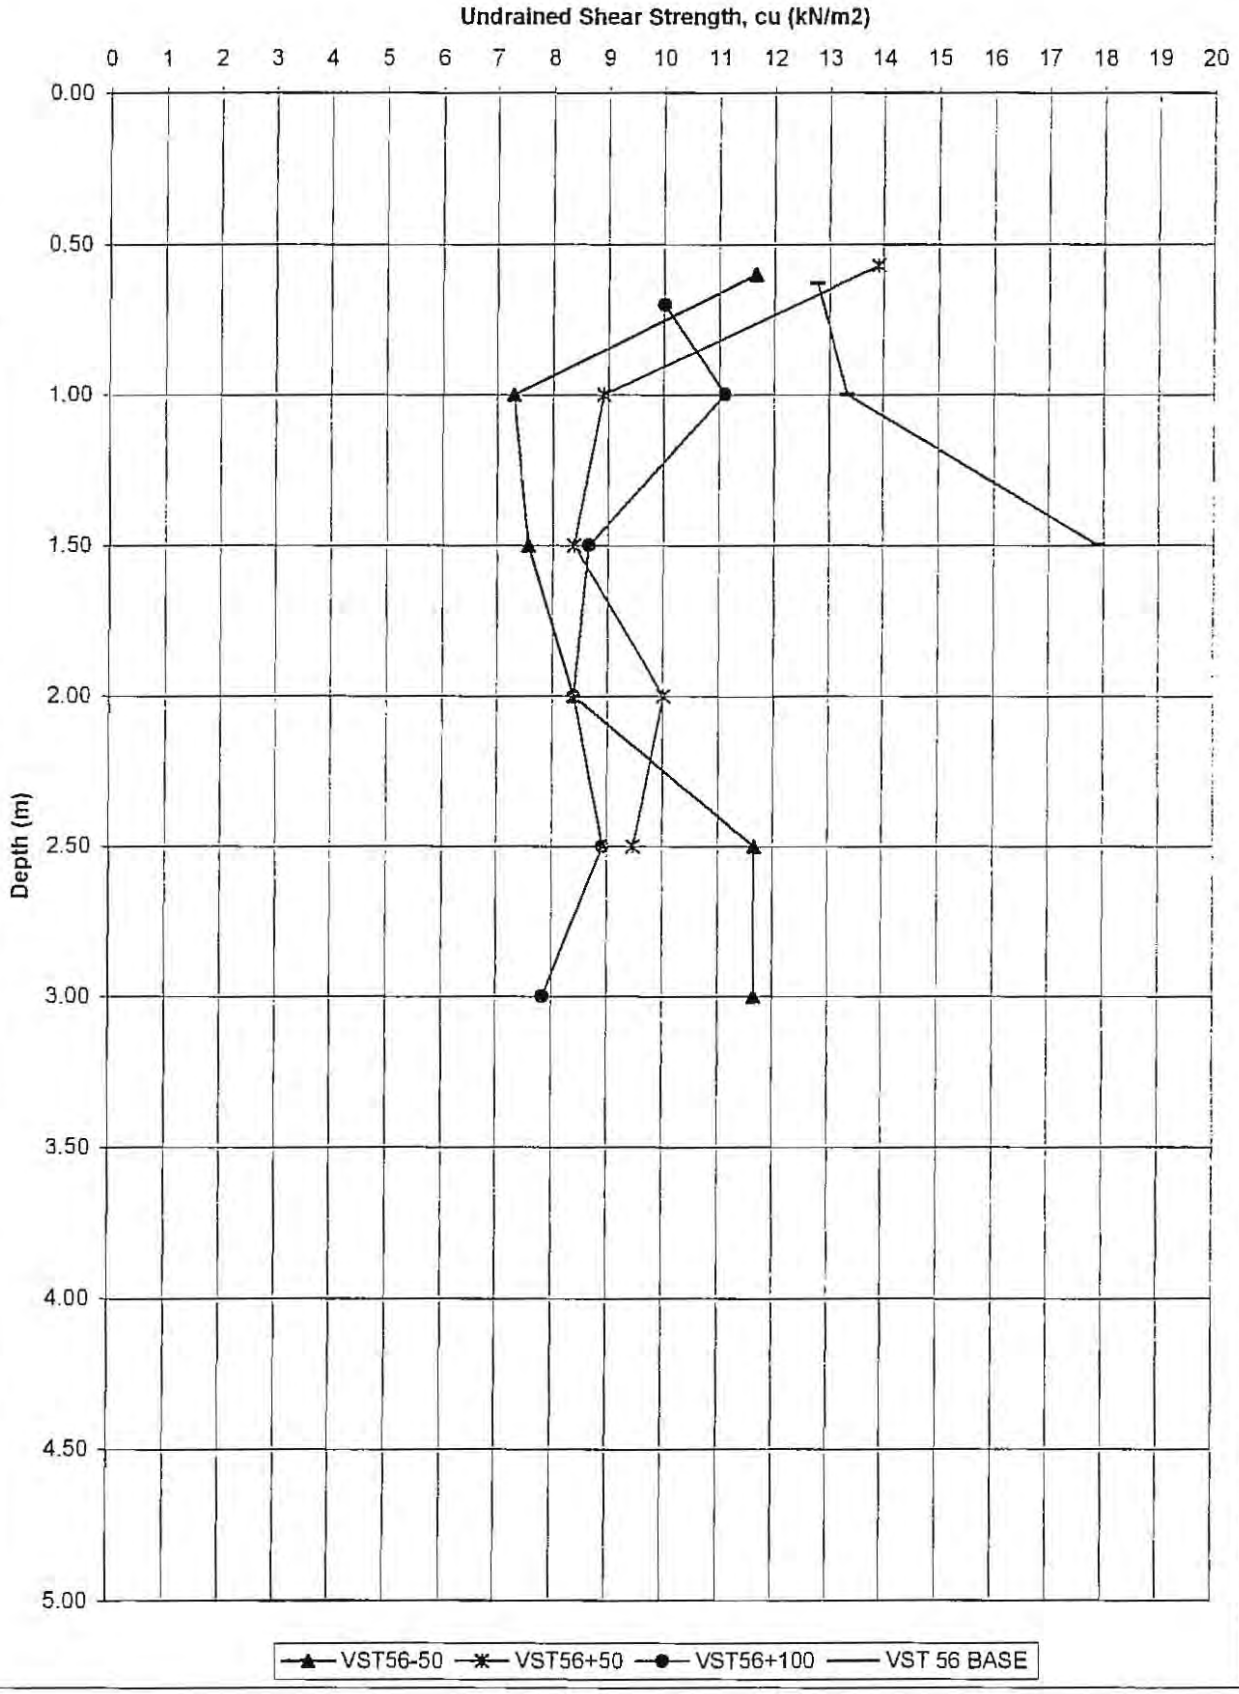
0.63	24	13	12.8				
1	25	6	13.3				
1.5	33	6	17.9				
Points to Note: Valley feature present between 0 and +50 meters.							
Land sloping from both sides of turbine into valley feature and to the north							
. Drains present adjacent to road on downslope side joining northward flowing drain in valley.							
Difficulty encountered at turbine base and +50 in advancing vane into ground and retrieving vane.

VST Resultsalong downslope of floating road in Cell T56

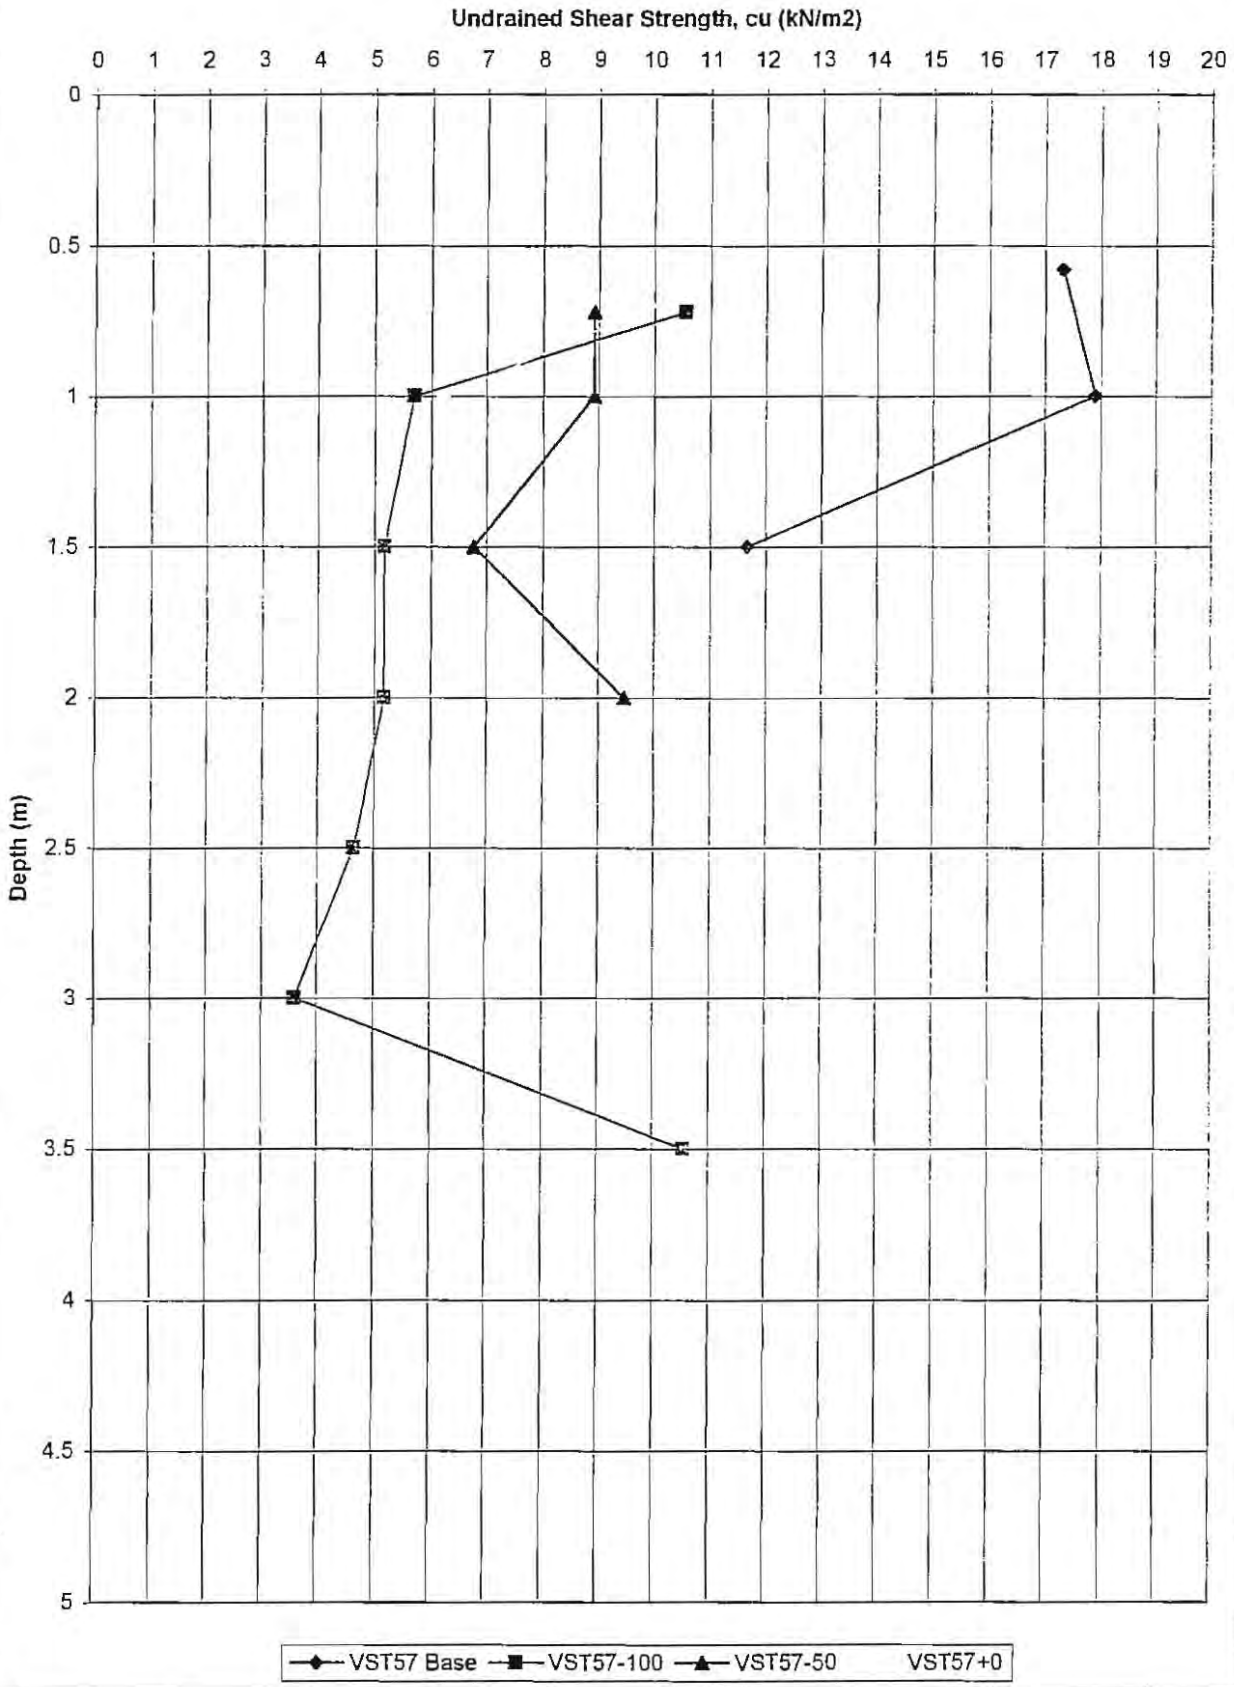
VST Results along downslope of floating road in Cell T57

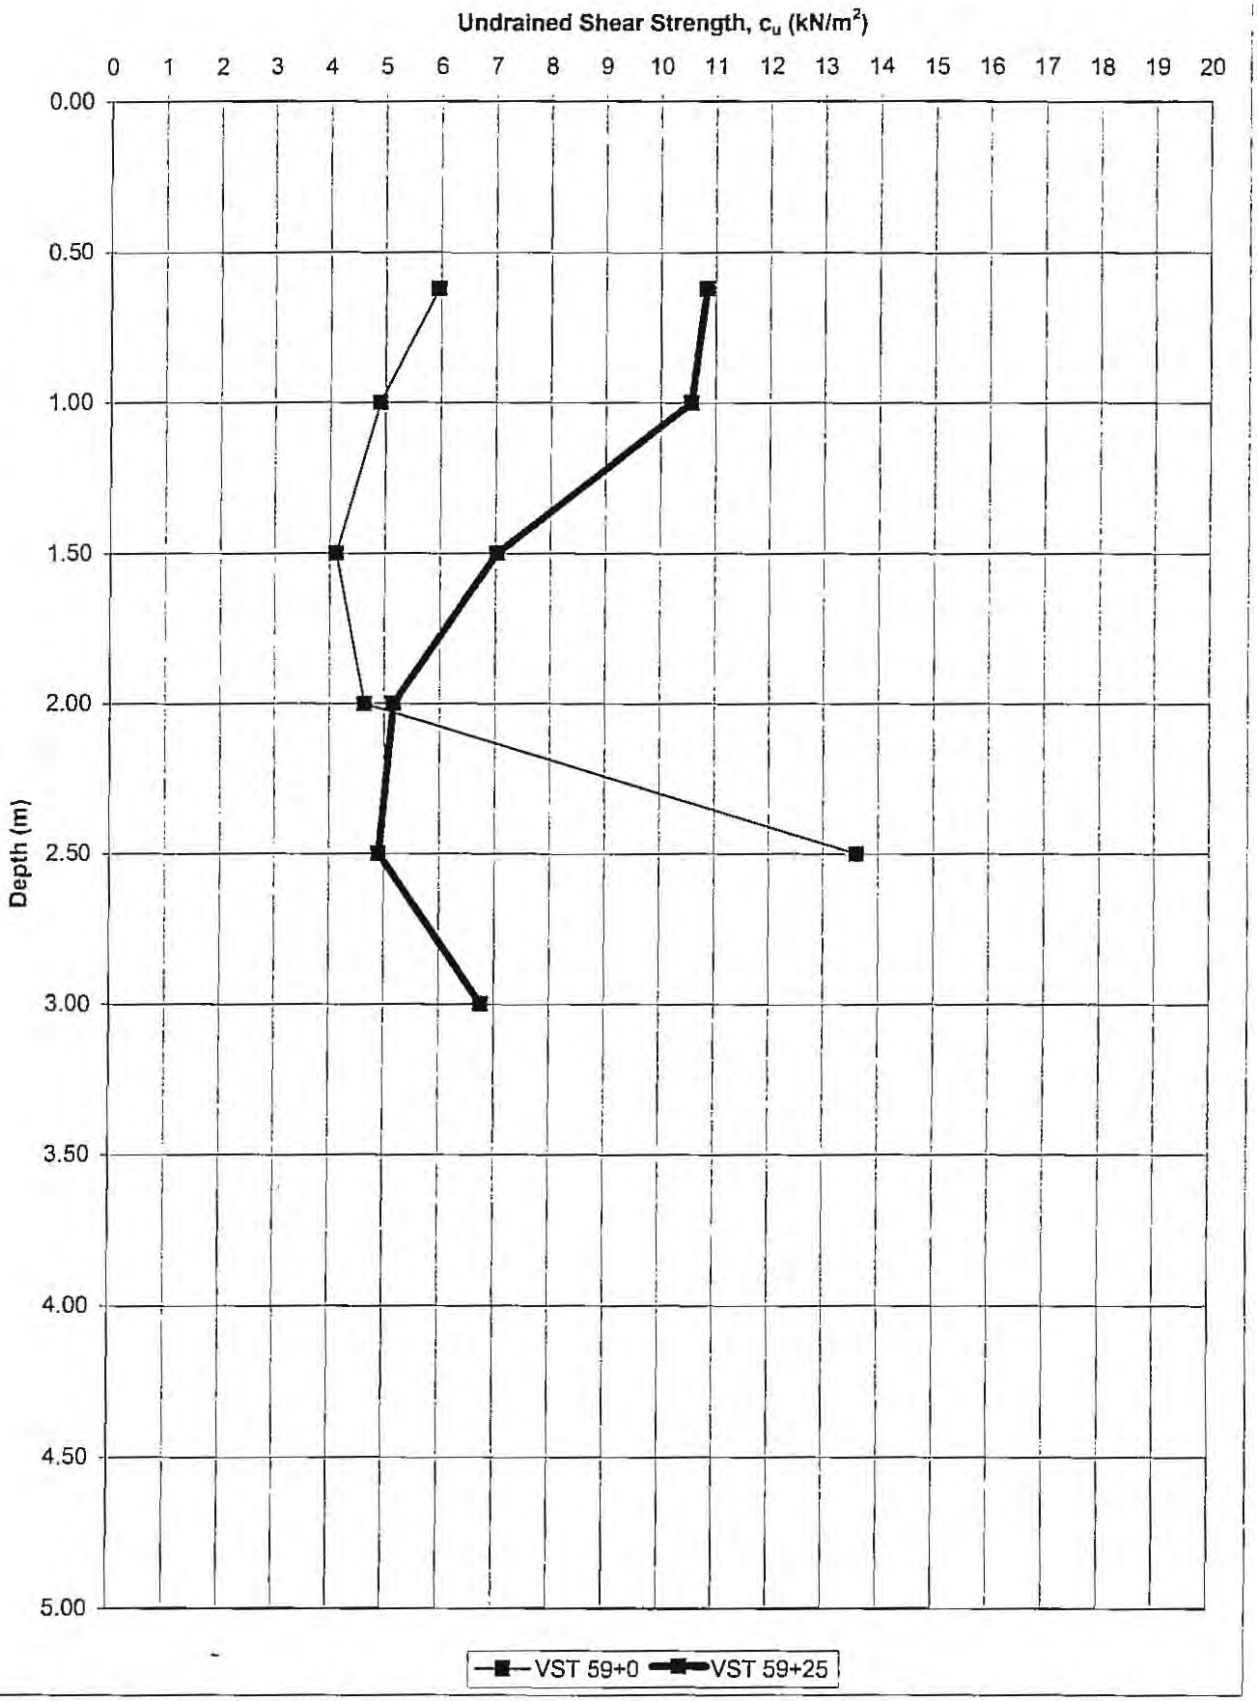
VST Results along downslope of floating road in Cell T59

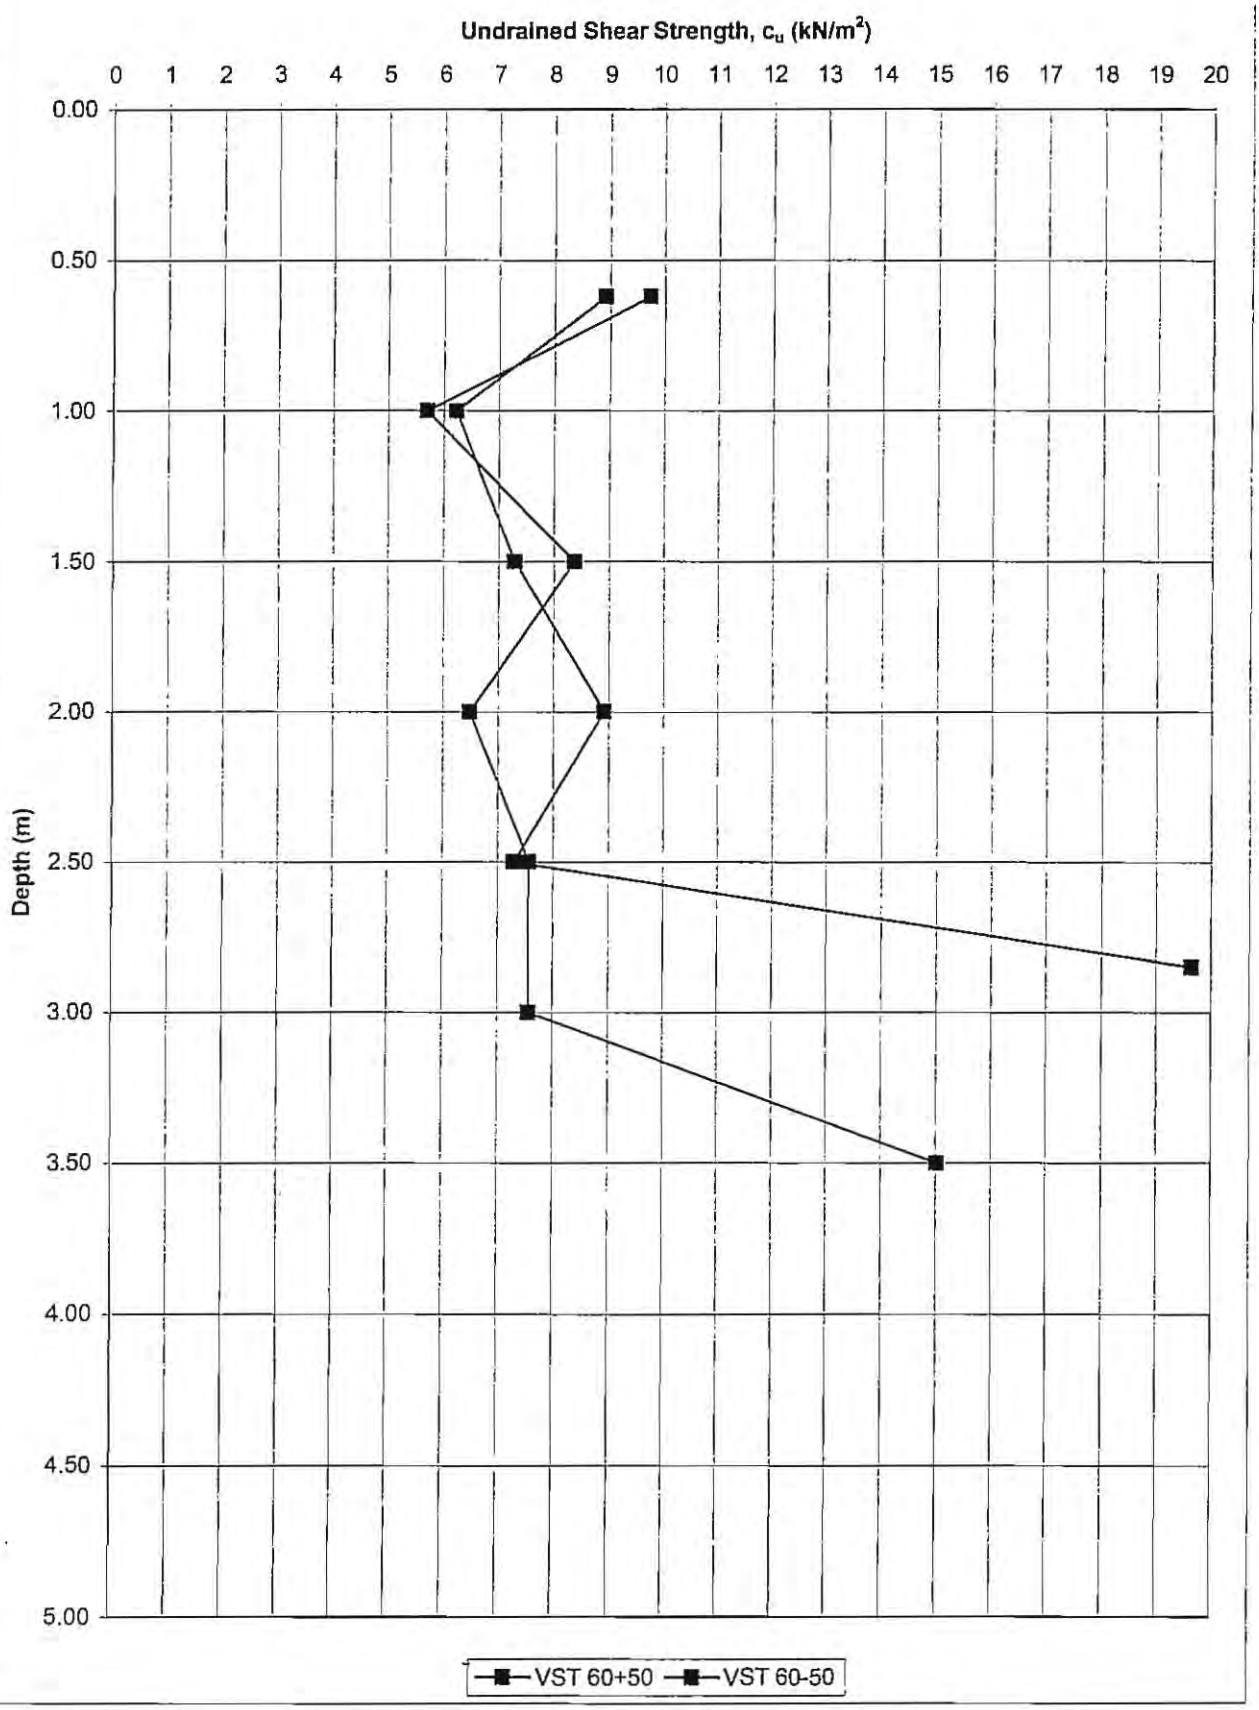
VST Results along downslope of floating road in Cell T60

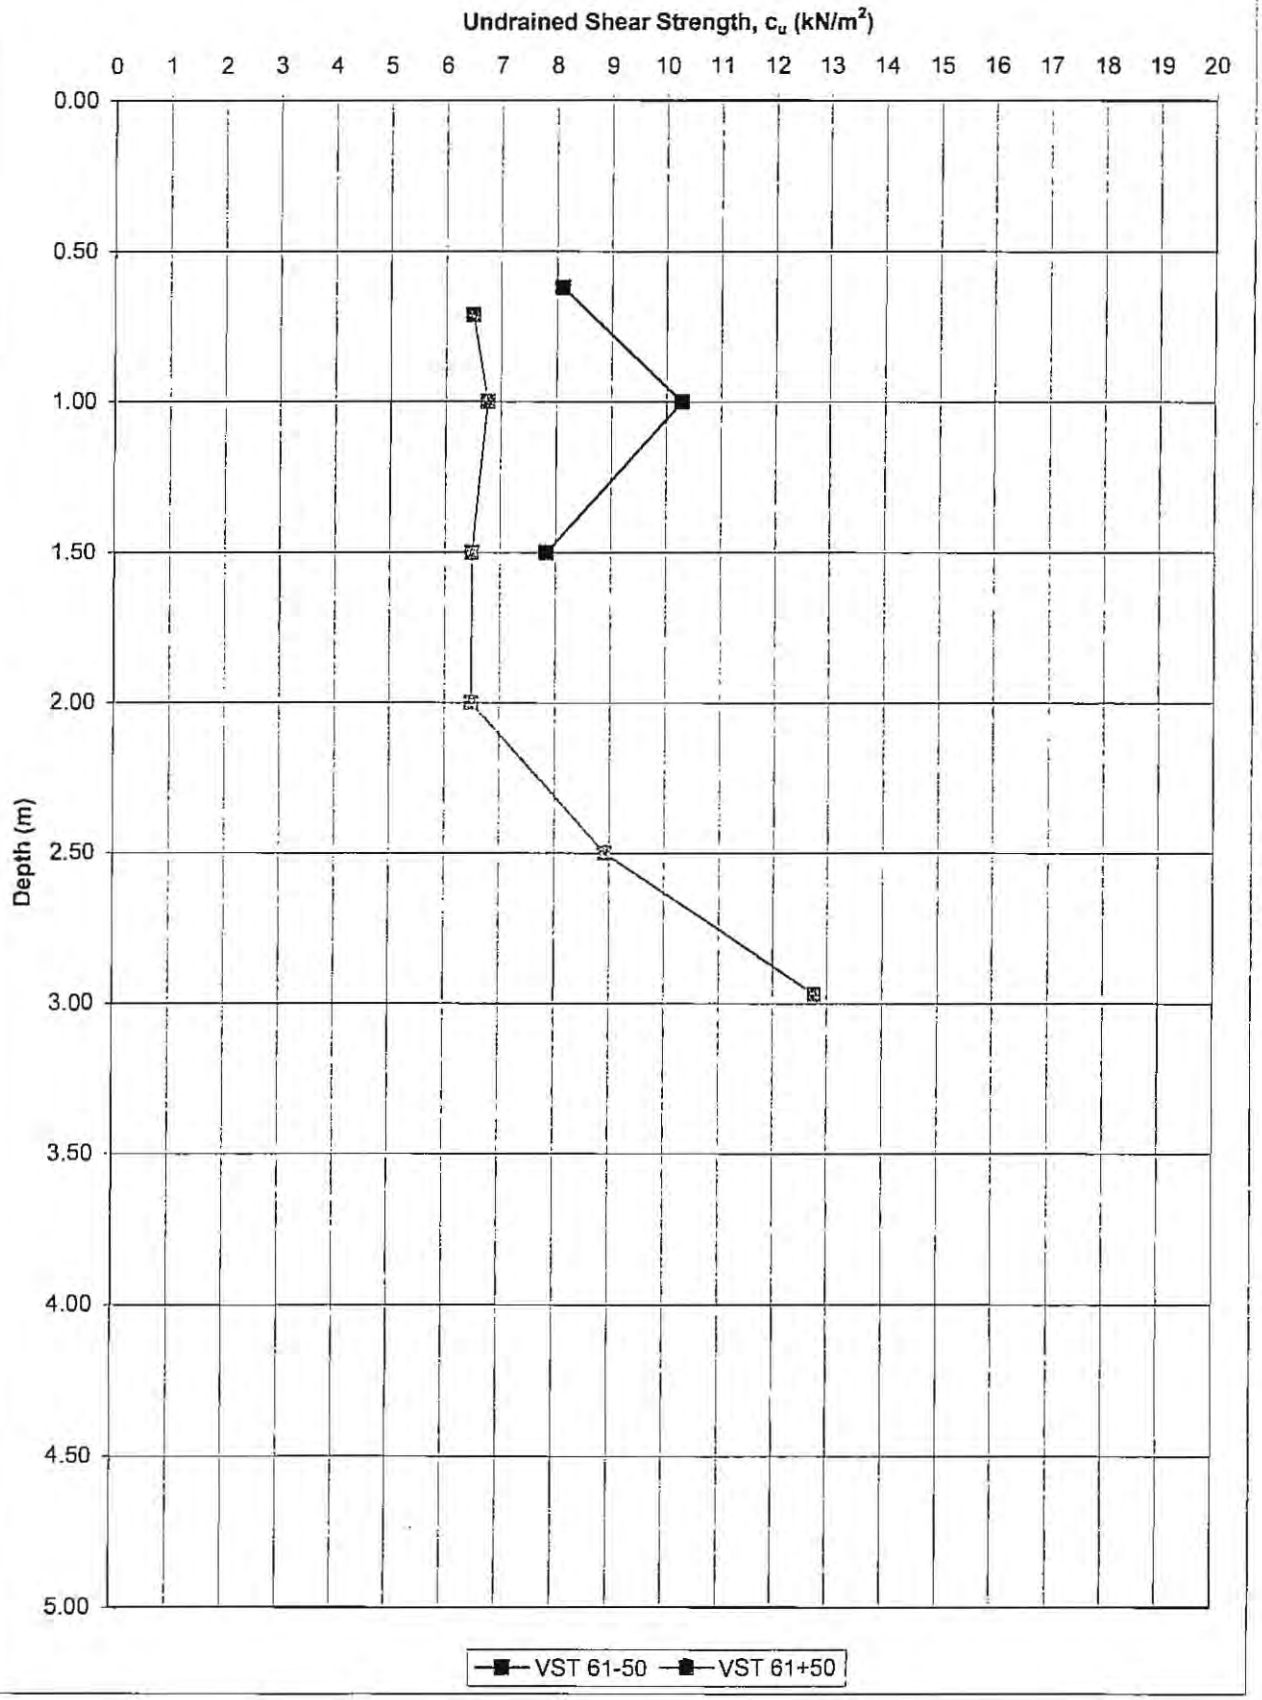
VST Results along downslope of floating road in Cell T61

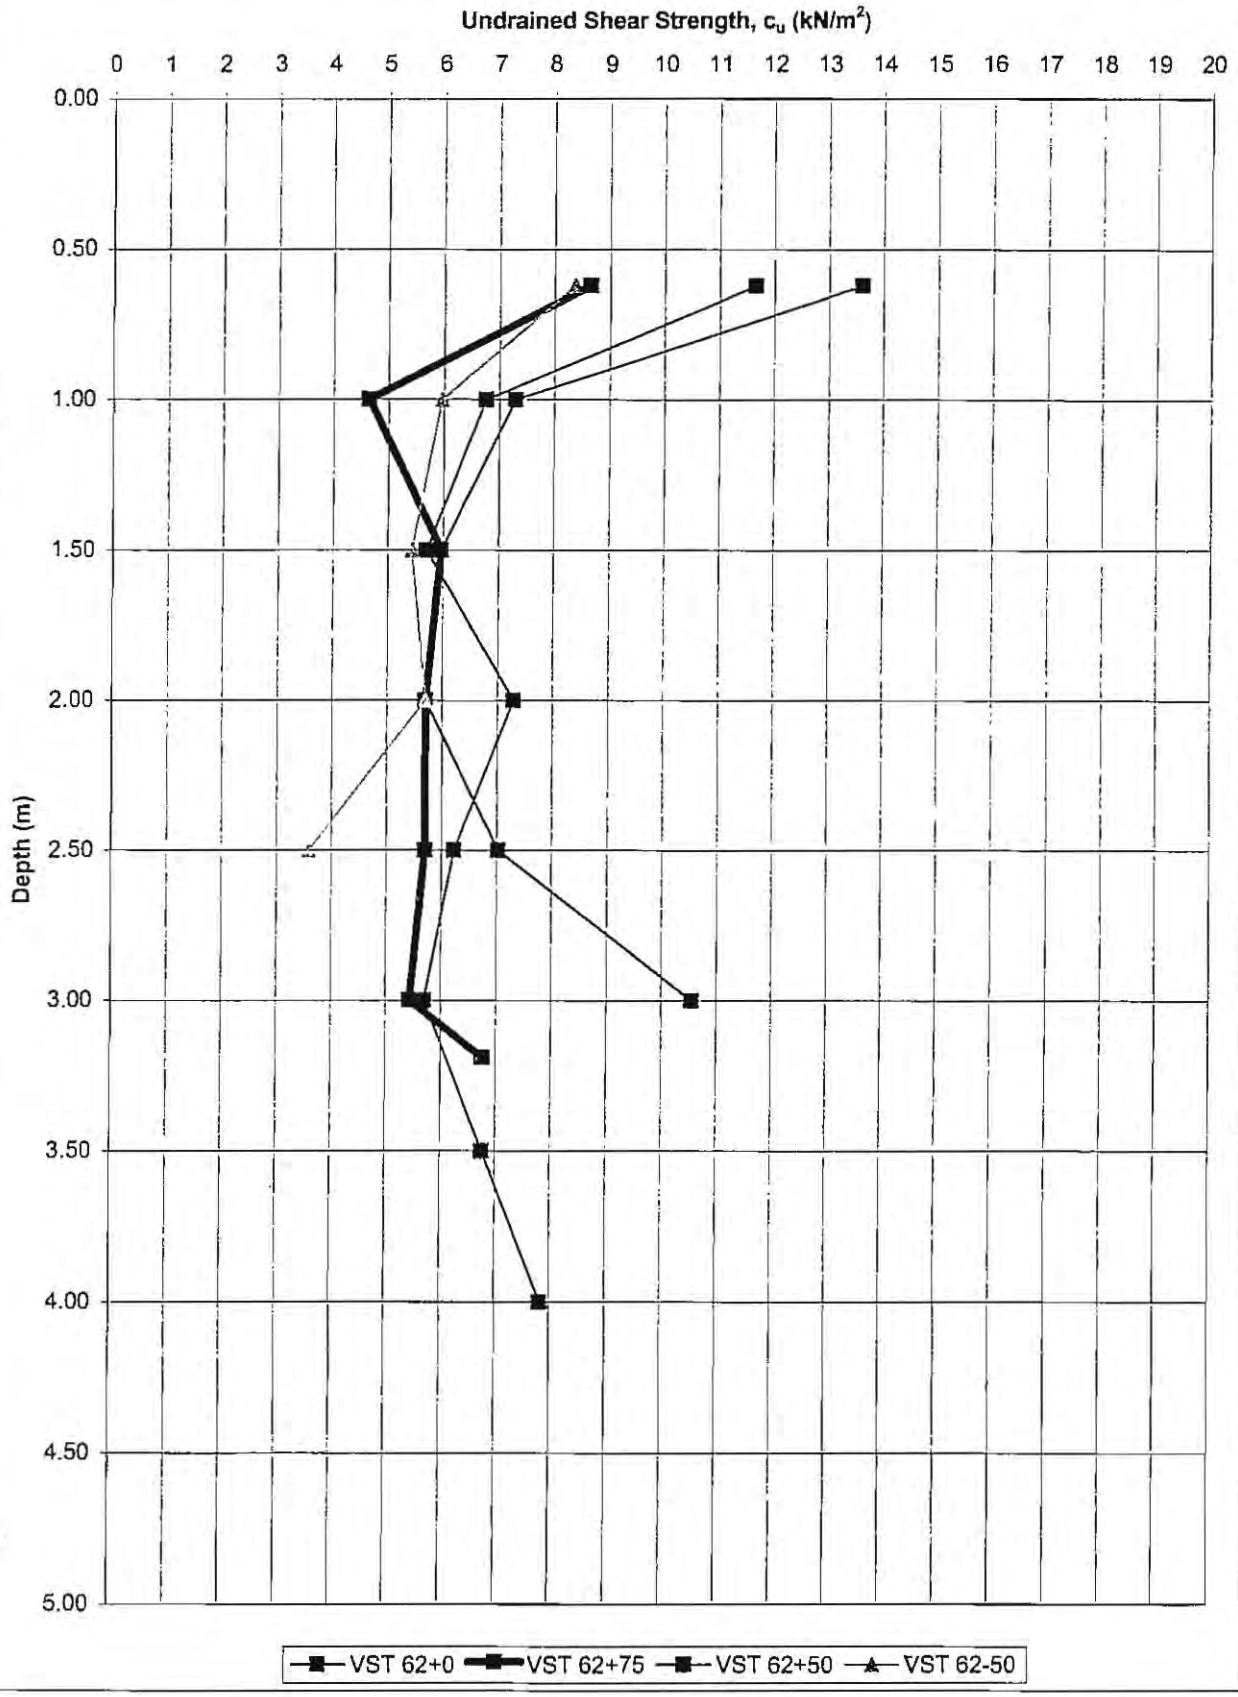
VST Results along downslope of floating road in Cell T62

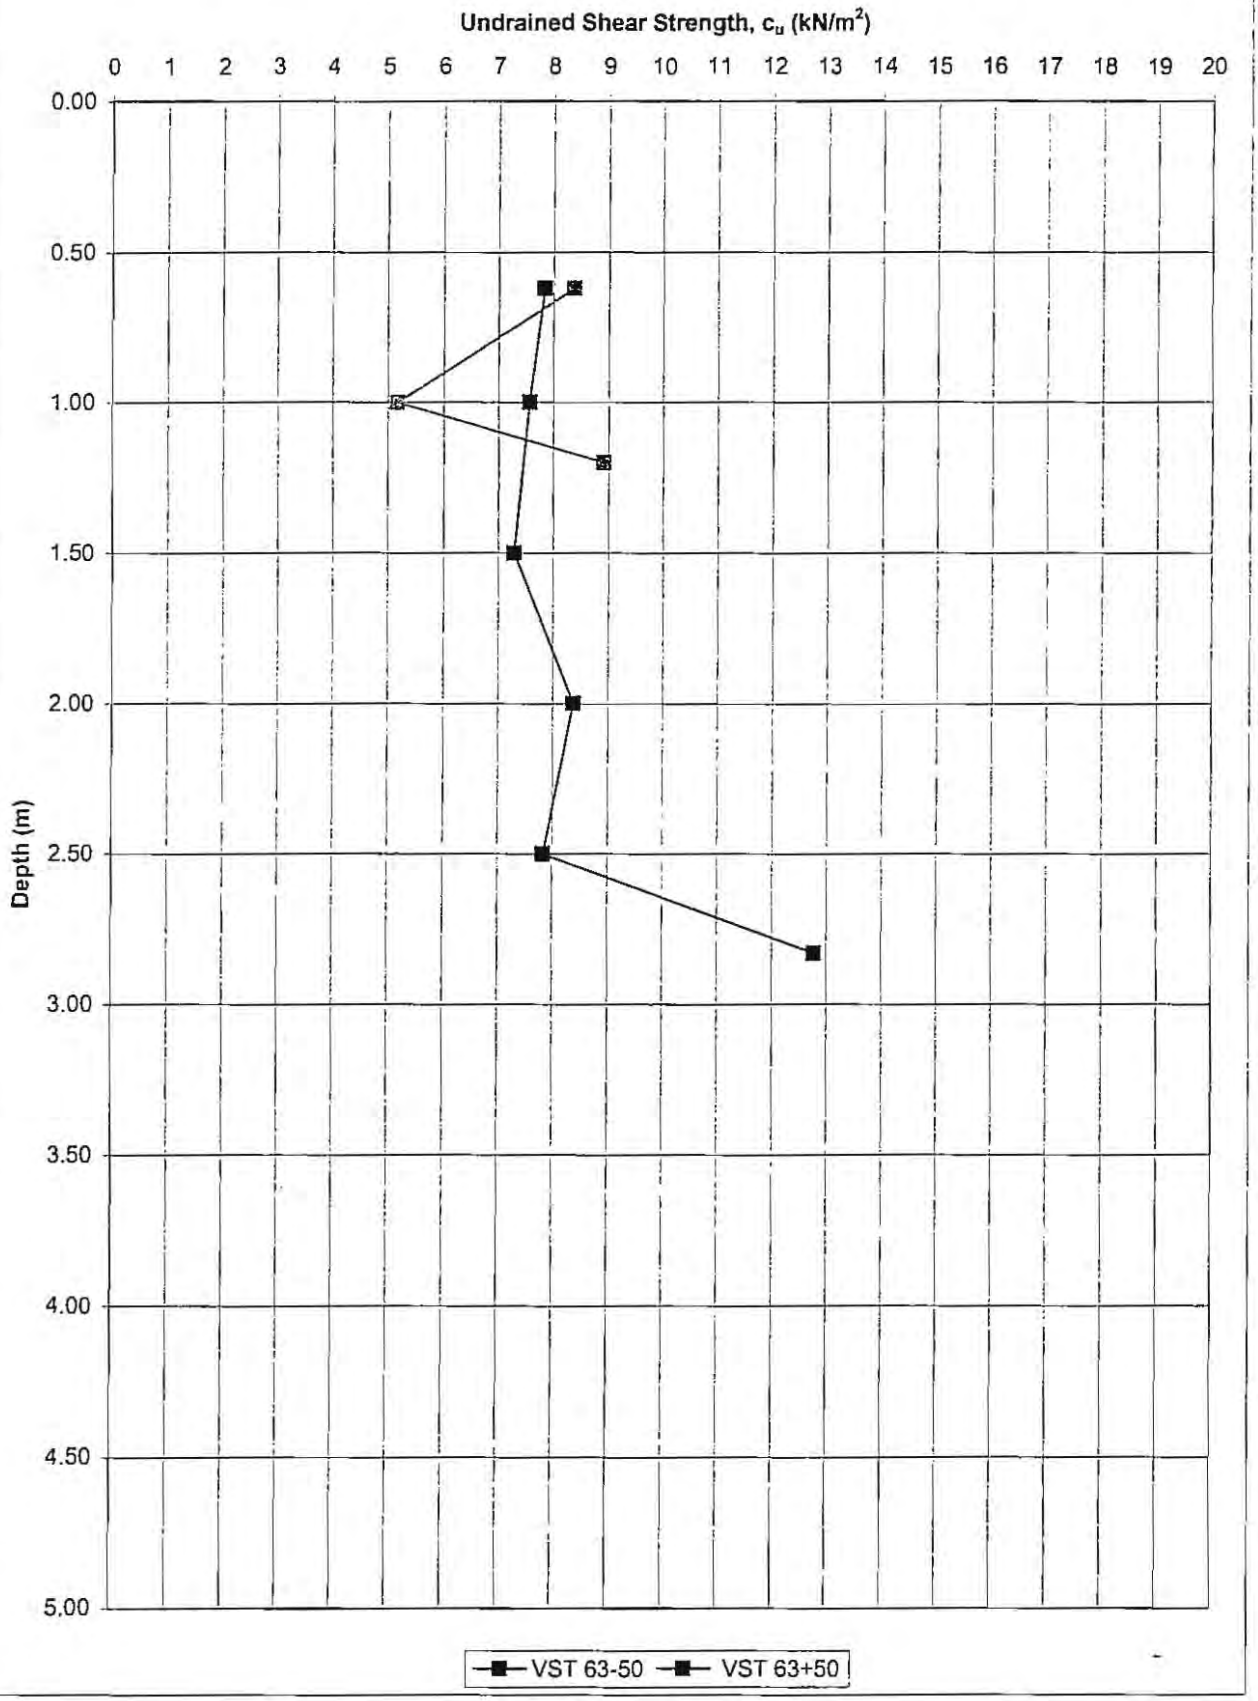
VST Results along downslope of floating road in Cell T63

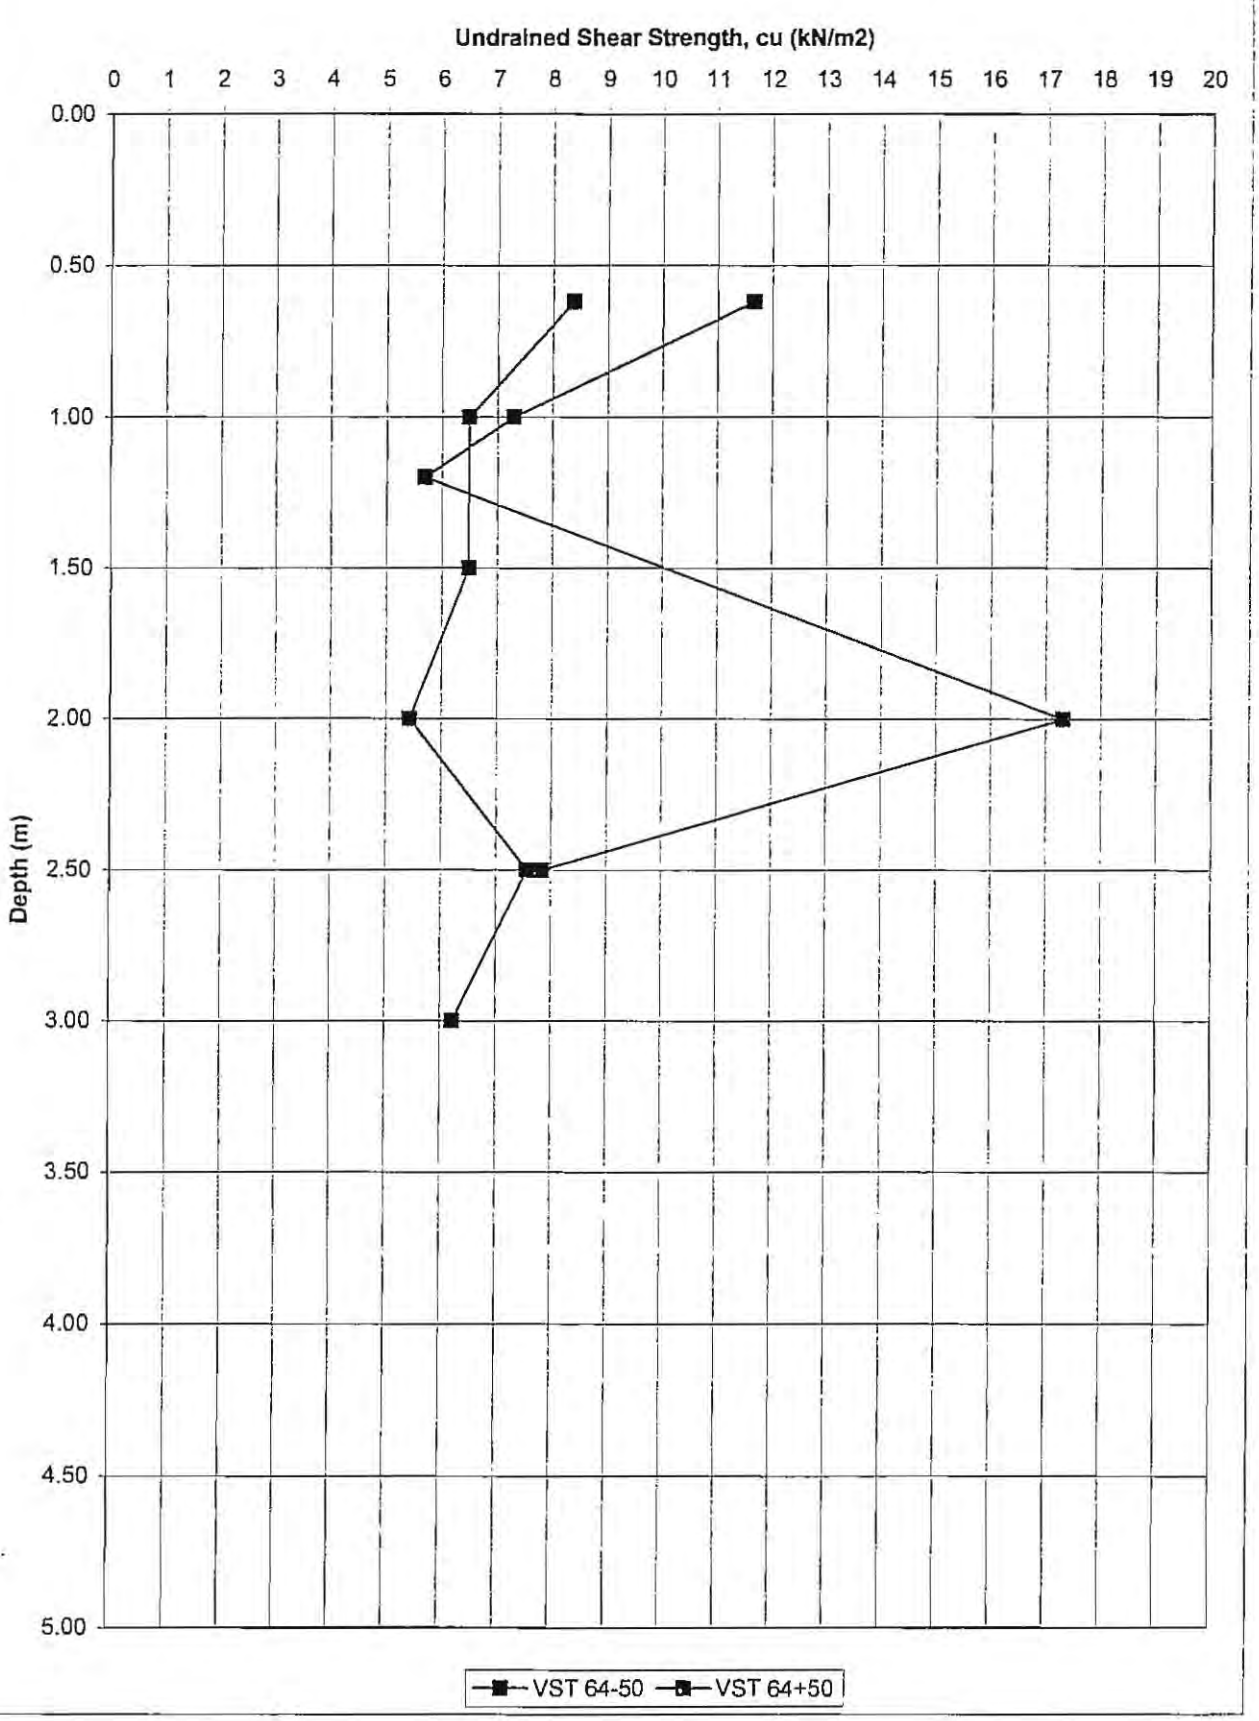
VST Results along downslope of floating road in Cell T64

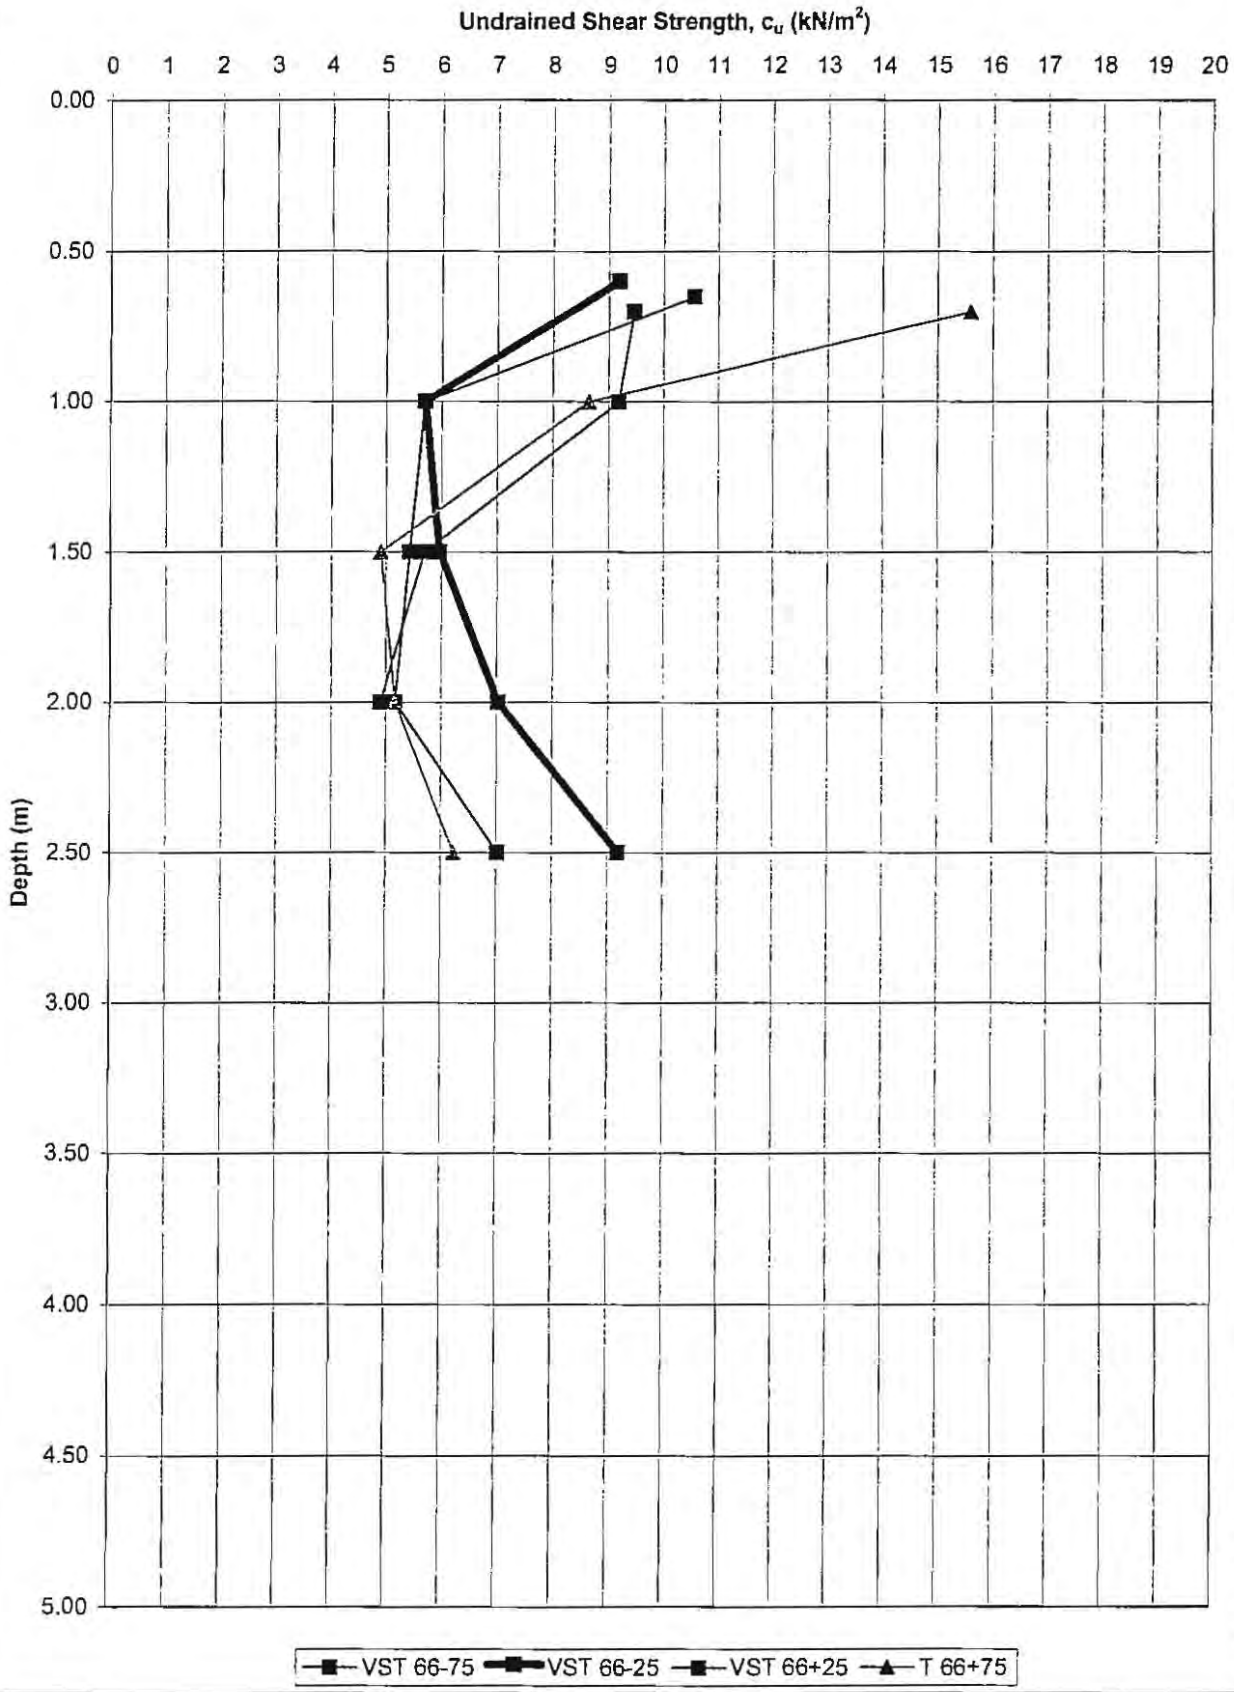
VST Results along downslope of floating road in Cell T66
