Derrybrien Wind Farm Development Decommissioning Project – Retained Development

GEOTECHNICAL STABILITY REPORT - WIND FARM SITE (PART I)

DERRYBRIEN WIND FARM
GEOTECHNICAL STABILITY REPORT & ASSESSMENT OF STABILITY IMPACTS OF ON-SITE ACTIVITIES

Document No:	**11-147-R04**	**Issue 02 (Rev. 0)**
Made:	Conor O'Donnell / Niamh Farrell	
Checked:	Conor O'Donnell

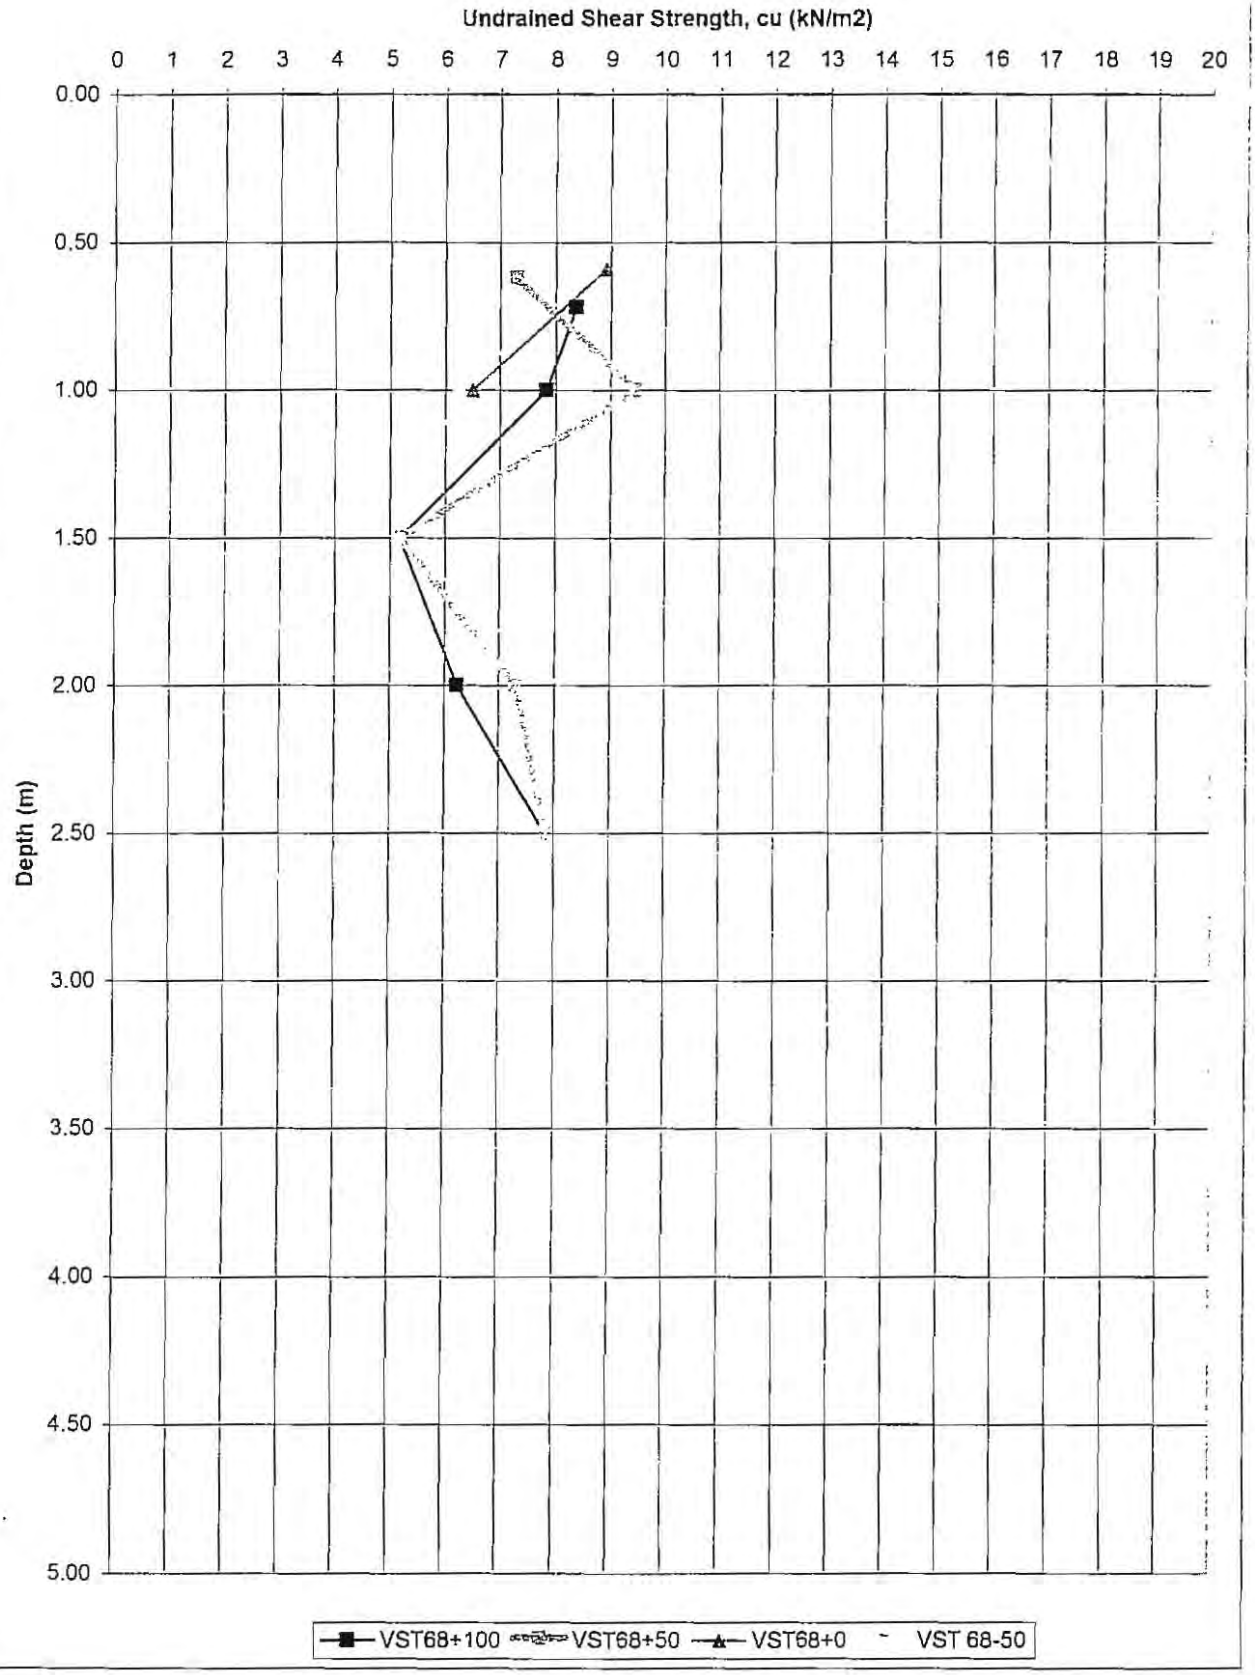
VST Results along downslope of floating road in Cell T68

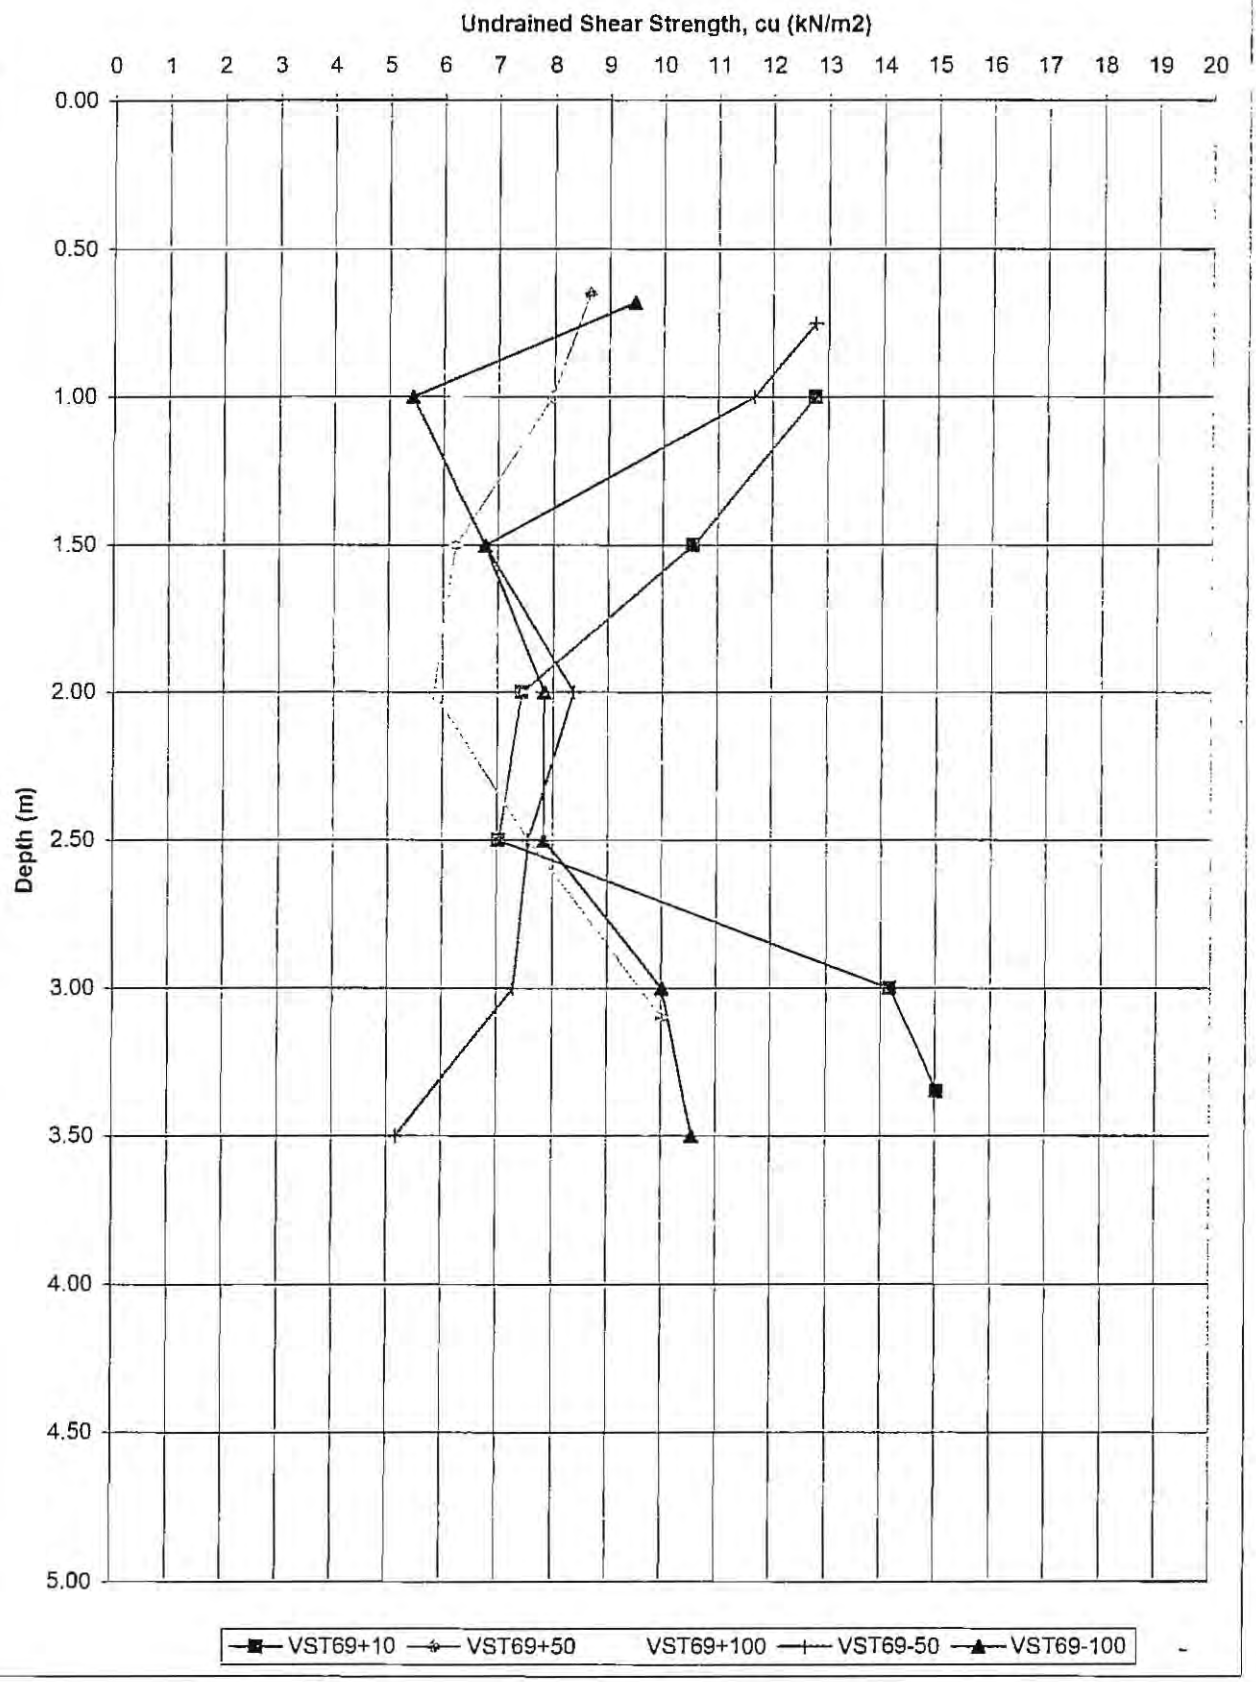
VST Results along downslope of floating road in Cell T69

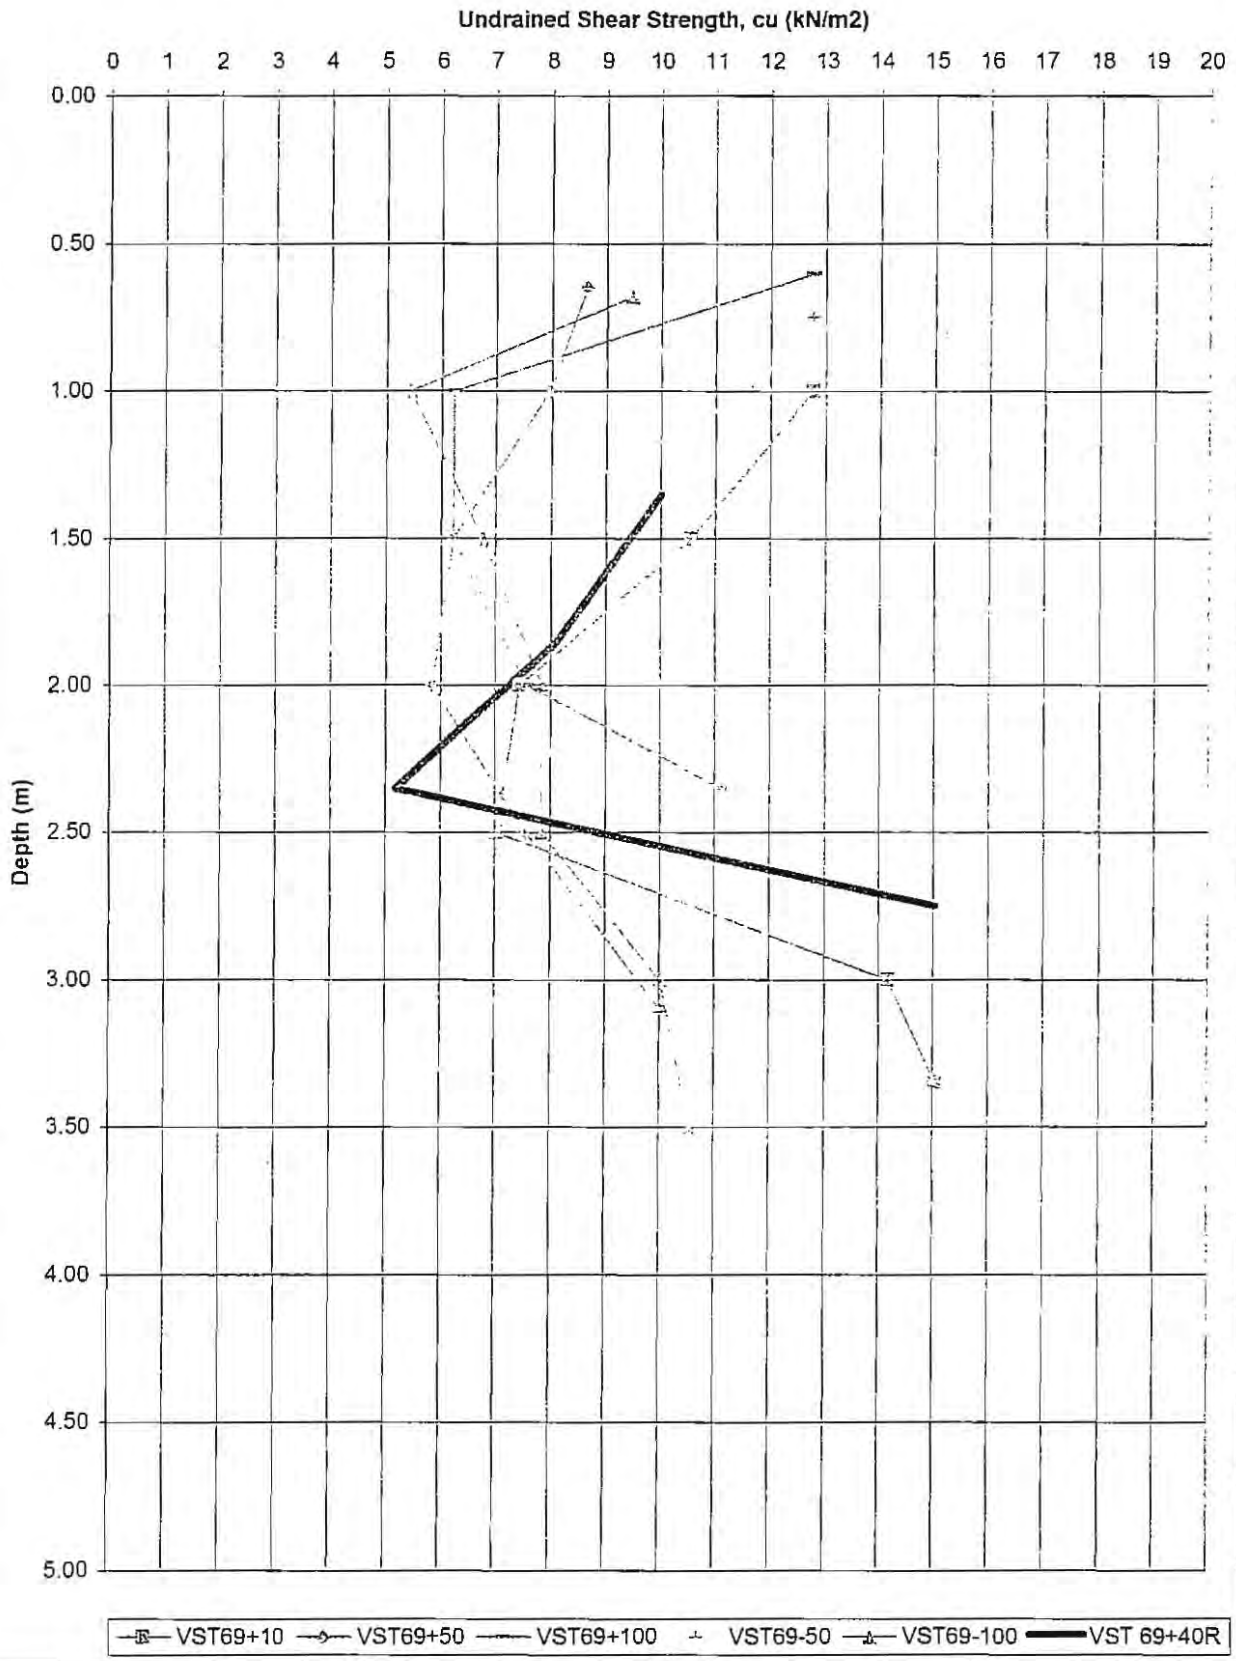
VST Results under floating road in Cell T69 (results along downslope side shown in background)

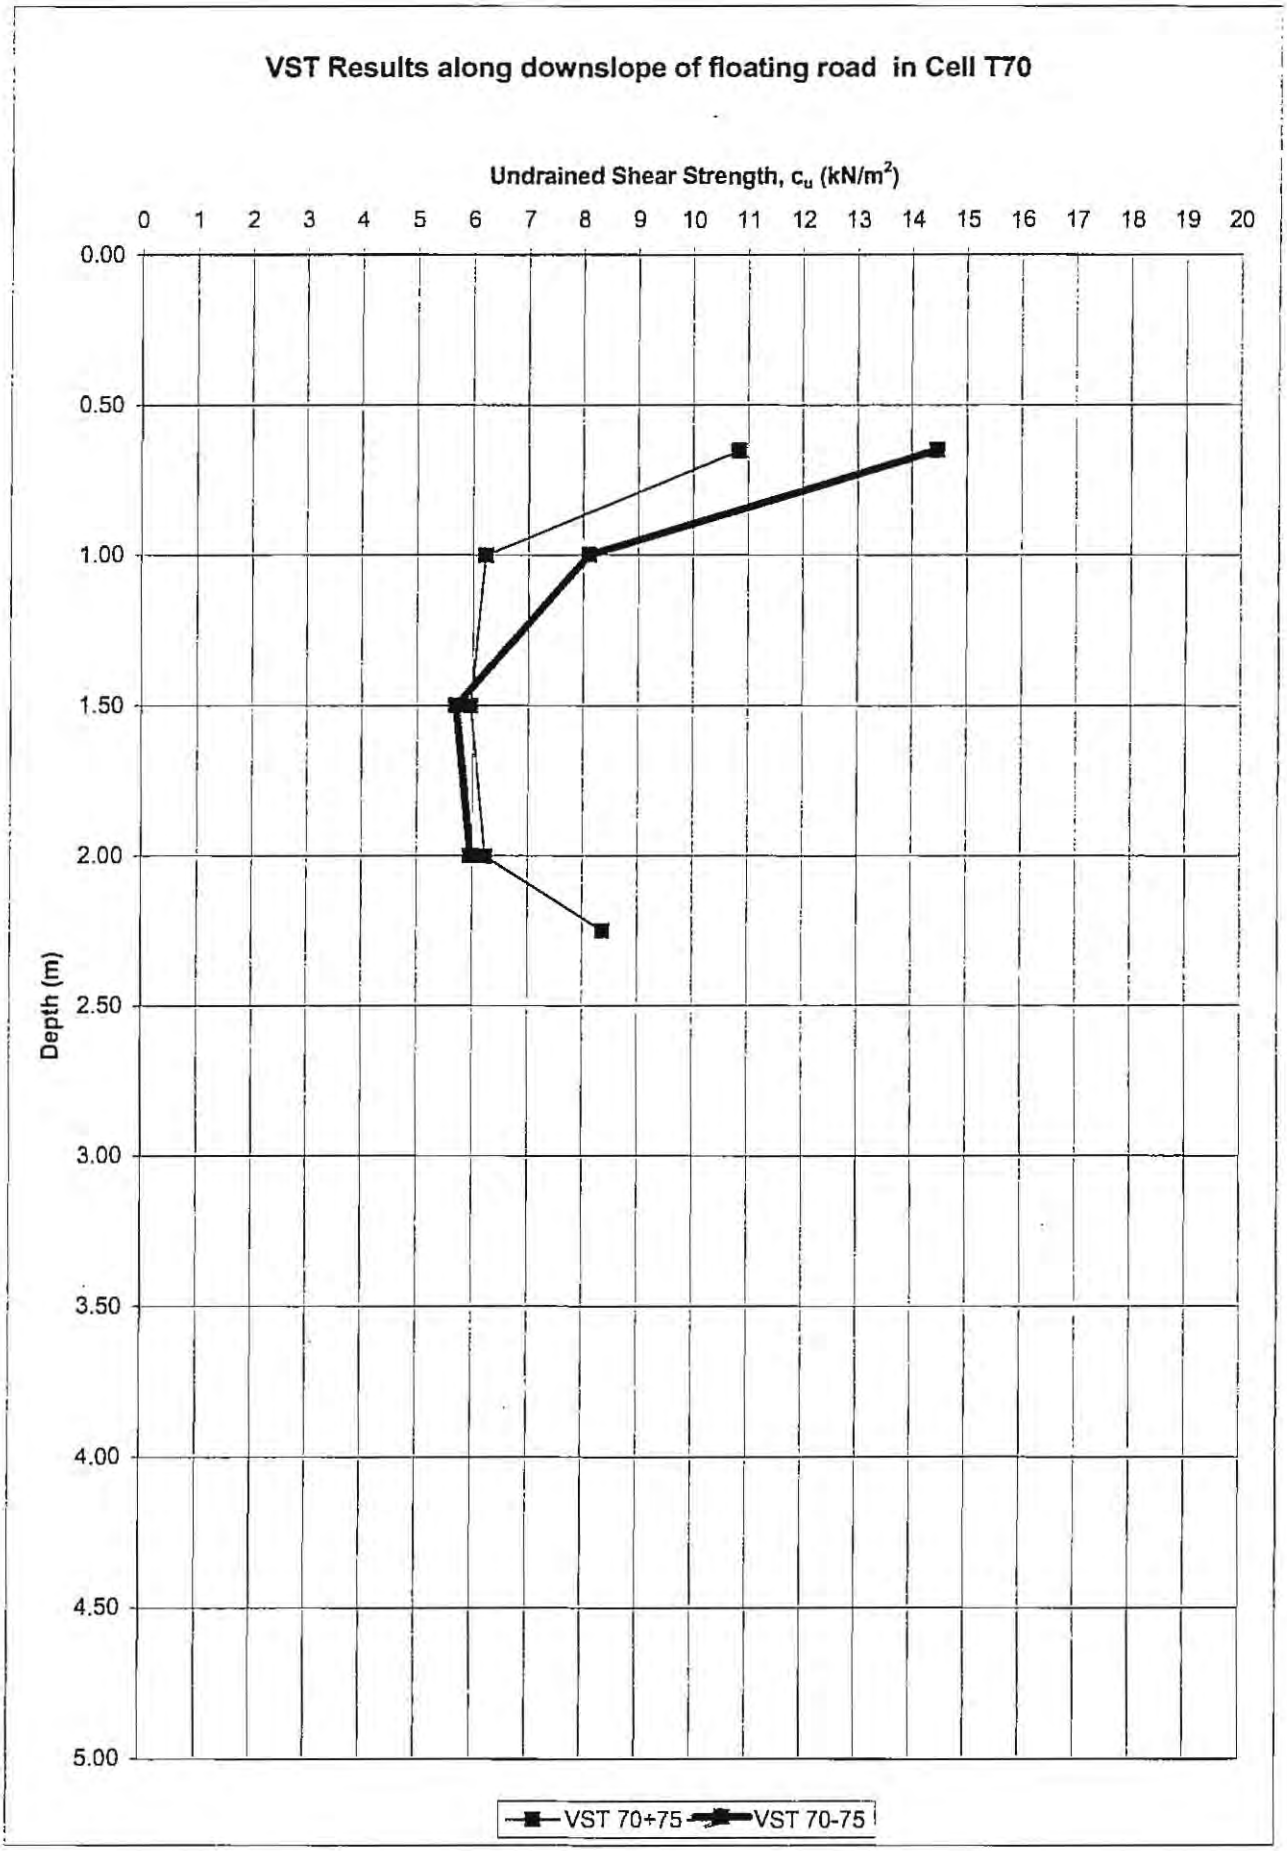
VST Results along downslope of floating road in Cell T70
Undrained Shear Strength, c_u (kN/m^2)
0 1 2 3 4 5 6 7 8 9 10 11 12 13 14 15 16 17 18 19 20
0.00 0.50 1.00 1.50 2.00 2.50 3.00 3.50 4.00 4.50 5.00
Depth (m)
VST 70+75
VST 70-75

Cell T70 (T70+75)					
Design Depth of Peat = 2.62 m (Actual range: 0.4 m - 2.6 m)					
Slope Angle = 3.3° on the ground surface and 2.7° at the base of peat.					
Road Thickness = 1.0 m stone (assumed)					
Undrained Shear Strength Profile from Geonor H-10 Vane					
Side of Road			Under Road		
Depth (m)	c_{uk} (kN/m^2)	c_{ud} (kN/m^2)	Depth (m)	c_{uk} (kN/m^2)	c_{ud} (kN/m^2)
0.0 - 1.0	8.5	6.1	1.0 - 1.6	8.5	6.1
1.0 - 2.0	6.0	4.3	1.6 - 2.3	6.0	4.3
2.0 - 2.6	7.2	5.1	2.3 - 2.6	7.2	5.1

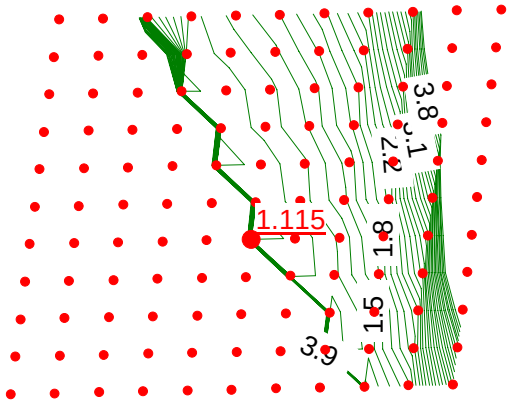
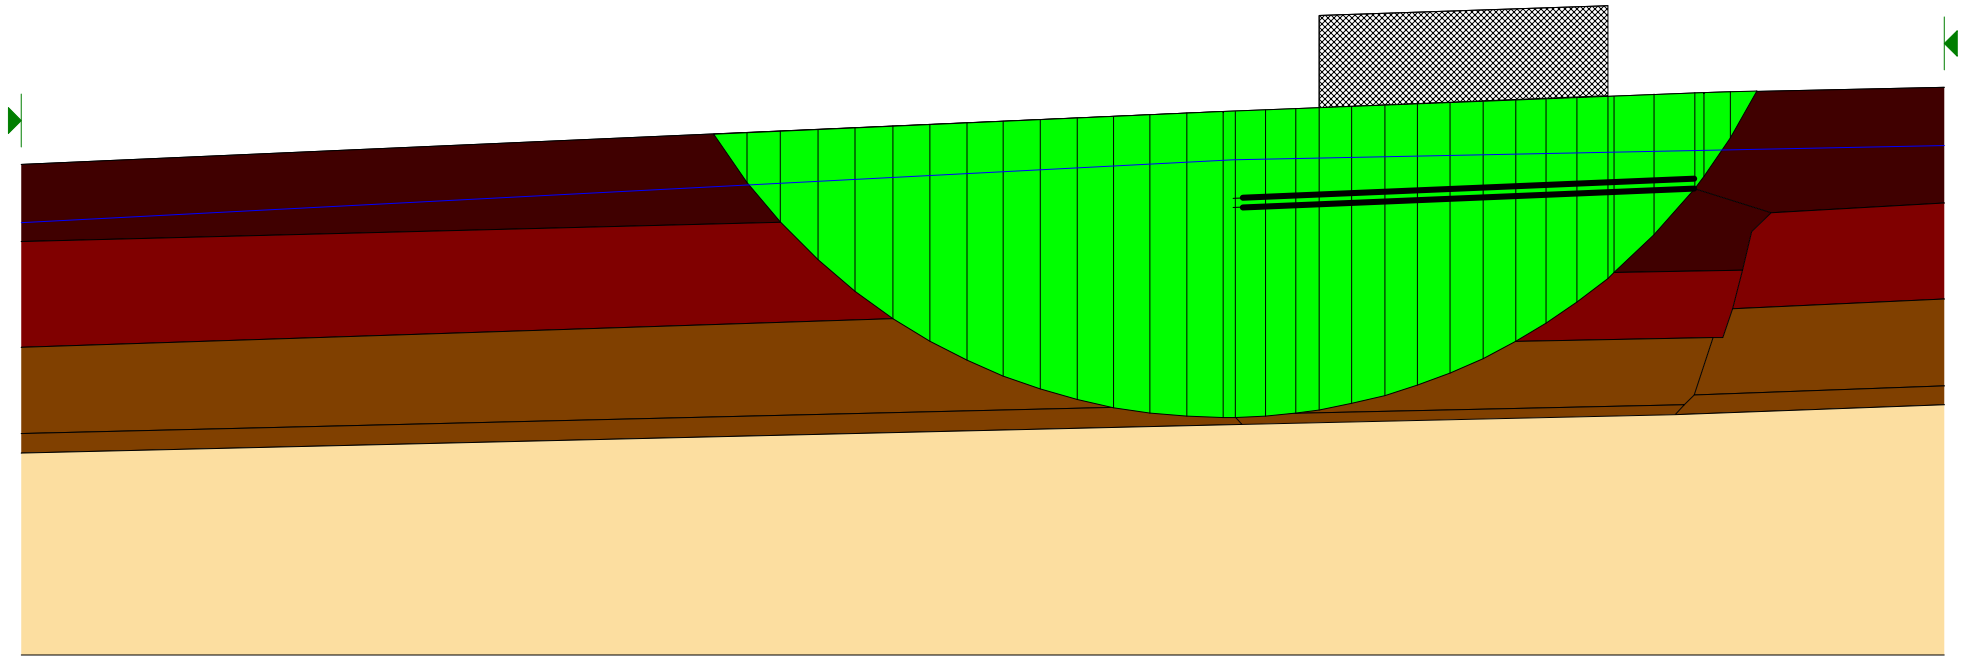
T2-100

5.0 m wide road - 1.0 m thick
Basal reinforcement with trees and 1 layer of Tensar SS30 Geogrid

Depth of peat = 3.3 m on downslope side of road
Slope angle = 2.3 Deg at surface, 1.3 Deg at base of peat

Partial factor of 1.3 applied to live load (17.1 kPa)
Calculated margin of safety >1.0 => OK

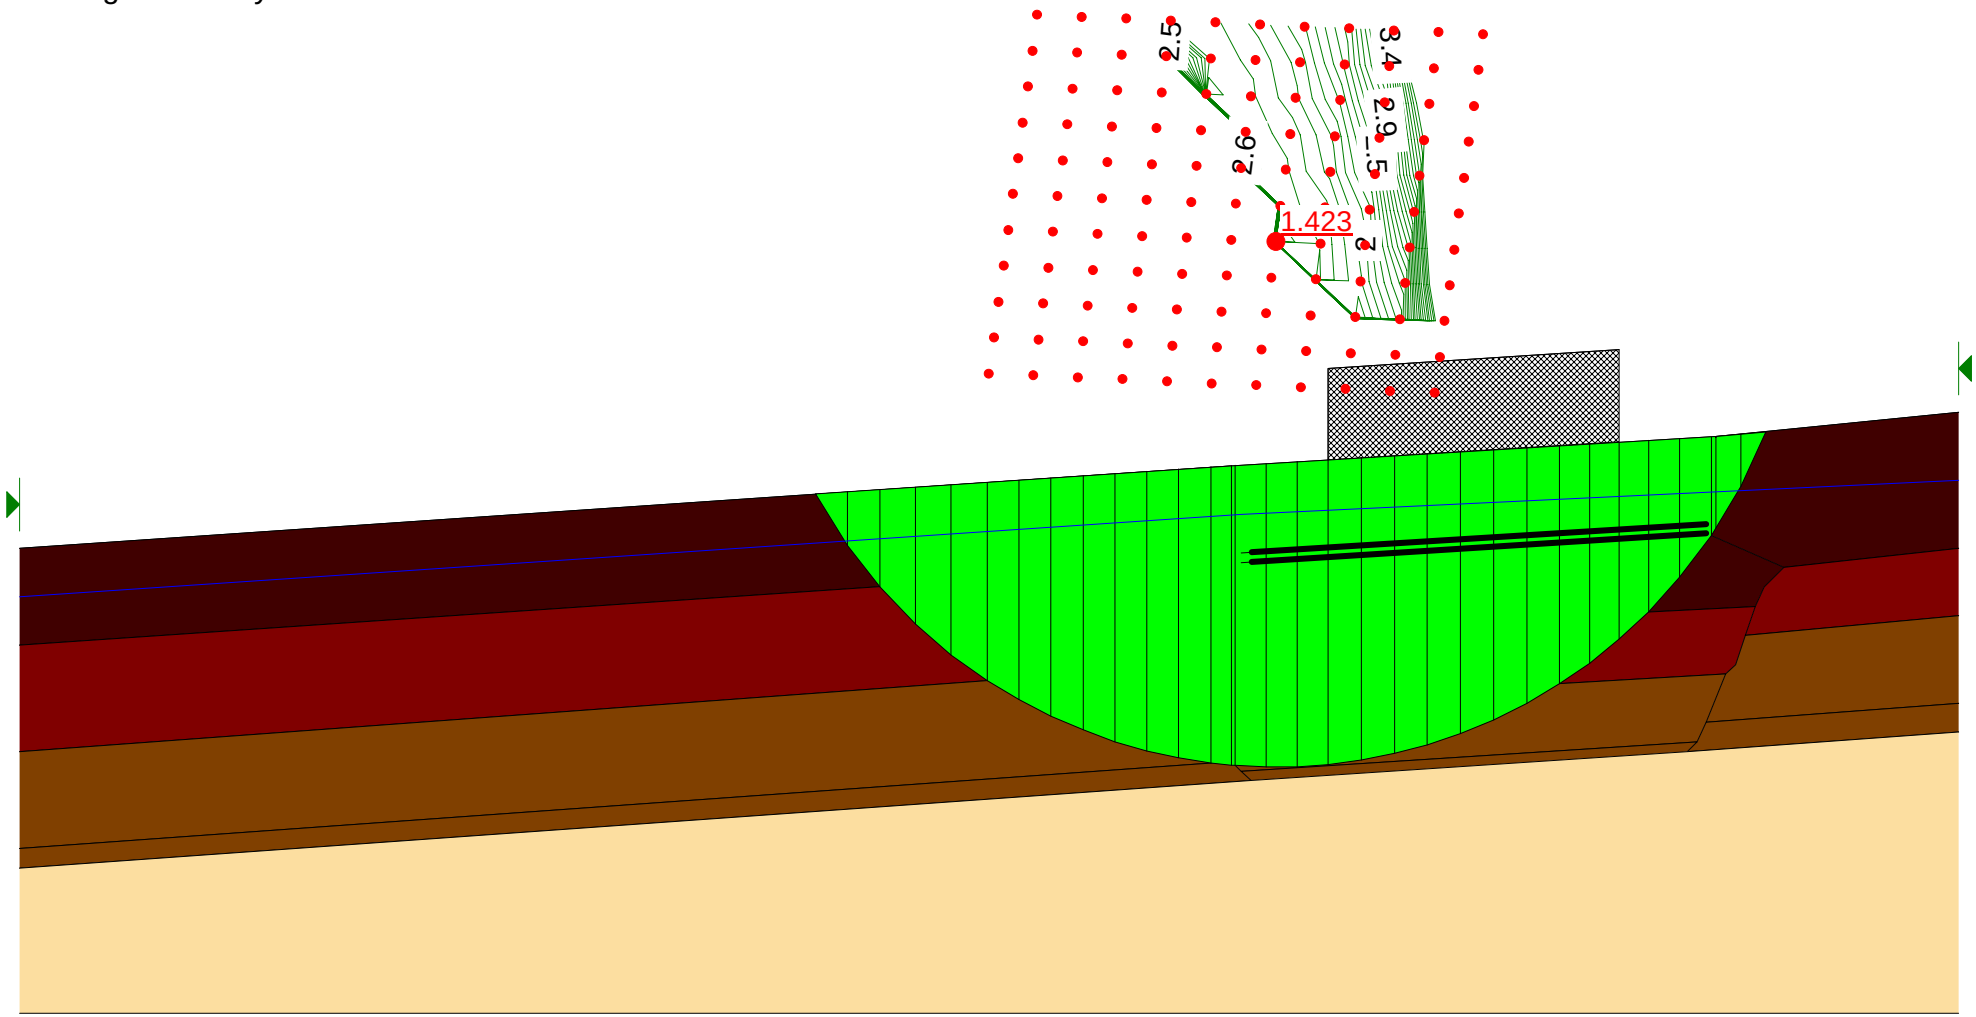
T5

5.0 m wide road - 1.0 m thick
Basal reinforcement with trees and 1 layer of Tensar SS30 Geogrid

Partial factor of 1.3 applied to live load (17.1 kPa)
Calculated margin of safety >1.0 => OK

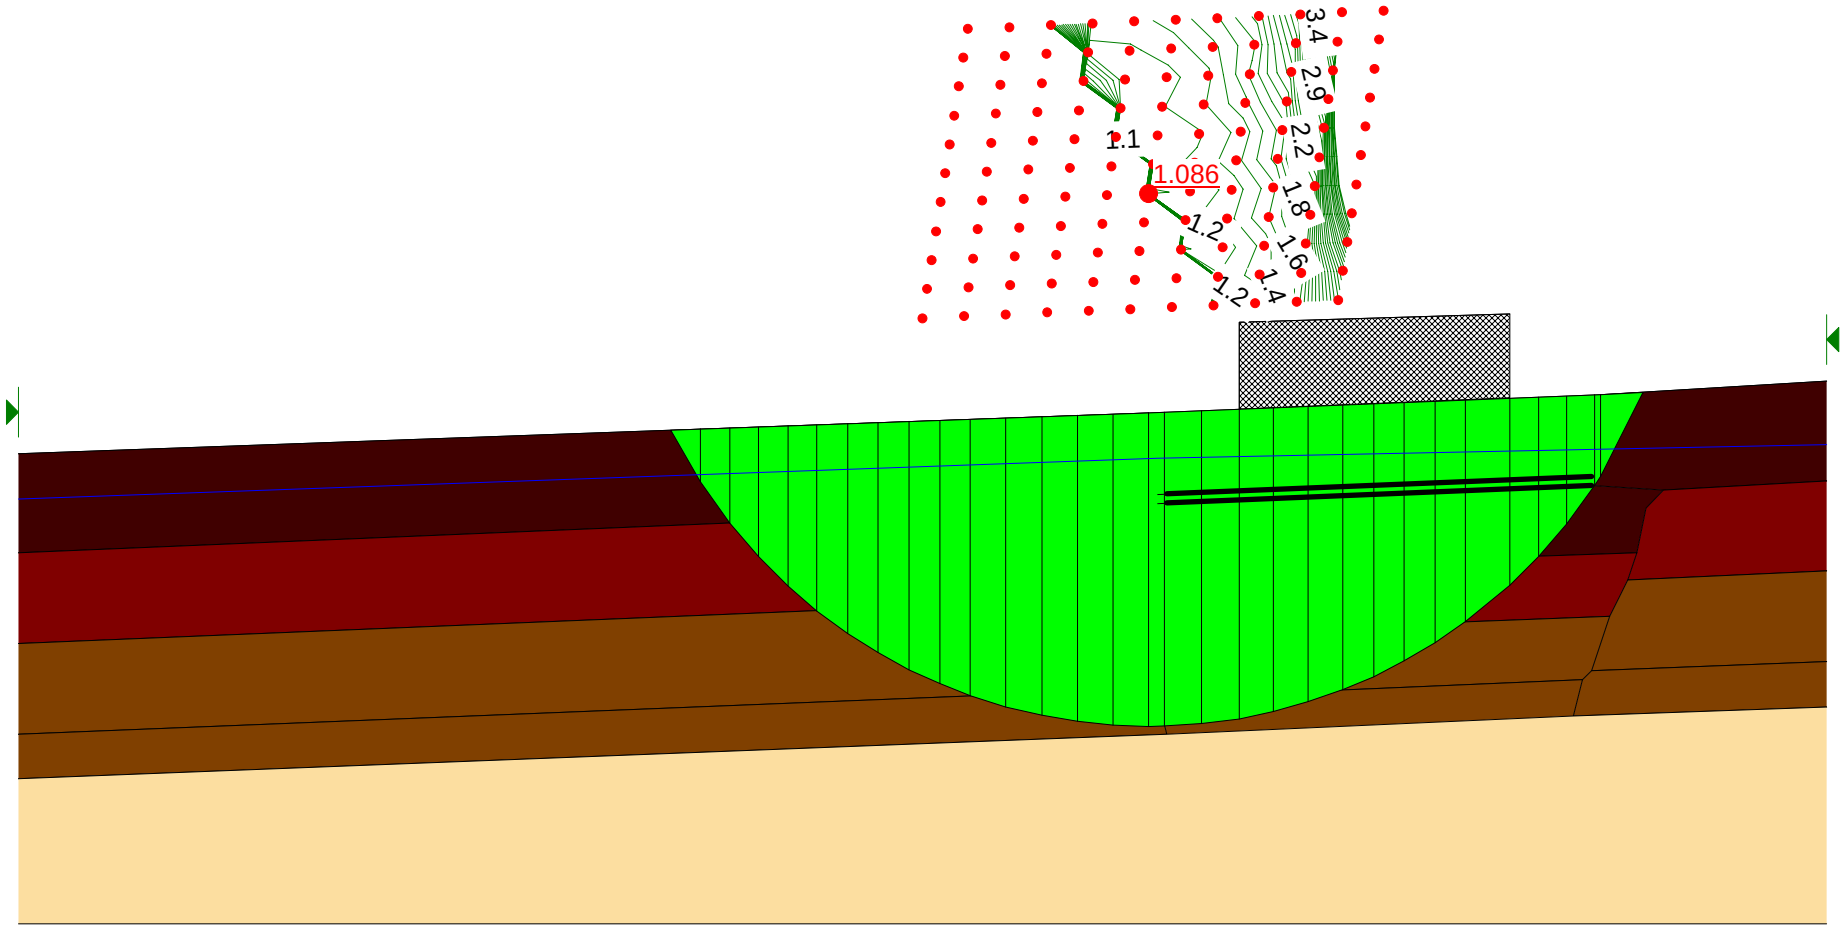
T11+100

5.0 m wide road - 1.0 m thick
Basal reinforcement with trees and 1 layer of Tensar SS30 Geogrid

Depth of peat = 3.5 m on downslope side of road
Slope angle = 2.0 Deg at surface, 2.5 Deg at base of peat

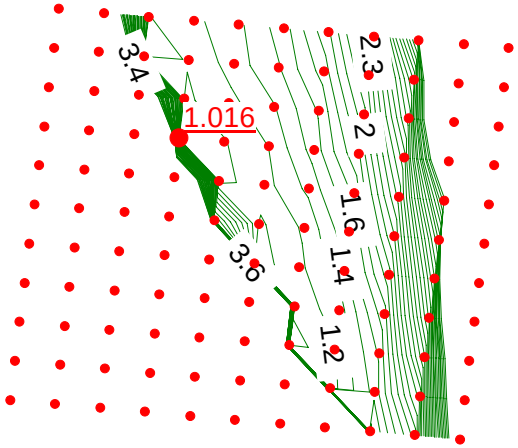
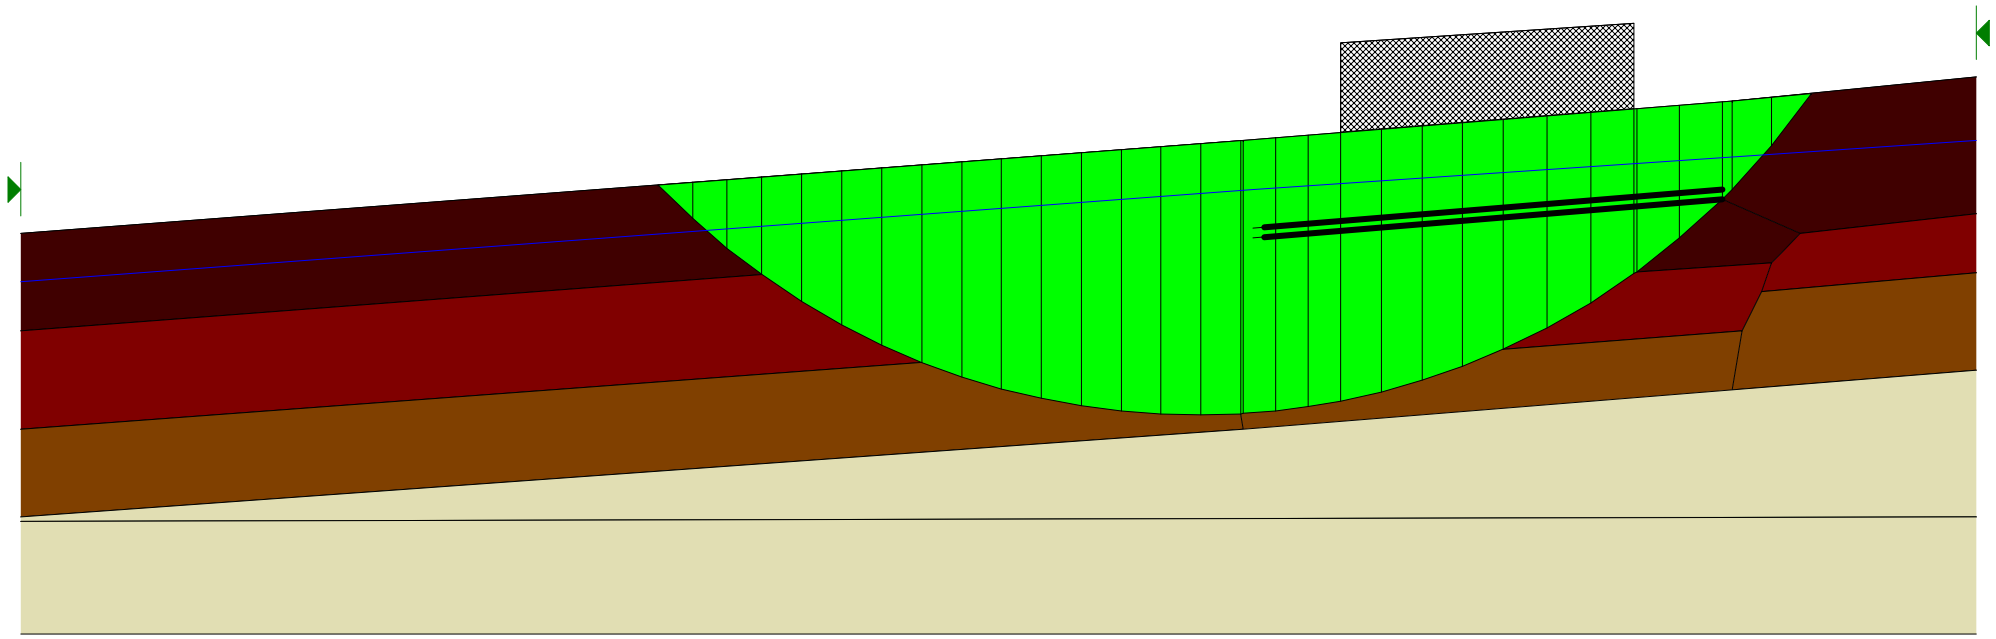
T13-25

5.0 m wide road - 1.0 m thick
Basal reinforcement with trees and 1 layer of Tensar SS30 Geogrid

Depth of peat = 2.9 m on downslope side of road
Slope angle = 4.2 Deg at surface, 4.3 Deg at base of peat

Partial factor of 1.3 applied to live load (17.1 kPa)
Calculated margin of safety >1.0 => OK

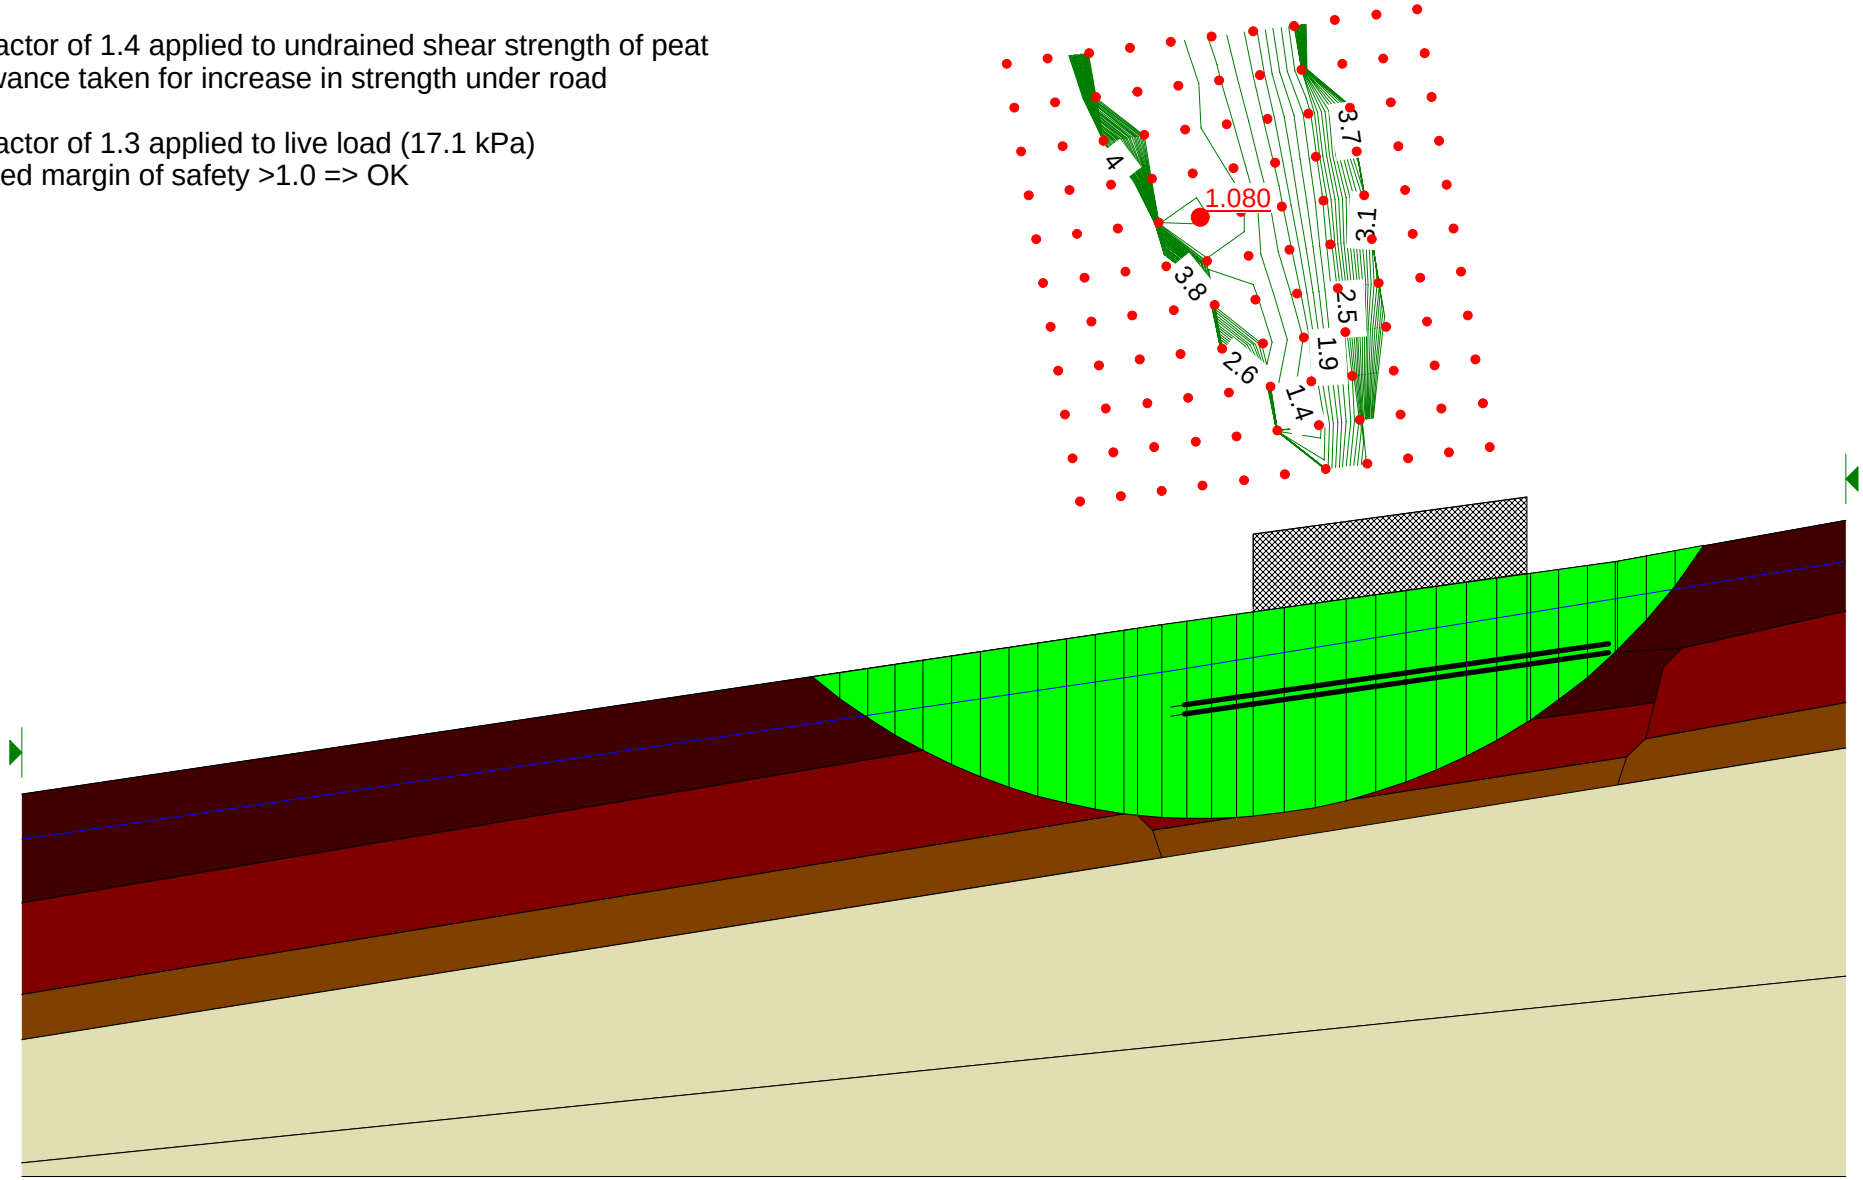
Derrybrien Windfarm - Floating Road Analysis: Cell T18

5.0 m wide road - 1.0 m thick
Basal reinforcement with trees and 1 layer of Tensar SS30 Geogrid

Depth of peat = 2.5 m on downslope side of road
Slope angle = 8.0 Deg at surface, 8.9 Deg at base of peat

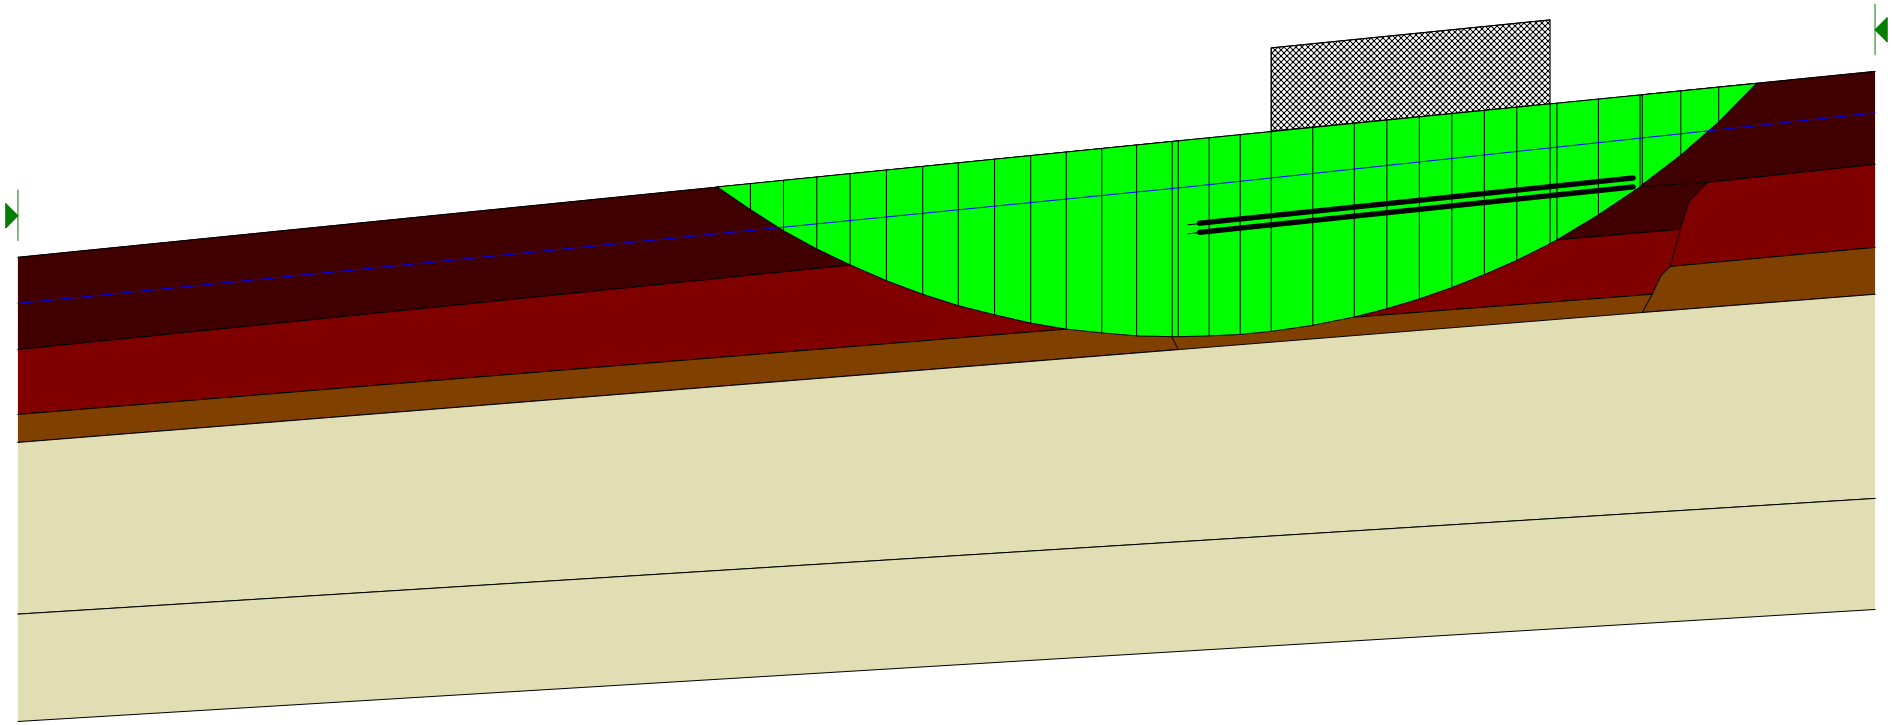
T25-25

5.0 m wide road - 1.0 m thick
Basal reinforcement with trees and 1 layer of Tensar SS30 Geogrid

Depth of peat = 2.1 m on downslope side of road
Slope angle = 5.3 Deg at surface, 4.6 Deg at base of peat

Partial factor of 1.3 applied to live load (17.1 kPa)
Calculated margin of safety >1.0 => OK

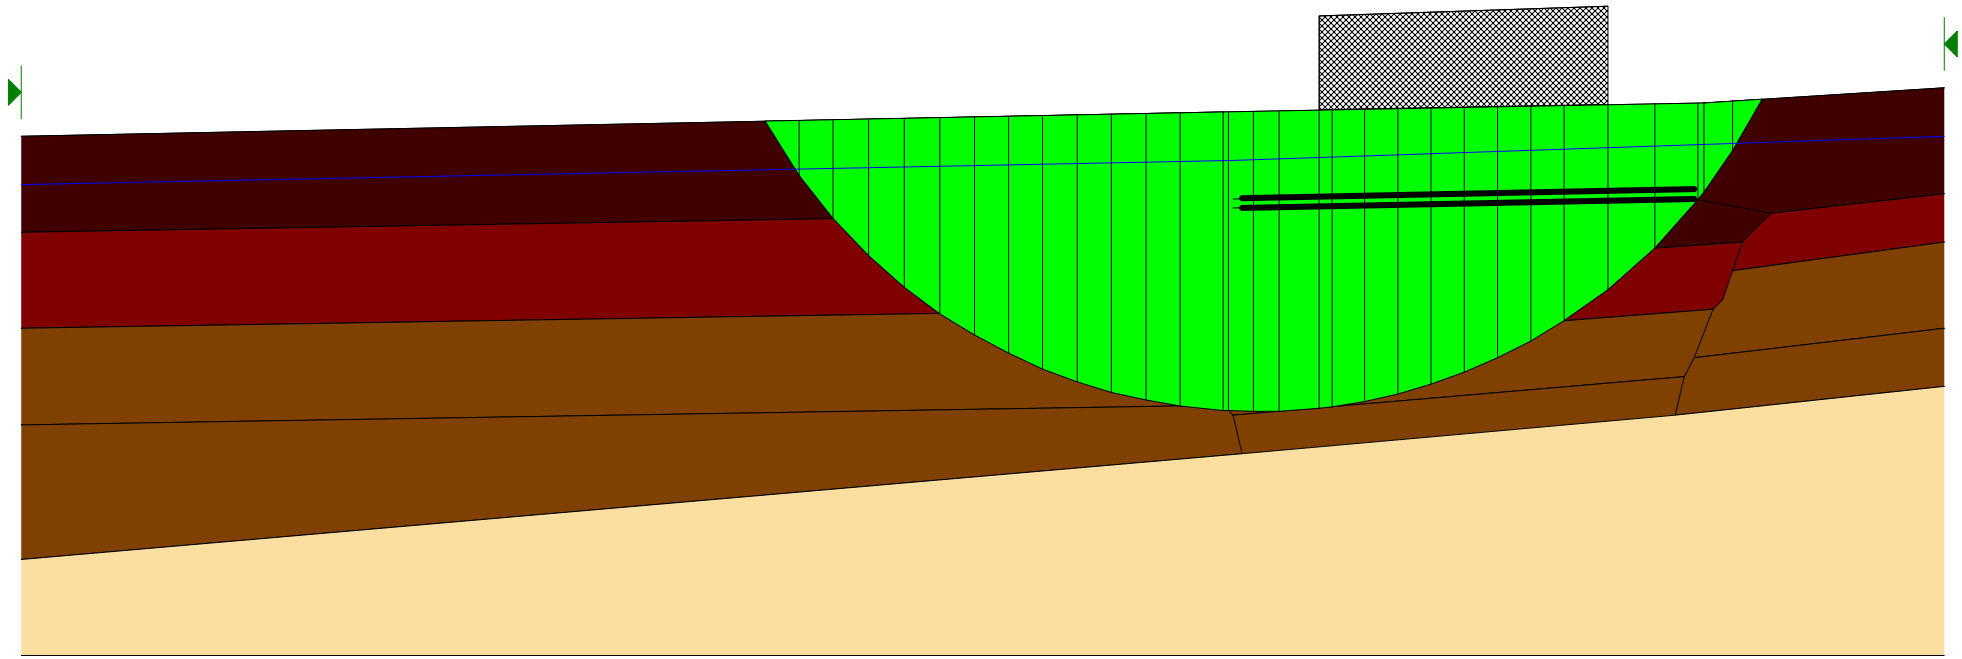
T27+75

5.0 m wide road - 1.0 m thick
Basal reinforcement with trees and 1 layer of Tensar SS30 Geogrid

Depth of peat = 3.5 m on downslope side of road
Slope angle = 1.0 Deg at surface, 5.0 Deg at base of peat

Partial factor of 1.4 applied to undrained shear strength of peat
No allowance taken for increase in strength under road

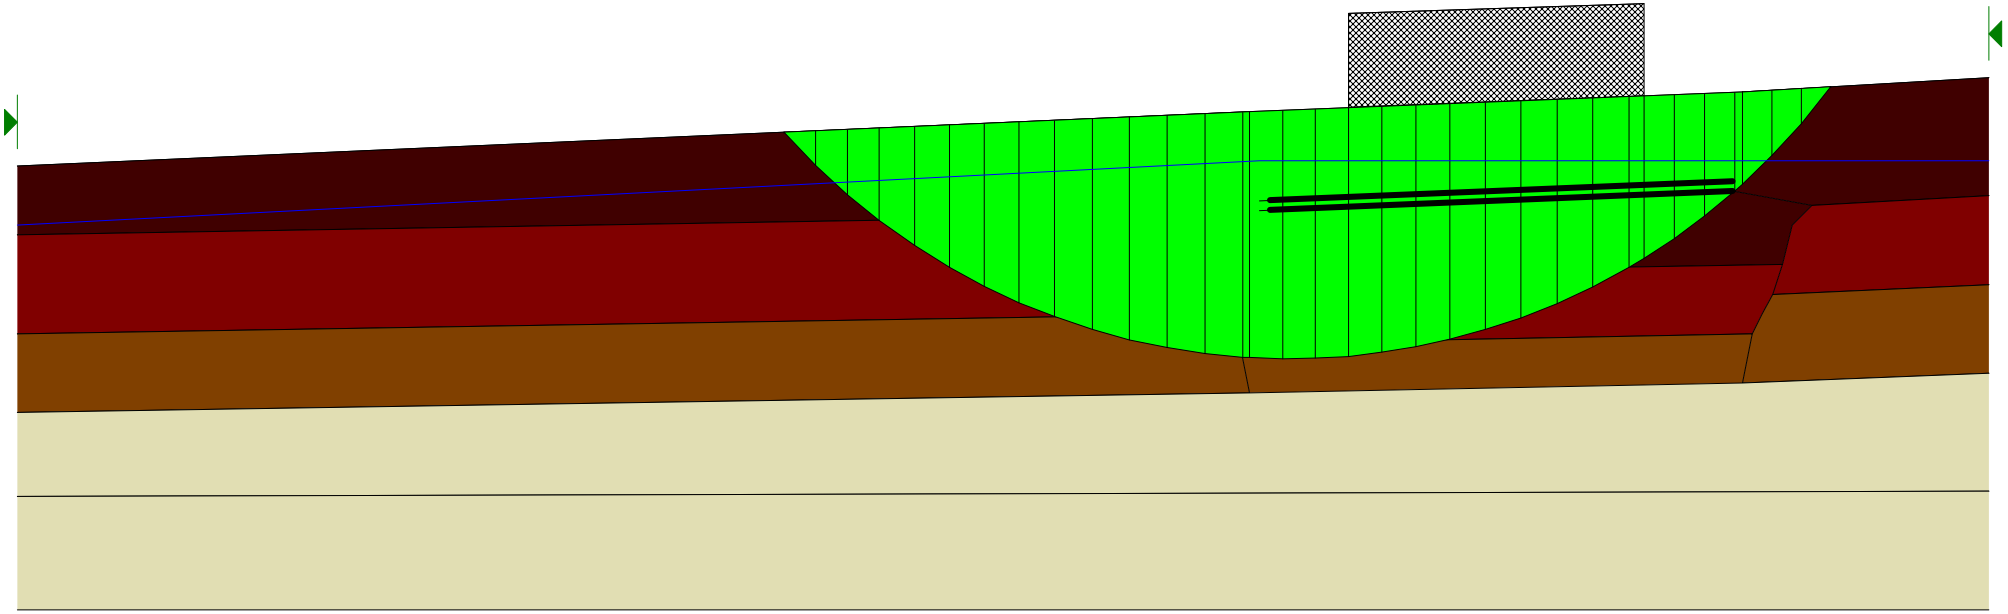
T30

5.0 m wide road - 1.0 m thick
Basal reinforcement with trees and 1 layer of Tensar SS30 Geogrid

Depth of peat = 2.8 m on downslope side of road
Slope angle = 2.5 Deg at surface, 0.7 Deg at base of peat

Partial factor of 1.3 applied to live load (17.1 kPa)
Calculated margin of safety >1.0 => OK
