Derrybrien Wind Farm Development Decommissioning Project – Retained Development

GEOTECHNICAL STABILITY REPORT - WIND FARM SITE (PART I)

DERRYBRIEN WIND FARM
GEOTECHNICAL STABILITY REPORT & ASSESSMENT OF STABILITY IMPACTS OF ON-SITE ACTIVITIES

Document No:	**11-147-R04**	**Issue 02 (Rev. 0)**
Made:	Conor O'Donnell / Niamh Farrell	
Checked:	Conor O'Donnell

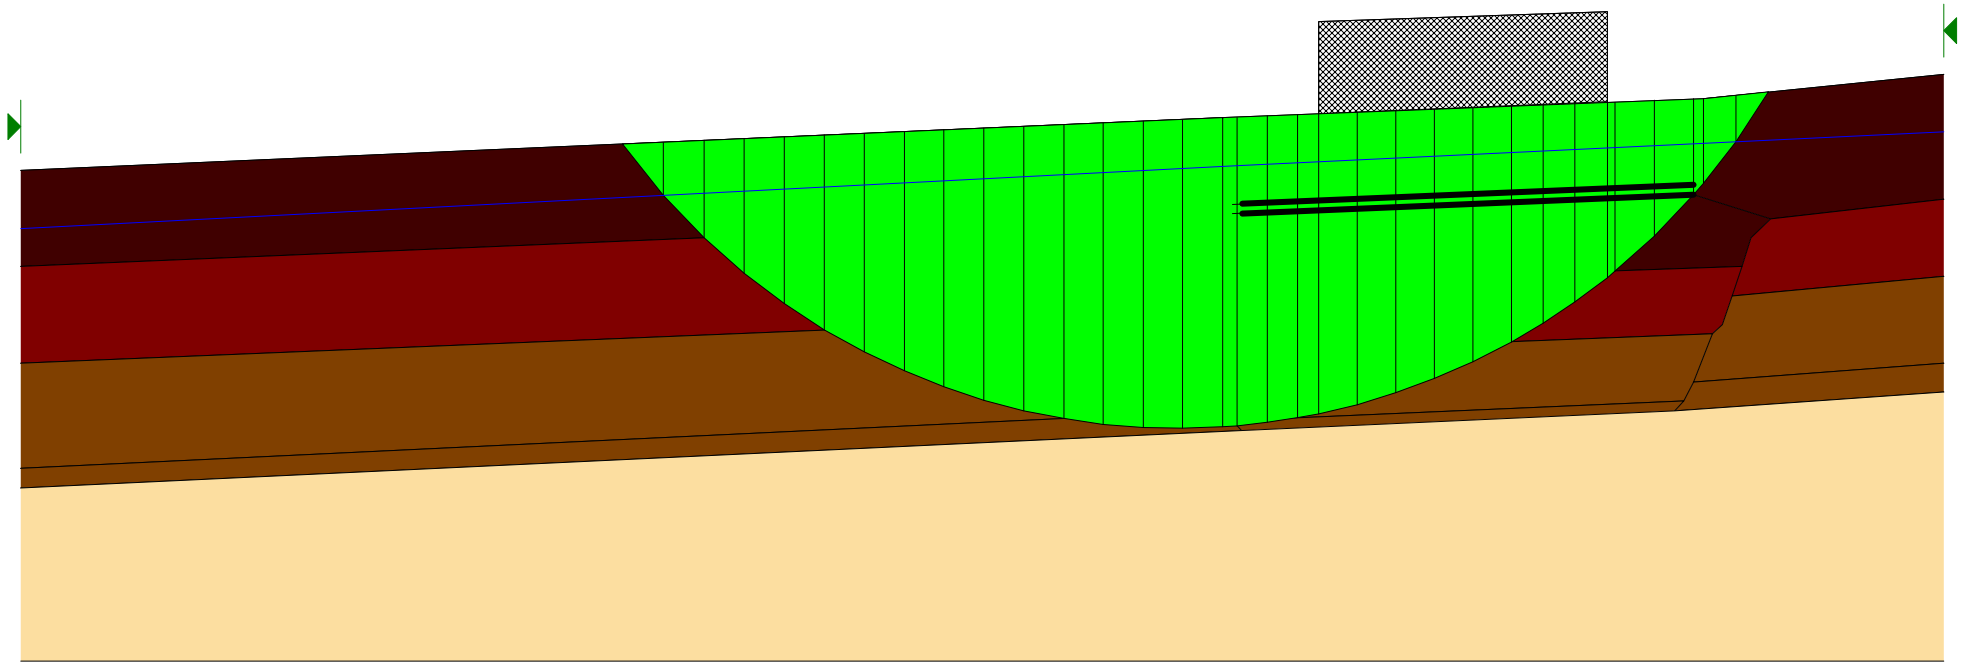
T42

5.0 m wide road - 1.0 m thick
Basal reinforcement with trees and 1 layer of Tensar SS30 Geogrid

Depth of peat = 3.2 m on downslope side of road
Slope angle = 2.5 Deg at surface, 2.9 Deg at base of peat

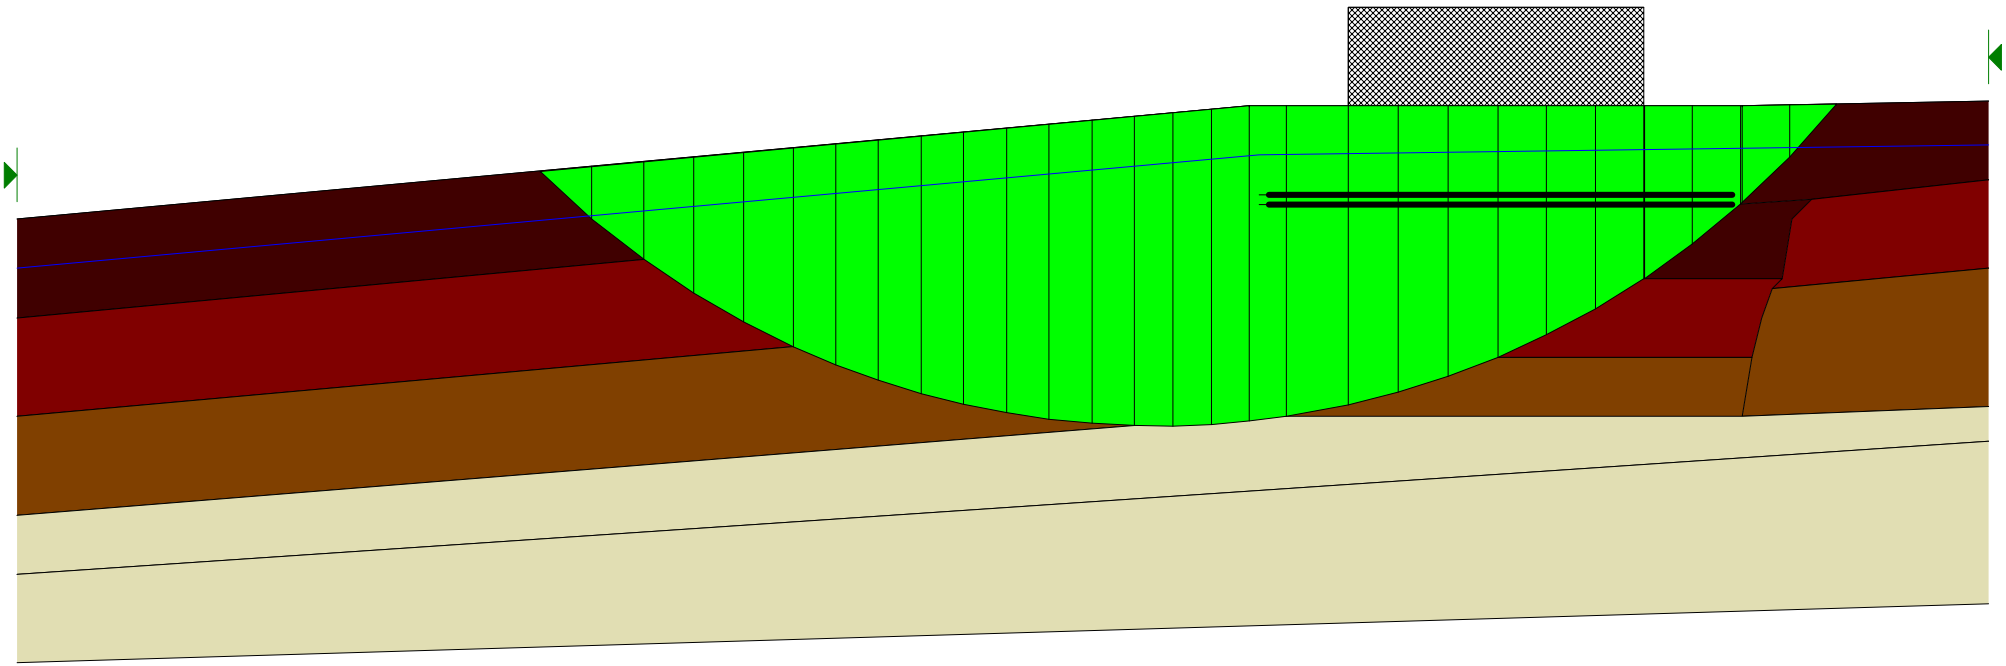
T51+75

5.0 m wide road 1.0 m thick
Basal reinforcement with trees and 1 layer of Tensar SS30 Geogrid

Depth of peat = 3.08 meters on downslope side of road
Slope angle = 5.2 Deg at surface, 4.7 Deg at base of peat

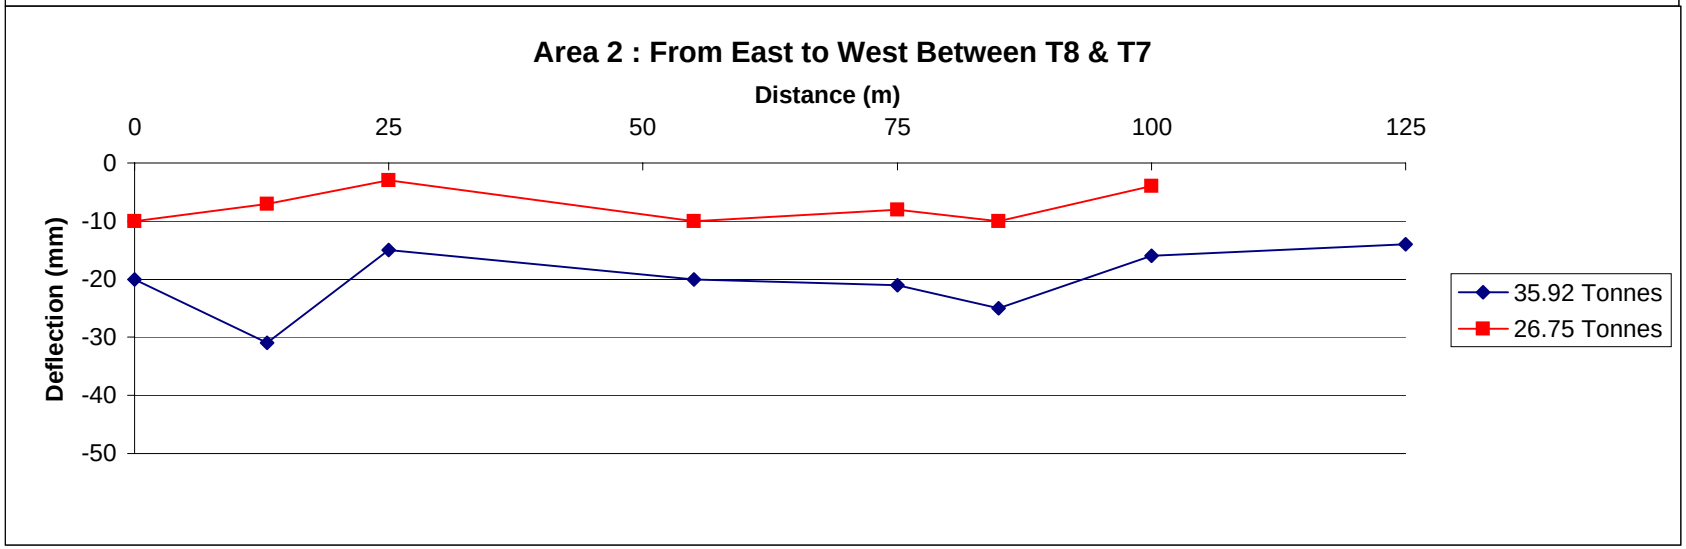
Note: Road deflection measured at 35.92 tonnes appear to be incorrect based on observed performance of road and will be re-checked during next phase of road testing.

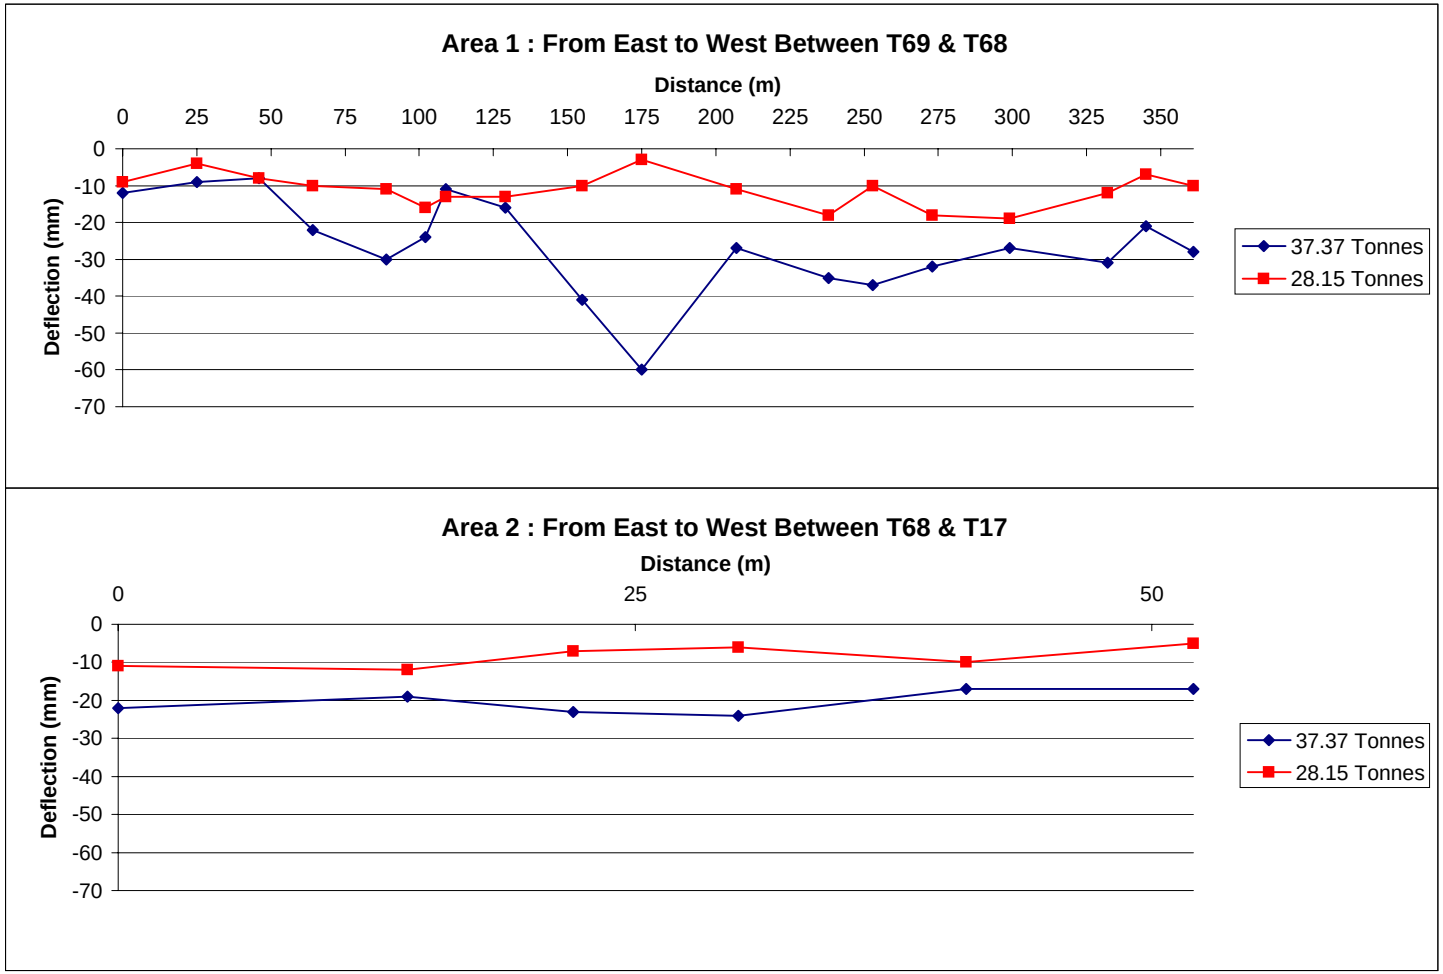
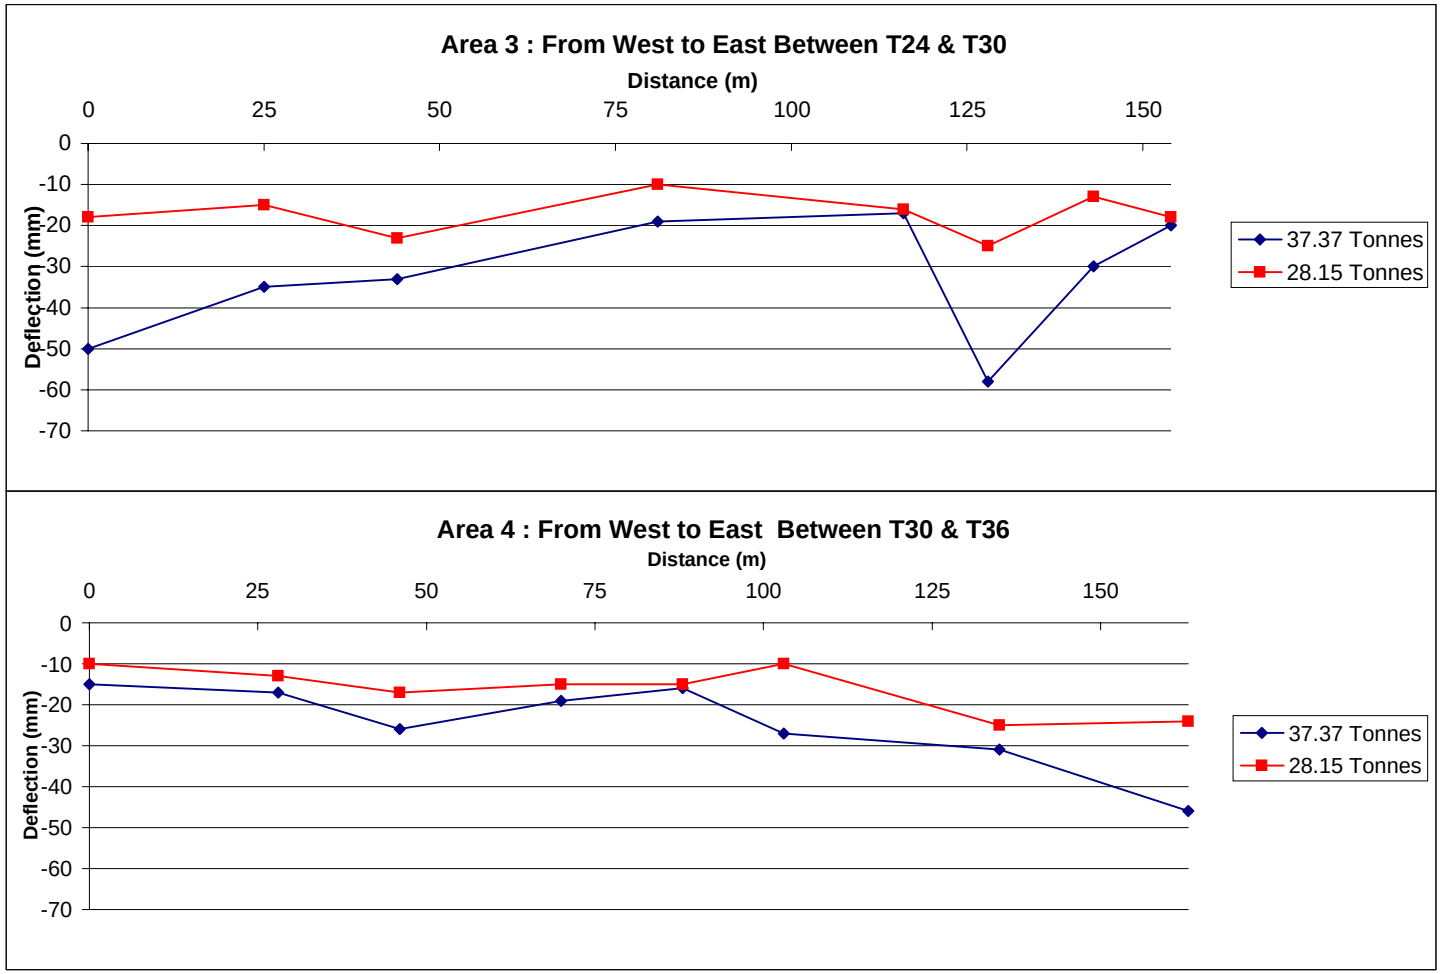
Derrybrien Windfarm - Road Test Results
Phase 3 Eastern Section of Site

Area 3 : From West to East Between T24 & T30
Distance (m)
0
25
50
75
100
125
150
0
-10
-20
-30
-40
-50
-60
-70
Deflection (mm)
37.37 Tonnes
28.15 Tonnes
Area 4 : From West to East Between T30 & T36
Distance (m)
0
25
50
75
100
125
150
0
-10
-20
-30
-40
-50
-60
-70
Deflection (mm)
37.37 Tonnes
28.15 Tonnes
